2022 GOVERNOR'S HISTORIC PRESERVATION AWARDS

First Congregational Church of Long Beach

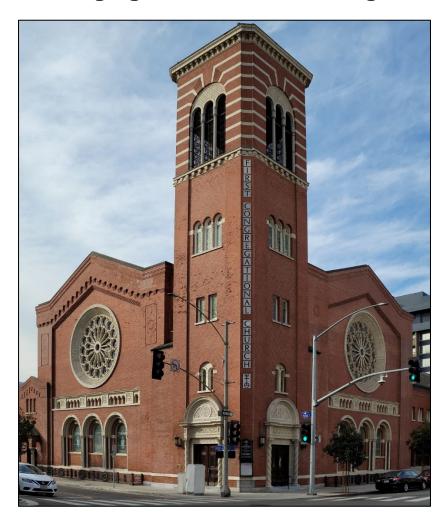
A multi-year, \$2.4 million project stabilized, cleaned, repaired, and restored the brick and terra cotta masonry of the First Congregational Church, a 1914 Italian Romanesque Revival building in downtown Long Beach, California. The church is designated by the City of Long Beach as a Historic Landmark and is listed on the National Register of Historic Places.
