Window Repair, Rehabilitation, and Replacement

November 2011

Deliverable 7.5.2 – Window Repair, Rehabilitation and Replacement: Draft Measure Guideline

Building Science Corporation

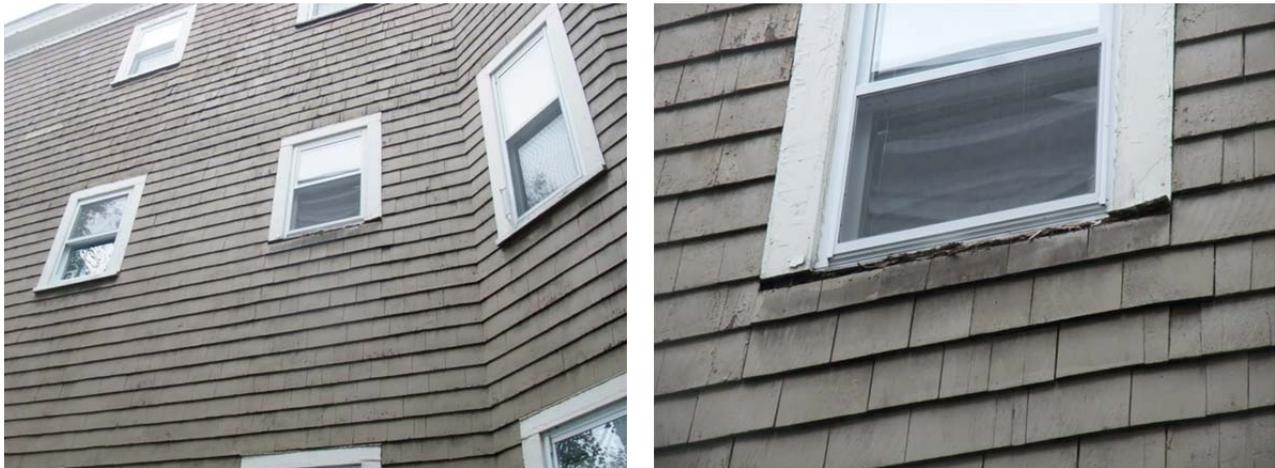
Figure 5. Failed window sill with replacement window installed

The window sill is arguably the most important element of the window assembly, as water will drain downward by gravity either into the wall (e.g., hole through sill) or directly onto the wall (failure of the sill extension). For all proposed measures in this document excluding complete window replacement, the condition of the sill is critical to the performance of the measure. Cracked or rotting sills need to be replaced prior to any work being done.

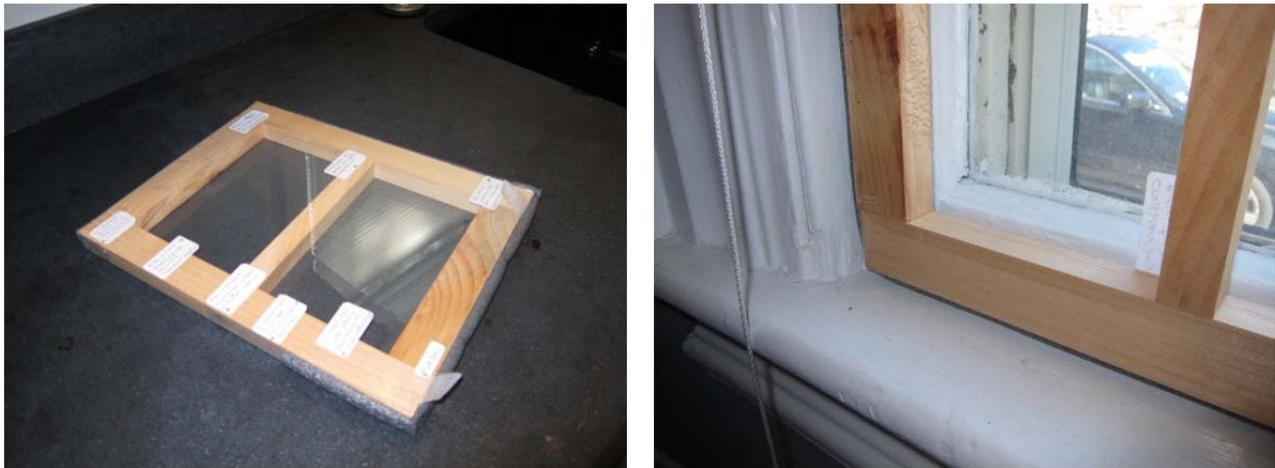
An alternate to exterior storm windows is removable interior storm windows. These can take a wide variety of forms, from films adhered to the interior of the window jambs, to site built frame wrapped with films that are friction fit into the window opening, to pre-manufactured fixed or operable glass or acrylic lites in a thin metal frame. The pre-manufactured versions are often installed via a metal angle and magnetic track fastened to the window frame.

Figure 7. Interior removable storm window sample

These systems are typically less permanent, and intended to be installed on a seasonal basis (usually during the winter in cold climates), as most of them limit the option of opening or closing the window after installation.

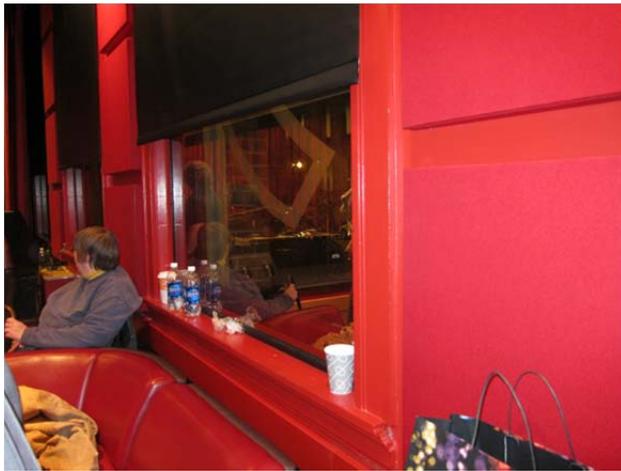
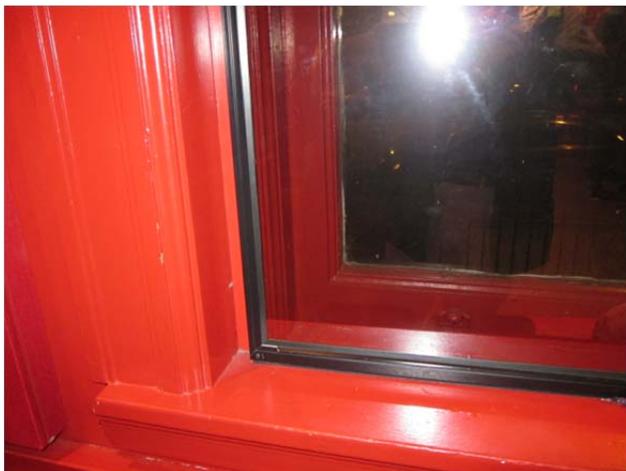
In certain cases, there is no urgent need for seasonal changeover, and a more permanent solution is desired. In these cases, permanent interior storms can be added. There are two approaches with this solution: 1) installation of a fixed glazing unit, 2) installation of an operable unit.

Figure 8. Interior storm window on double-hung original window

Fixed glazing units meet requirements if operation of the window is no longer needed. Fixed units can typically be made more airtight, and will have thinner frame profiles, so that the amount of vision area is not impacted. Also, they can often be installed in a manner that has minimal impact on the interior appearance of the window, so that interior aesthetics can be more closely maintained. An operational concern with this approach is that cleaning of the windows is no longer possible from the interior, and may be difficult from the exterior as well. While the more common approach has been to use single glazed lites (often clear acrylic for retrofits by homeowners), there is an option to use double and triple glazed IGUs (insulated glazing units) as well, for increased energy performance.

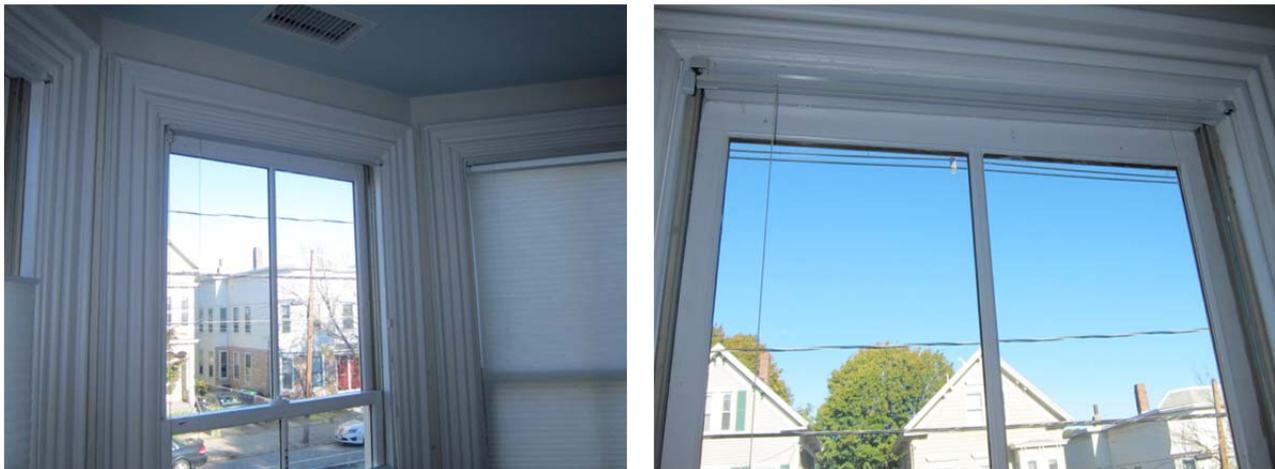
Figure 10. Sash replacement, showing out of square opening and requirement for sash extension

It is an option to replace the window sashes while leaving the existing frame in place. This is a good option if there is a desire to maintain the original appearance, but the existing sashes cannot accommodate new IGUs, or are in sufficiently poor condition to warrant replacement in lieu of rehabilitation. The replacement sashes must be custom built for the frame opening, as there is very little opportunity for adjustment. Window frame condition and geometry can be a factor. The window jambs however need to be very close to parallel to allow for smooth operation and to prevent unwanted air leakage between the frame and sash. If the replacement sashes are made from wood, the windows can be out of square to a certain degree since the top and bottom of the sashes can be cut to match the angles.

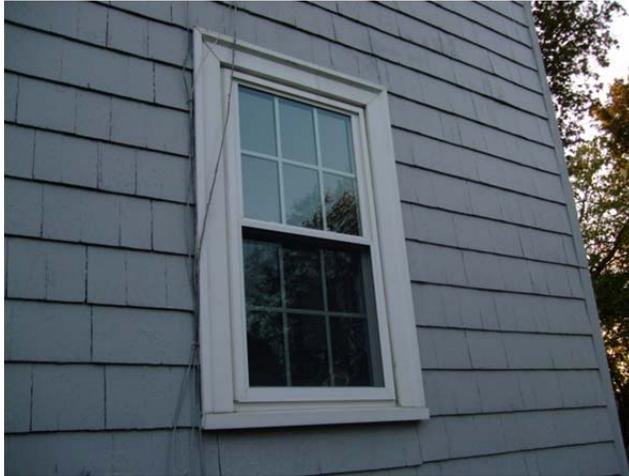
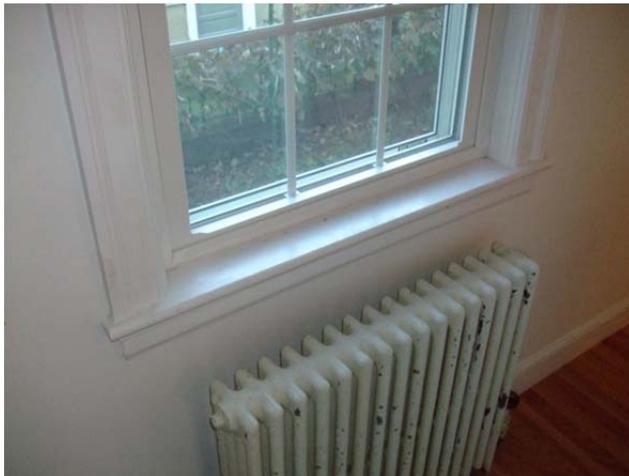
Figure 12. Insert replacement vinyl frame window

option). The result is a completely new window assembly. A down side to this approach is that the amount of vision area of the windows is reduced by the addition of an additional window frame with sashes. For already small window openings, this reduction may be significant and undesirable. For larger windows, the impact will be less noticeable.

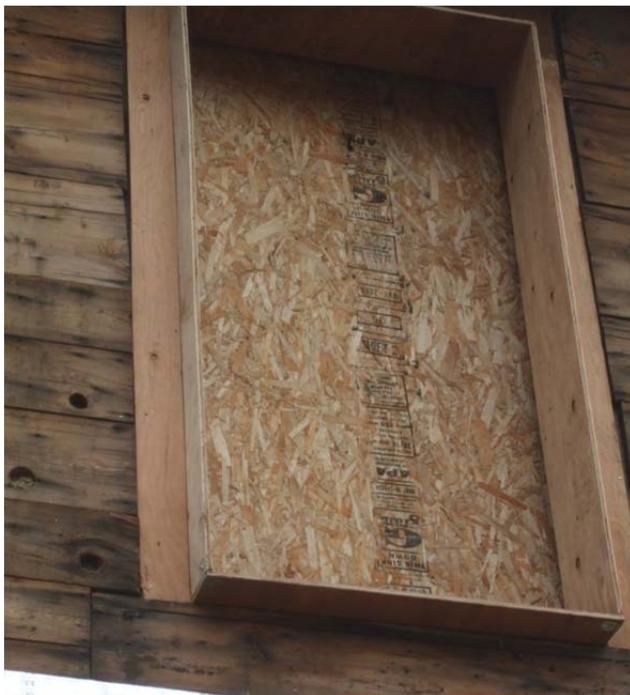
Figure 13. New window rough opening framed with and extension box to allow for the addition of exterior insulation

Ultimately the existing window can be completely removed and replaced with a new window. The benefit of this measure is that the window installation details can be brought up to current window installation standards. This approach is typically most common with more extensive building retrofits, as it generally requires disturbance to both interior as well as exterior finishes. When combined with a more extensive energy retrofit that includes the addition of exterior insulation to the building, it provides the most freedom for design and placement of the window. The windows can be installed in place with the framing or be pushed towards the exterior to line up more traditionally with the plane of the siding.

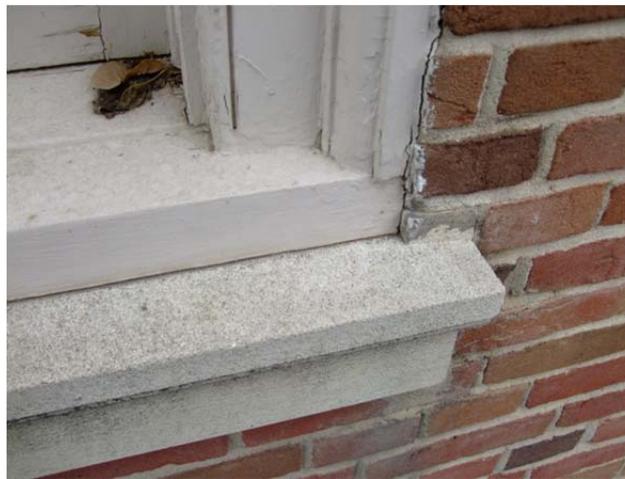
Figure 17. Wood window sill on top of masonry sill

Similar approaches are used in mass masonry walls with a few slight changes to the concept. At the window head, the window frame is set back from the face of the masonry (approximately 1 wythe), so the head flashing is traditionally eliminated. At the jambs, the window casing either butts directly up against the brick, or is overlapped by the outer wythe with the joint caulked. The sill is shingle lapped over a stone, concrete, or brick sill. The masonry sill is usually sloped to the exterior.

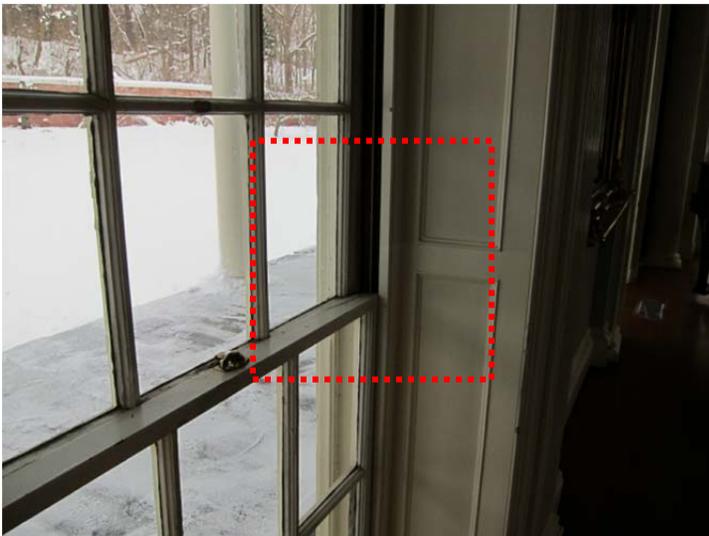
Figure 20. Infrared images of window air leakage (depressurization test)

In addition to the meeting rail and jamb air leakage, leaks can also be found at the head and sill, as shown in Figure 20.

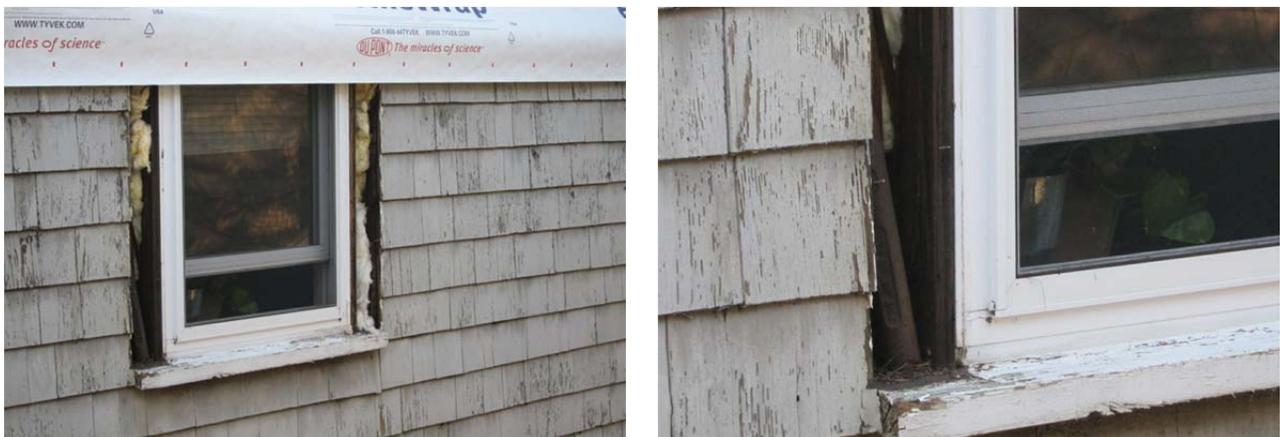
Figure 23. Sash weight pockets, showing abandoned sash weight and insulation installation

The largest of the voids are typically at the weight pockets, created to house the sash counter weights. The weights are connected to the sashes through either ropes or chains that run from the sash to a pulley near the top of the window jamb and into the weight pocket. When combined with an interior storm window (both temporary and permanent), the pulley weight pockets can create a condensation potential (discussed below), as they are a pathway for movement of interior air into the space between the existing window and the new interior glazing element. Often, the sash weights can be eliminated by retrofitting the windows a spring-loaded tape balance. Abandoned weight pockets are a source of energy loss from both a conductance perspective as well as from uncontrolled air leakage. Even when they are insulated, it is often done in a “blind” manner (inserting insulation through an access hole in the jamb), resulting in poor installation quality.

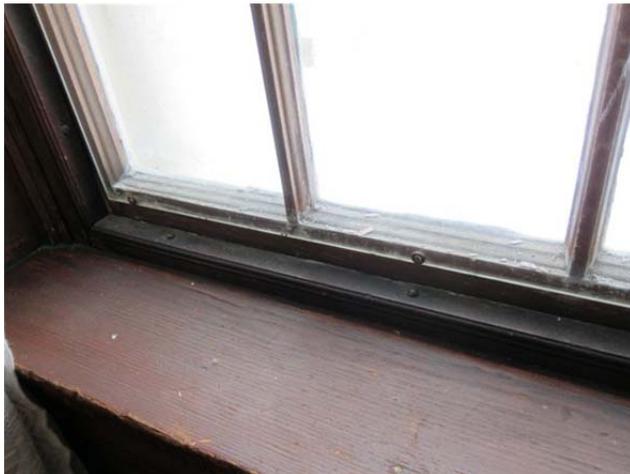
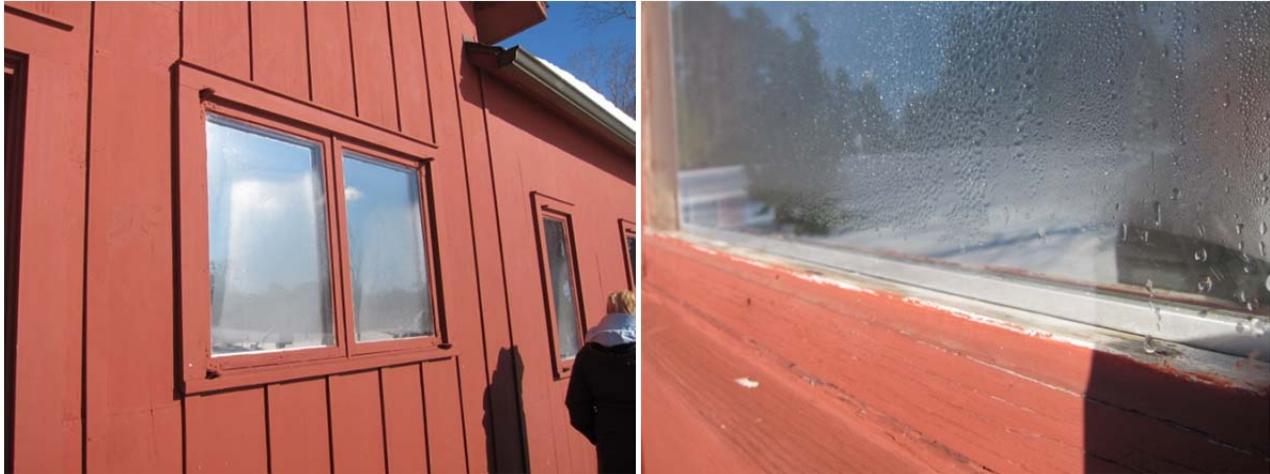
Figure 24: Examples of condensation problems with interior storm retrofits

The addition of interior or exterior glazing elements to the original window creates a potential for the formation of condensation between the two glazing elements. The placement of the interior or exterior of the window creates an insulating air pocket, resulting in the outer glazing element to be at a lower temperature at wintertime conditions. This increases the chance of condensation forming, if interior moisture laden air is able to infiltrate into the space.

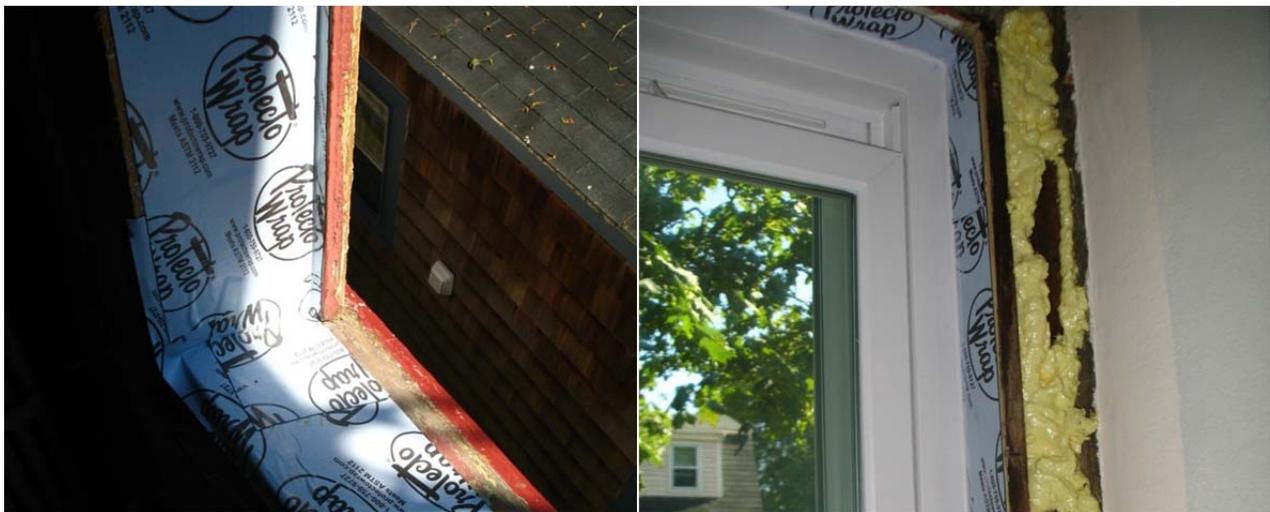
Figure 35. Examples of membrane installation in a wood window frame
