# 2014 GOVERNOR'S HISTORIC PRESERVATION AWARDS

## Hallidie Building Restoration

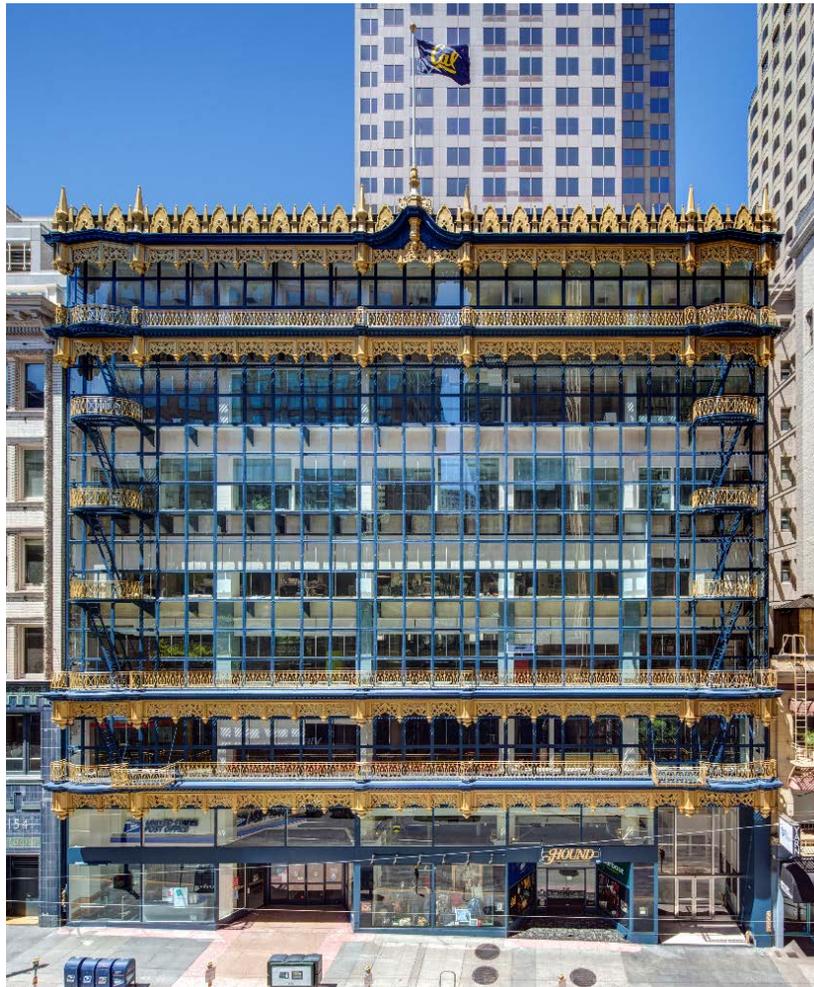
*The façade of the restored Hallidie Building in San Francisco*

The initial project scope was to replace the structural steel supports of the balconies and fire escapes, which had become unsafe due to severe corrosion. Investigation of the curtain wall began in 2010 at these locations, where the supports penetrate the façade, and expanded to include all of the window units and the structural T-mullions to which they connect. The final scope of the project included a full

restoration of the curtain wall, balconies and fire escapes, and the highly ornamental sheet metal. As a San Francisco Landmark, the repair work was required to comply with the Secretary of the Interior's Standards for Rehabilitation of Historic Buildings. The design team included a preservation architect, Page & Turnbull, for consultation on repair approaches and to ensure best preservation practices were followed. The team also included a materials scientist who reviewed repairs for proper material compatibility. Project efforts included, among others: proper documentation and cataloging of all elements removed from the building; removal of historic materials in a way that would minimize damage; identification of compatible replacement materials in order to retain the building's historic integrity; extensive color analysis to determine the original blue and gold colors of the façade; and cataloging of all features repaired or replaced and of all treatment procedures.
