2018 GOVERNOR'S HISTORIC PRESERVATION AWARDS

Cucamonga Service Station

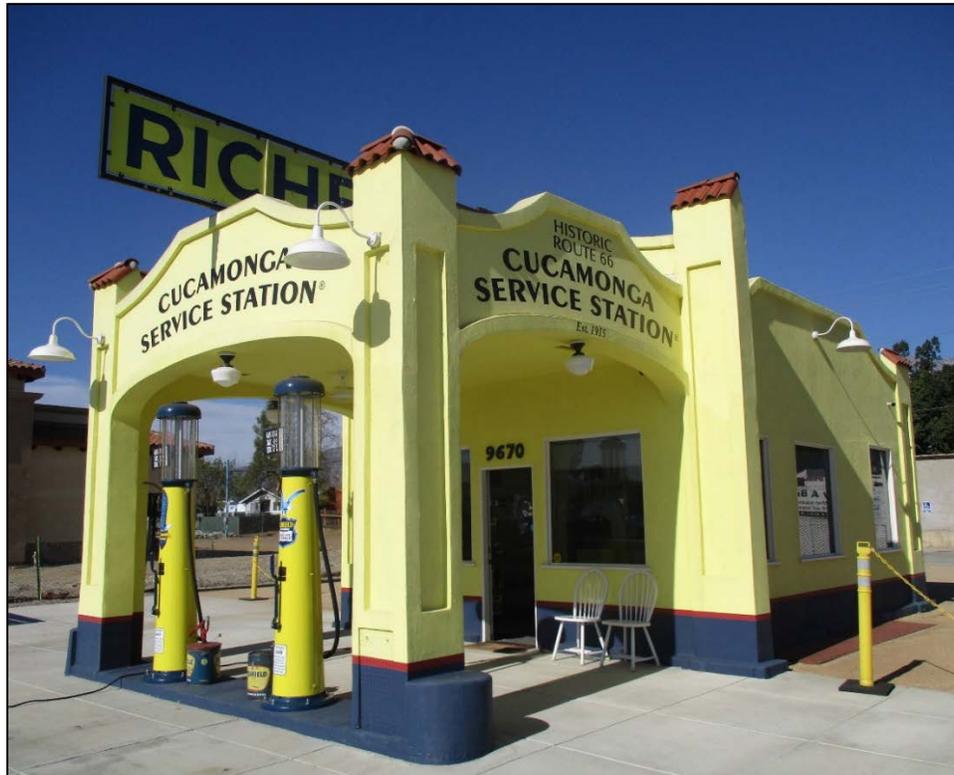
Substantial water damage required replacement of the roof and much of its wood, as well as some of the wood in the walls. The foundation had also experienced significant erosion, requiring repair. Exterior stucco, the station floor, and Spanish tile topping the columns, were all remarkably intact.

Removal of layers of paint from the exterior revealed the original Richfield color scheme of yellow, blue, and red. The station was repainted in the original color scheme, and an original Richfield sign installed on the station's rooftop to match the station's appearance as documented in period photographs. The concrete floor was given a period appropriate sealant and finish, and 1920s-style fixtures and push-button light switches were used throughout.
