## 2021 GOVERNOR'S HISTORIC PRESERVATION AWARDS

### Paramount Theatre of the Arts Façade Restoration

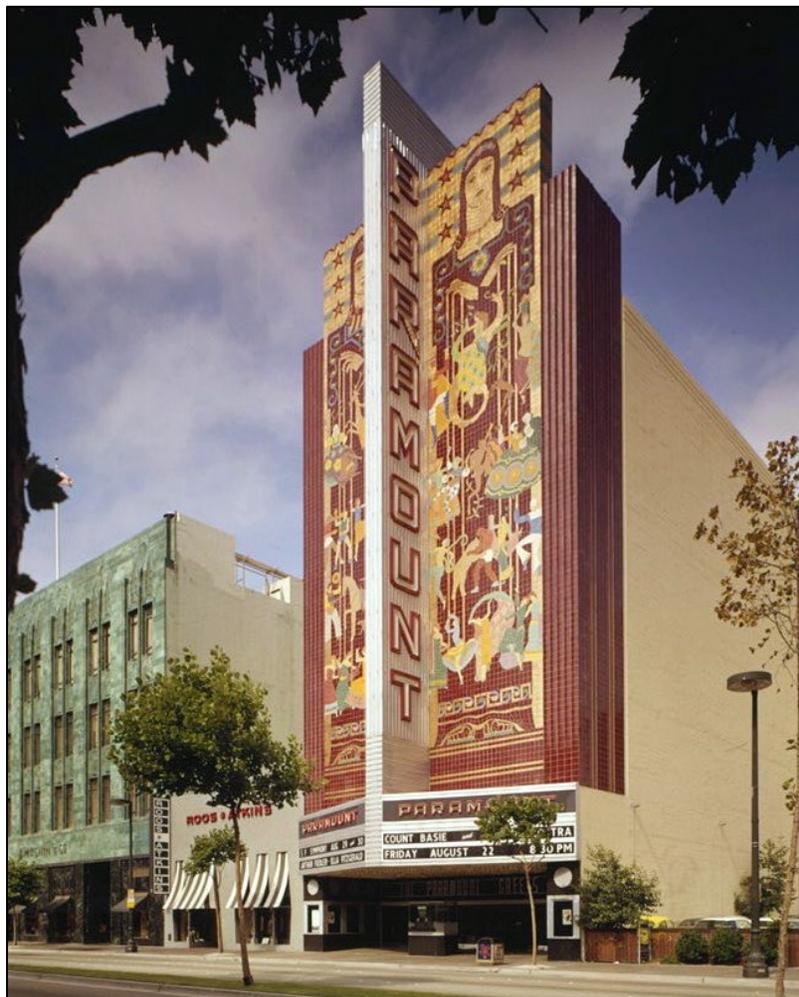
The east (Broadway Street) elevation of the reinforced concrete structure features a monumental terra cotta tile mosaic, which extends over 100 feet above the street level. The mosaics, which depict brightly colored male and female figures overseeing scenes of the performing arts, were specifically designed for the Paramount by Gladding, McBean, & Company. The scenes are framed by maroon

and gold tiles on all sides. The mosaics are divided by a streamlined vertical blade sign bearing the name "PARAMOUNT." The façade retains high integrity, as alterations to the mosaics have been limited to minor repairs.

A façade survey in Spring 2018 determined that while much of the mosaic was in excellent condition, ultraviolet degradation of previous repairs, as well as spalling of the chevron-shaped tiles flanking the mosaics, had negatively impacted the appearance of the façade. In Winter 2019, work began to repair and stabilize the terra cotta façade and restore the blade sign between the mosaics. Work complied with the Rehabilitation Treatment of the Secretary of the Interior's Standards.

Ultraviolet (UV) exposure had caused years of coatings to fade and peel. Removal of the coating revealed deep spalling. Replacement of the terra cotta, with a wider joint between the tiles, prevented friction spalling while maintaining the façade's appearance and the original design intent. The original maroon glaze formula was used by Gladding, McBean, so the original and replacement terra cotta segments matched perfectly. Multi-colored mosaic scenes on the principal façade were in nearly perfect condition, so repairs consisted merely of joint re-pointing and limited spall repair. The small copper roofs at the top of the mosaics had become loose over time and were not protecting the mosaic. To prevent future damage, the copper roofs were removed, and refurbished, and waterproofing membrane installed prior to reinstalling the copper. Work on the iconic blade sign included patching corroded sections, and re-coating of the sign prior to reinstallation of the stored neon lights, most of which were original to the 1930 construction.
