National Register of Historic Places Registration Form

Historic name: Cucamonga Service Station **DRAFT**
 Other names/site number: None
 Name of related multiple property listing:
U.S. Highway 66 in California MPS
 (Enter "N/A" if property is not part of a multiple property listing)

Street & number: 9670 Foothill Blvd.
 City or town: Rancho Cucamonga State: CA County: San Bernardino
 Not For Publication: Vicinity:

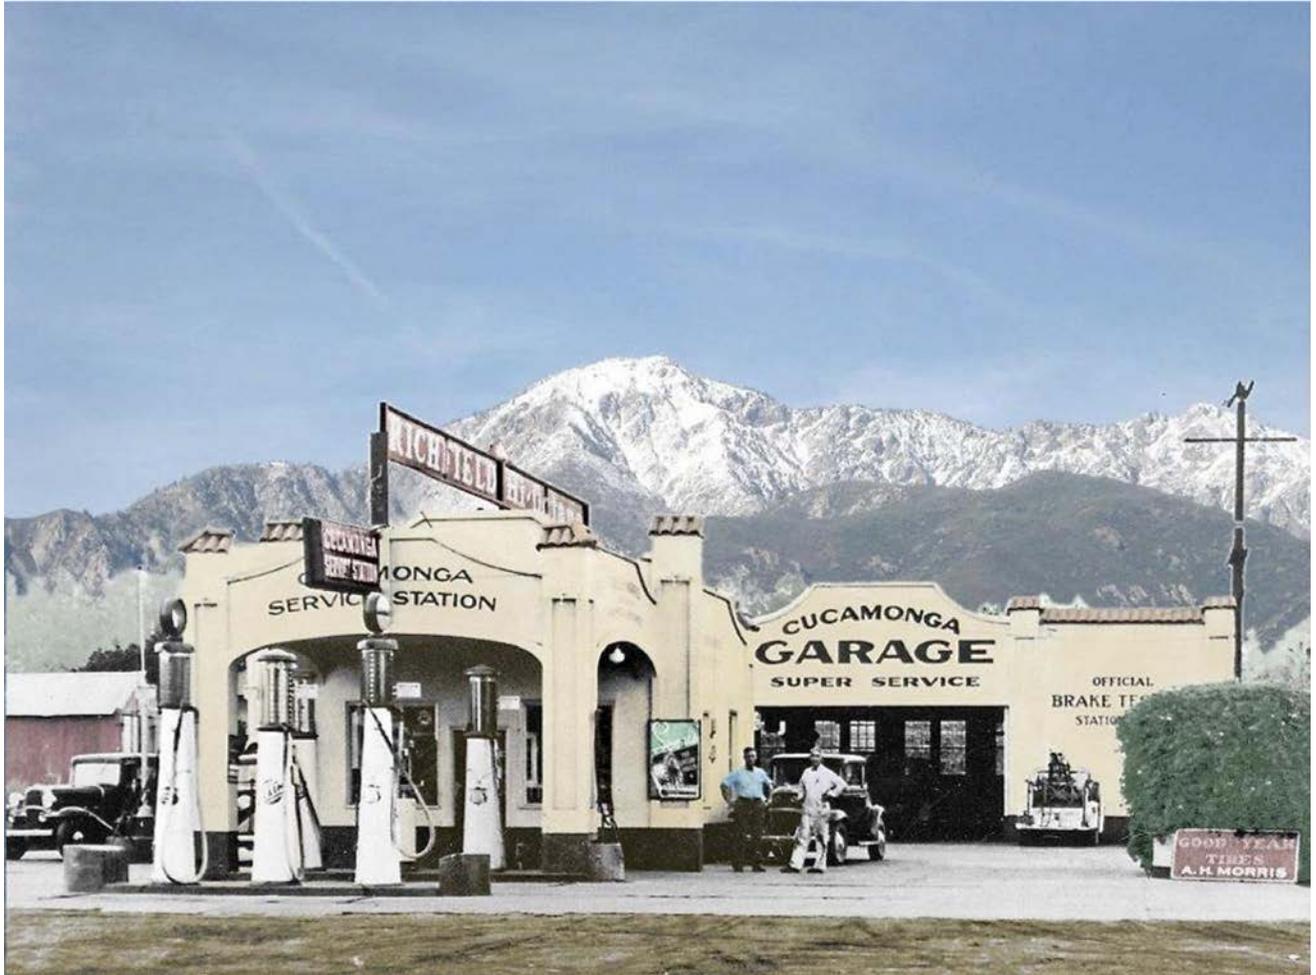
Figure 1: Photo of station as it appeared in the 1930s, showing Richfield colors and signage. Garage behind station is no longer extant.

After the property's original construction in 1915, dual archways matching the architectural style of the station building were added on either side, (see Figure 2.) These archways were removed at some point prior to 1930 when later existing historic photos were taken (see Figures 1 and 3.) Because these elements were removed during the property's period of significance, their present absence does not result in a loss of historic integrity, as the current building reflects the station's original design and its extant design since 1930.

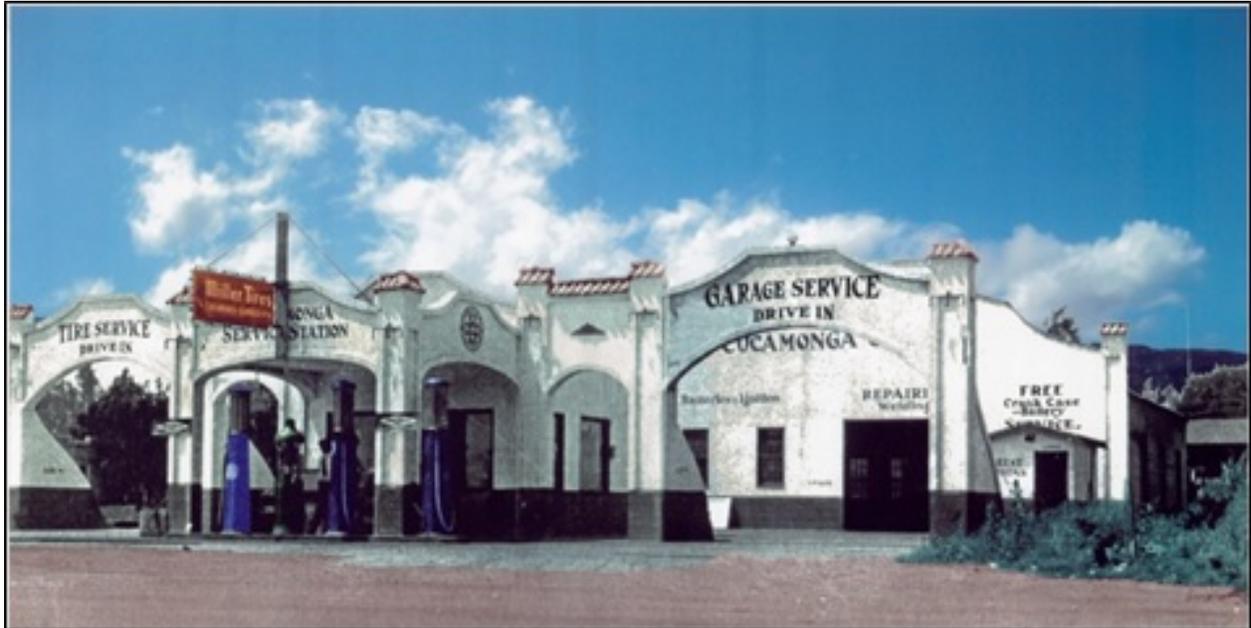
Figure 2: Photo of station from 1930s, painted postcard view showing archway features on either side of building entrance.

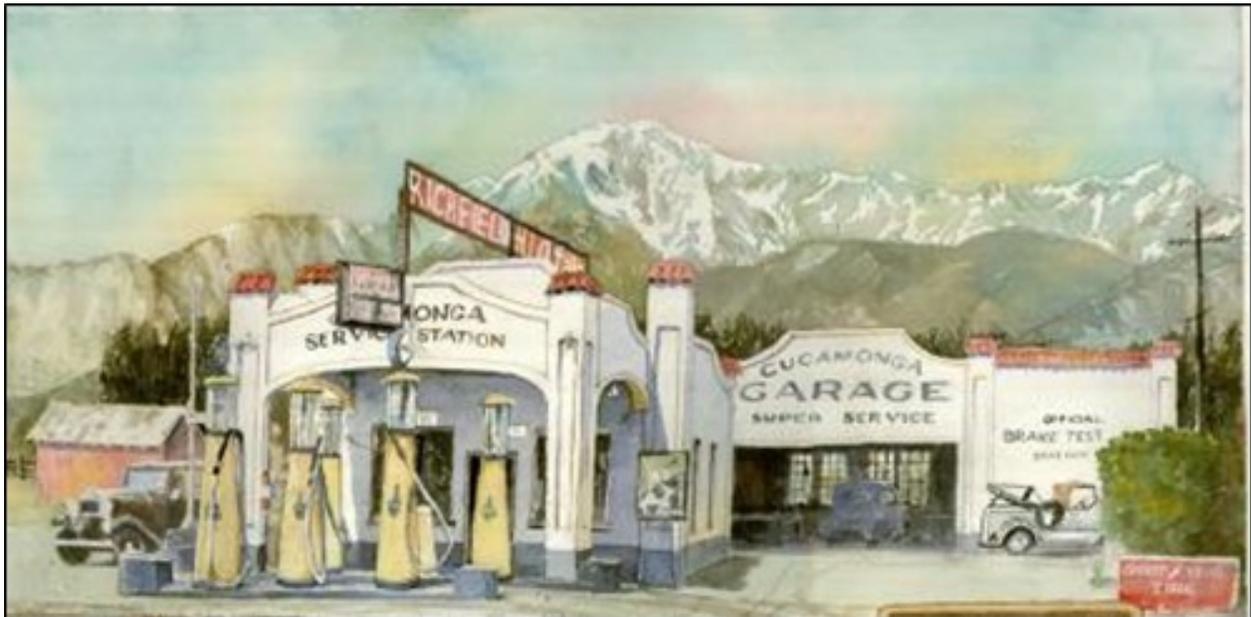
Figure 3: Additional postcard view after removal of archways, which took place in the late 1920s or early 1930s.

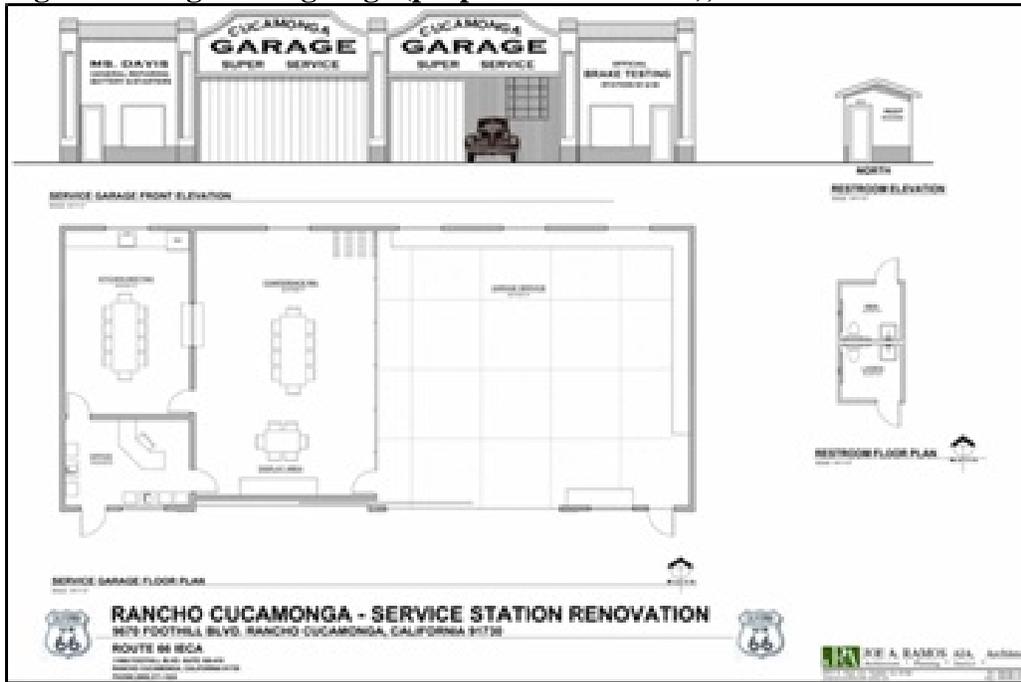
Figure 6: Diagram of garage (proposed restoration), since demolished.

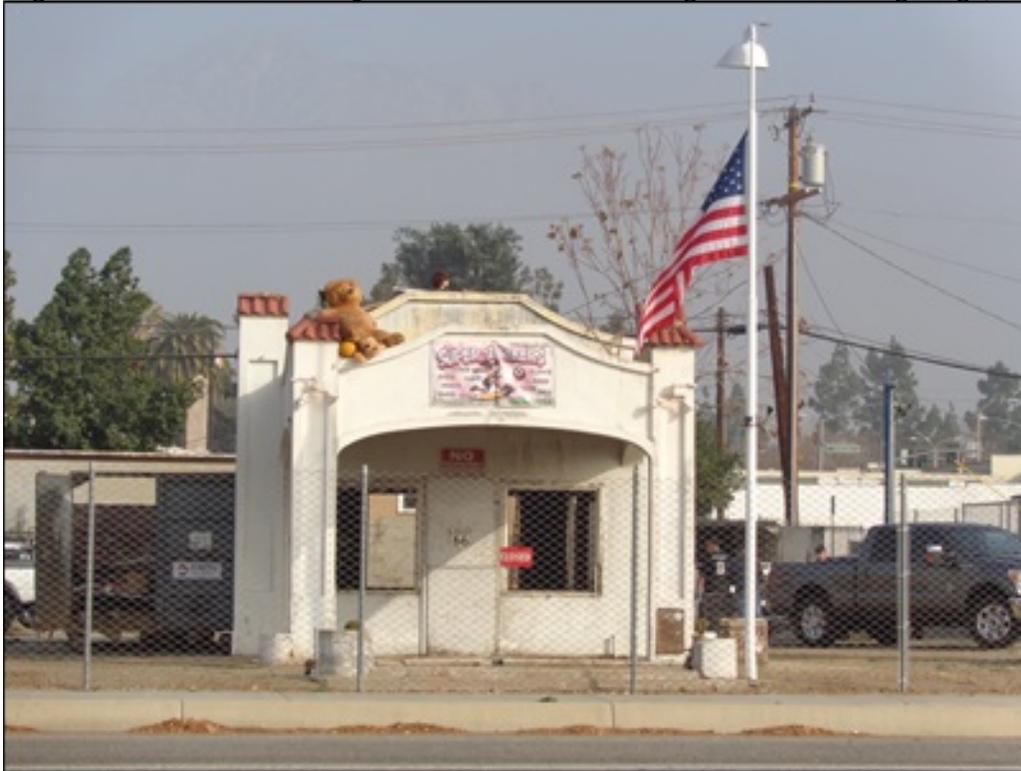
Figure 9: Pre-restoration photo of station following demolition of garage, circa 2013.

Before restoration began in 2013, the station had been abandoned since the early 1970s and had greatly deteriorated from decades of neglect. The roof and much of its wood had to be replaced and some of the wood in the walls had also rotted from water damage and was replaced. But the stucco on the exterior, the foundation, floor and Spanish tile topping the columns were all remarkably intact.
