# National Register of Historic Places Registration Form

Historic name: Woolworth Building DRAFT

Street & number: 1400 19<sup>th</sup> Street

City or town: Bakersfield State: CA County: Kern

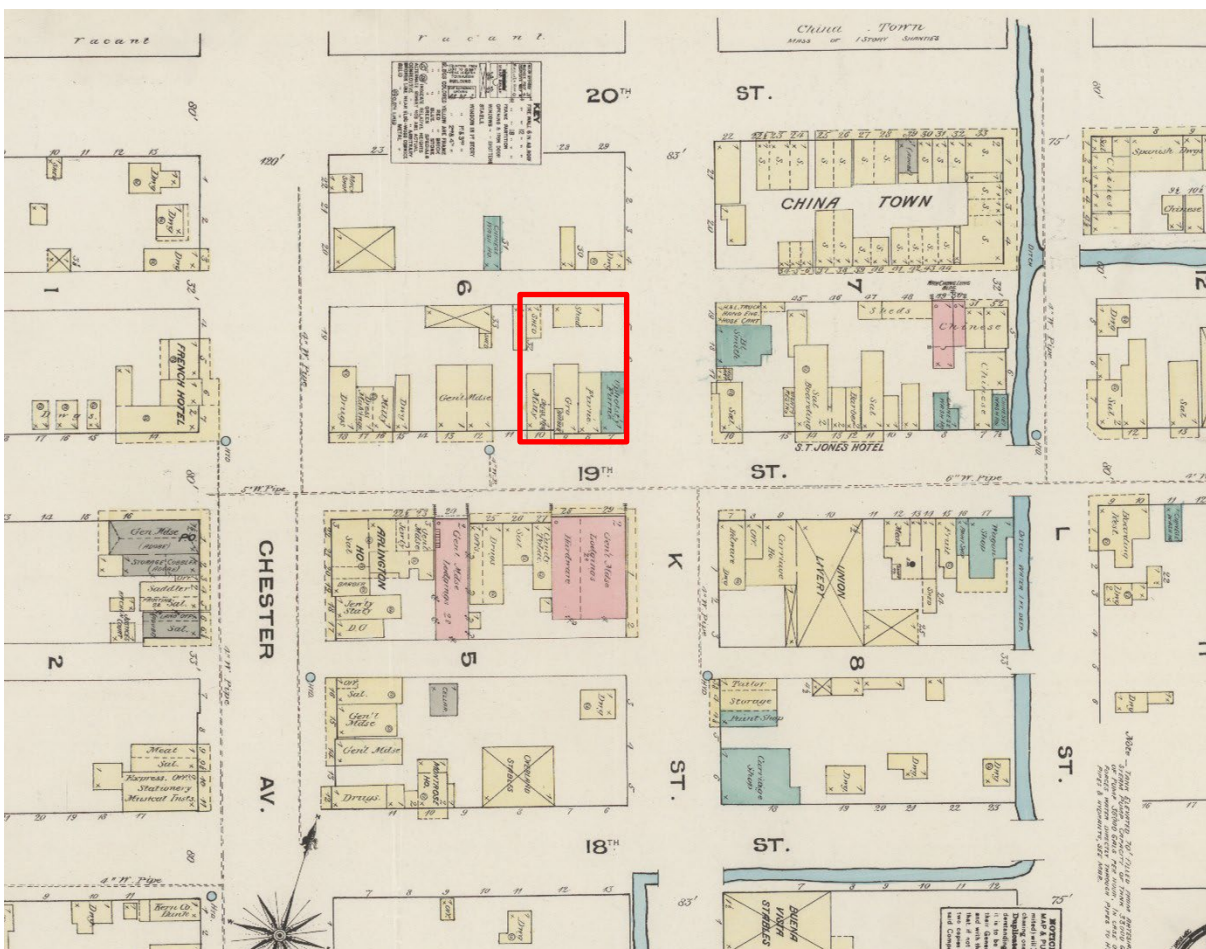
Figure 1. 1885 Sanborn Map and Publishing Company fire insurance map, showing commercial development near the site of the subject building at the intersection of 19<sup>th</sup> and K streets (outlined in red). Source: Library of Congress. Edited by Page & Turnbull.

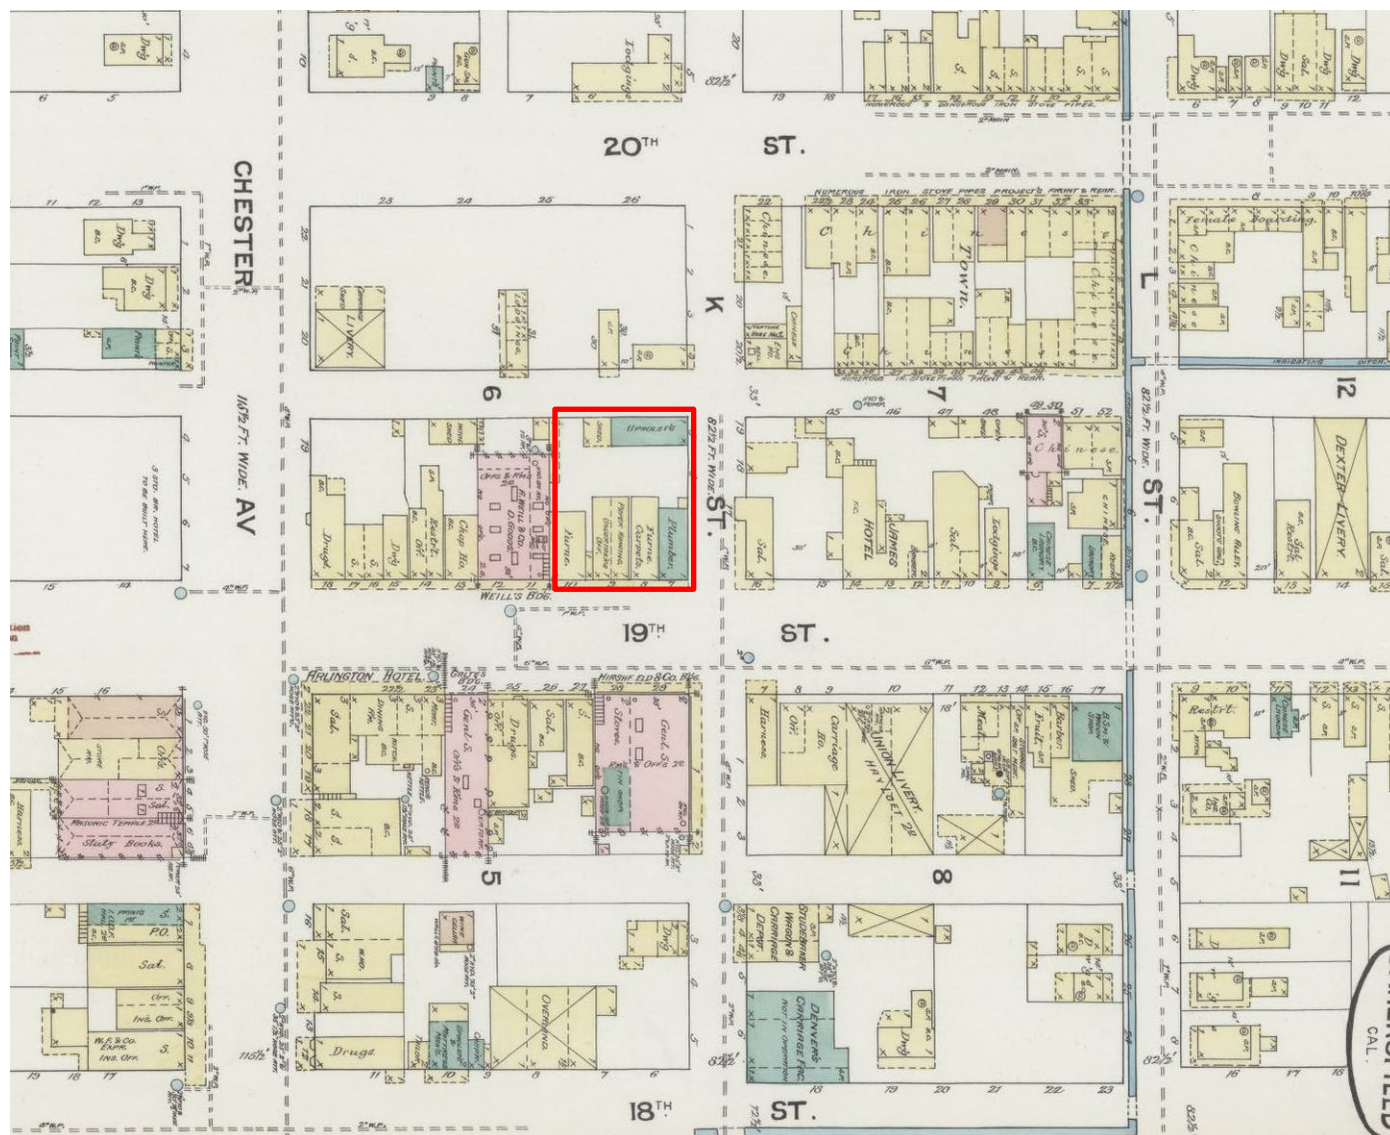
Figure 2. 1888 Sanborn-Perris Map Company fire insurance map, showing commercial development near the site of the subject building at the intersection of 19<sup>th</sup> and K streets (outlined in red). Source: Library of Congress. Edited by Page & Turnbull.

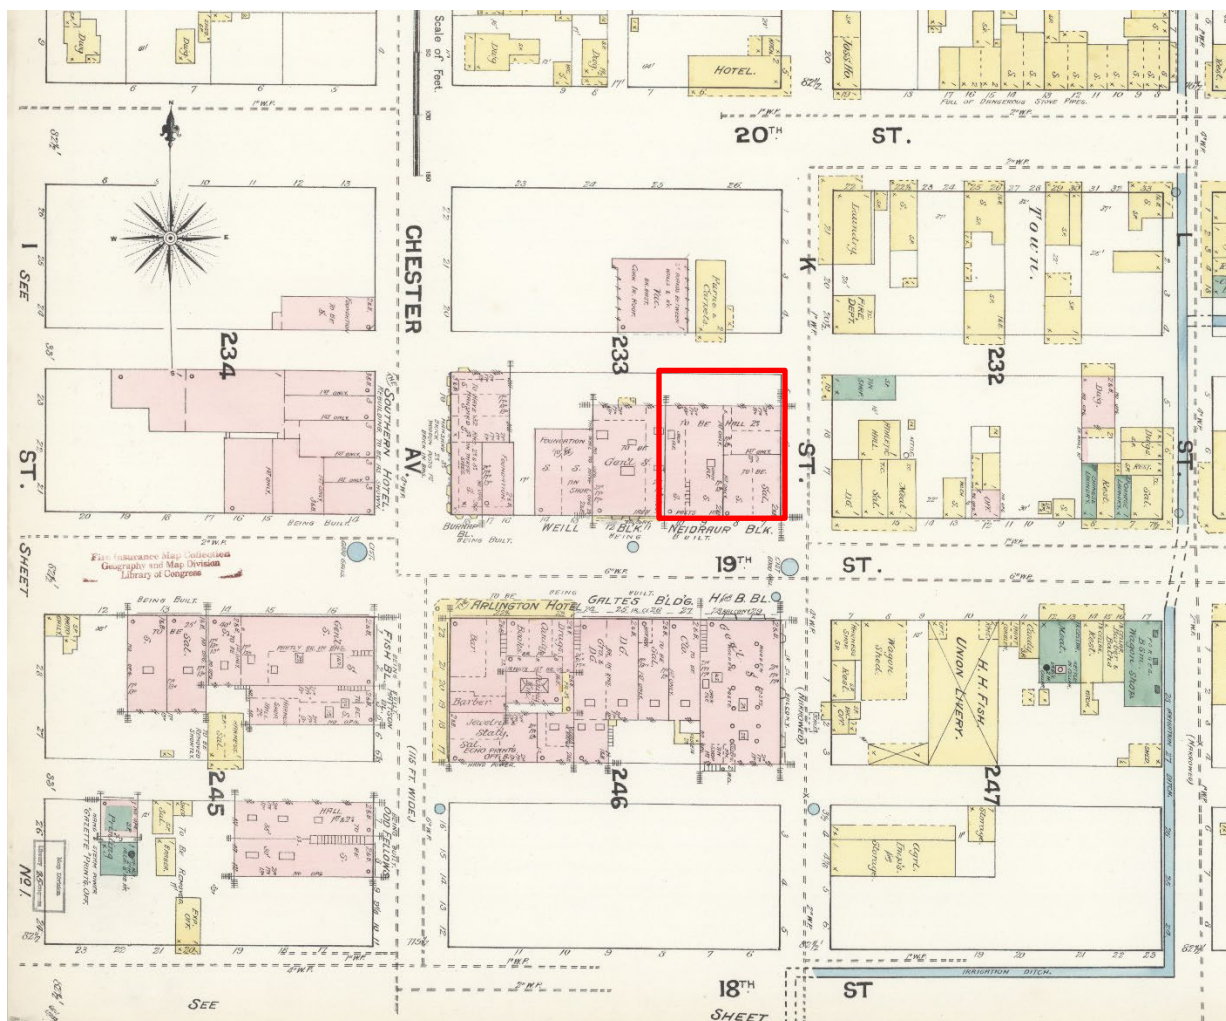
Figure 3. 1890 Sanborn-Perris Map Company fire insurance map, showing the construction of new masonry buildings (shaded pink) near the site of the subject building at the intersection of 19th and K streets (outlined in red) after the 1889 fire. Source: Library of Congress. Edited by Page & Turnbull.

In 1889, the worst fire in Bakersfield's history destroyed much of Bakersfield's commercial center. To avoid a similar disaster in the future, much of the town's urban core was rebuilt primarily in brick.<sup>15</sup> The four square blocks between I, K, 18<sup>th</sup>, and 20<sup>th</sup> streets, including buildings at the subject site, appear to have been almost entirely destroyed by the fire. Within a year, Sanborn fire insurance maps showed that several new two-story masonry buildings – including a new hotel, general store, saloons, drug stores, and grocery stores – were under construction on the site. The east side of K street, meanwhile, appears to have been spared from the fire and continued to contain a row of small wood-framed buildings (Figure 7).<sup>16</sup>

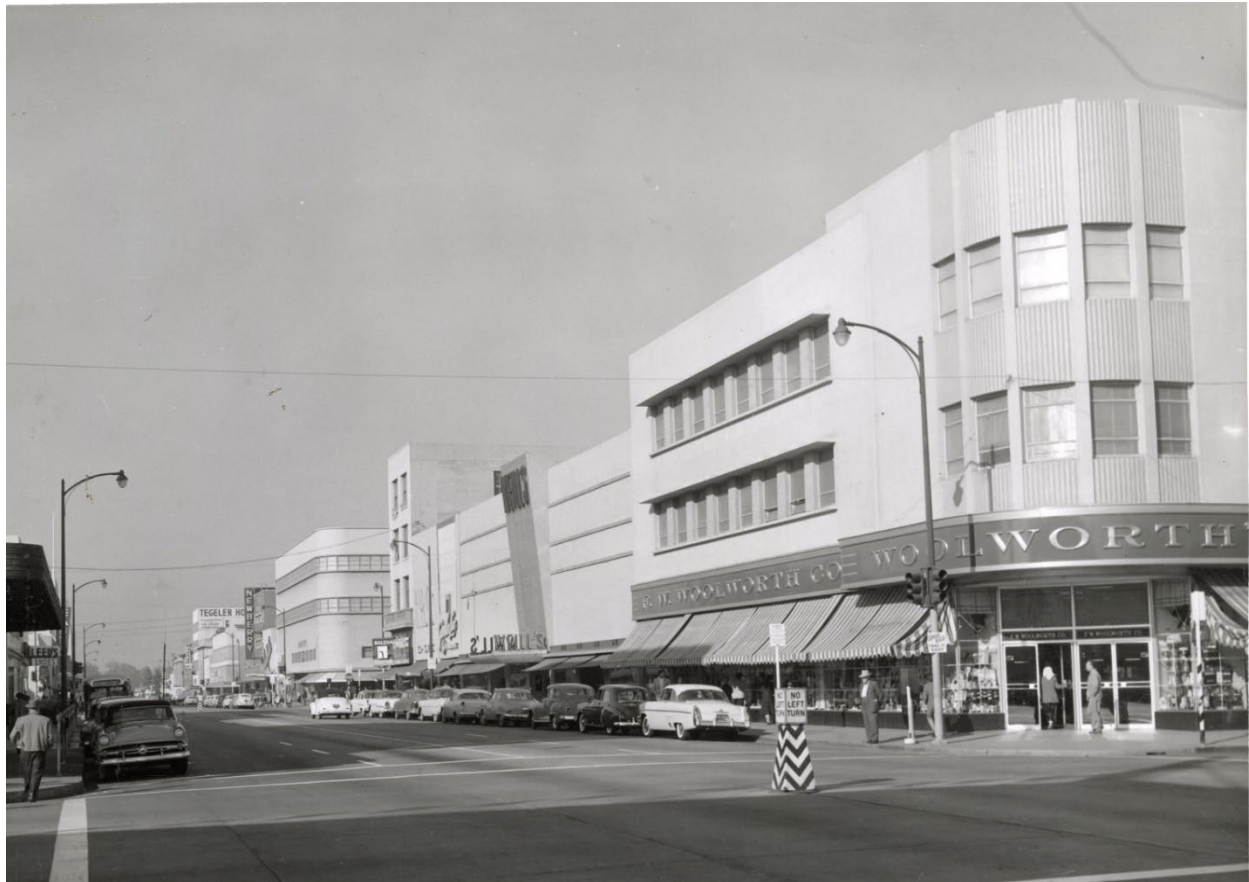
Figure 6. View looking west along 19th Street with the Woolworth Building at right. Photograph taken ca. 1950. Source: Kern County Museum, Photograph Collection.

As the century progressed, commercial and residential development began to fill in the surrounding blocks. One of the first commercial stores was an adobe store owned by Julius and George Chester (namesake for Chester Avenue) at the intersection of 19<sup>th</sup> Street and Chester Avenue, one block to the east of the subject site.<sup>12</sup> By 1885, the first fire insurance maps for Bakersfield showed that the intersections where Chester Avenue and K Street crossed 19<sup>th</sup> Street had developed into the town's main commercial section (Figure 5).<sup>13</sup> By 1888, the town's economic center expanded to an area centered around 17<sup>th</sup>, 20<sup>th</sup>, M, and I streets, with 19<sup>th</sup> Street to the east of Chester Avenue serving as the main commercial street. Dense commercial development, consisting mostly of narrow one-story wood-framed buildings and some larger masonry buildings, filled the blocks. Drug stores, saloons, general stores, a hotel, plumbing company, furniture stores, liverys, carriage shops, and other small stores occupied the intersection of K and 19<sup>th</sup> streets where the subject building is now located (Figure 6).<sup>14</sup>

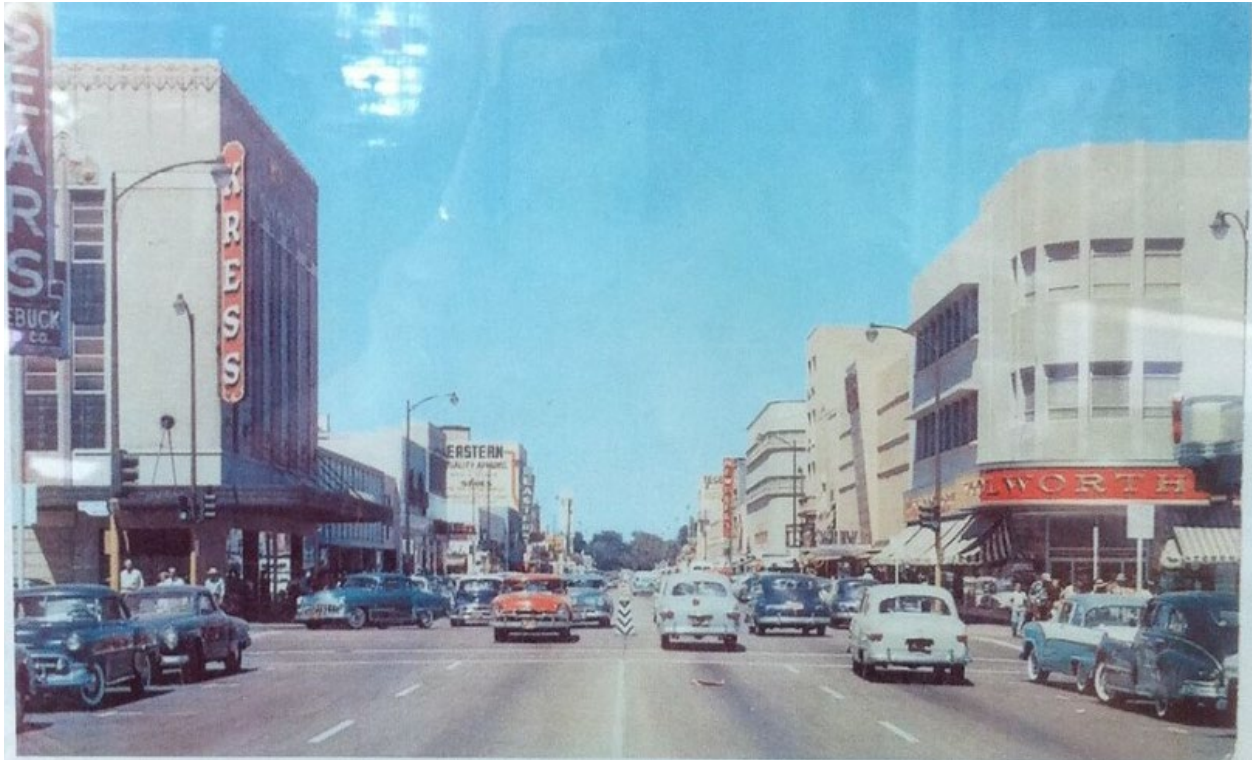
Figure 7. View west along 19th Street, with the Woolworth Building at the right. Photograph is undated but taken prior to 1960 alterations. Source: Flickr.com, user: Patrice Roe. Photograph reproduced in Lunch Counter space on ground floor.

In 1960, several alterations to the storefronts and interior were undertaken. These alterations included the installation of an additional stairway along the interior of the east wall between the first floor and basement, the replacement of the glass transoms over the retail entrances with illuminated plastic transoms with signage, the removal of the wood backboards and wood doors that originally lined the interior wall of the storefront systems, and the installation of new fluorescent lamp fixtures within the storefronts.<sup>3</sup> An initial plan to install a large plastic blade sign at the south façade is shown on elevation drawings from 1960, but the proposed blade sign does not appear to have ever been installed.<sup>4</sup> It is unclear whether the raised floors of the storefront windows were lowered in 1960, or were lowered in subsequent decades, but only some sections of the original raised storefront floors remain at the bays near each entrance.

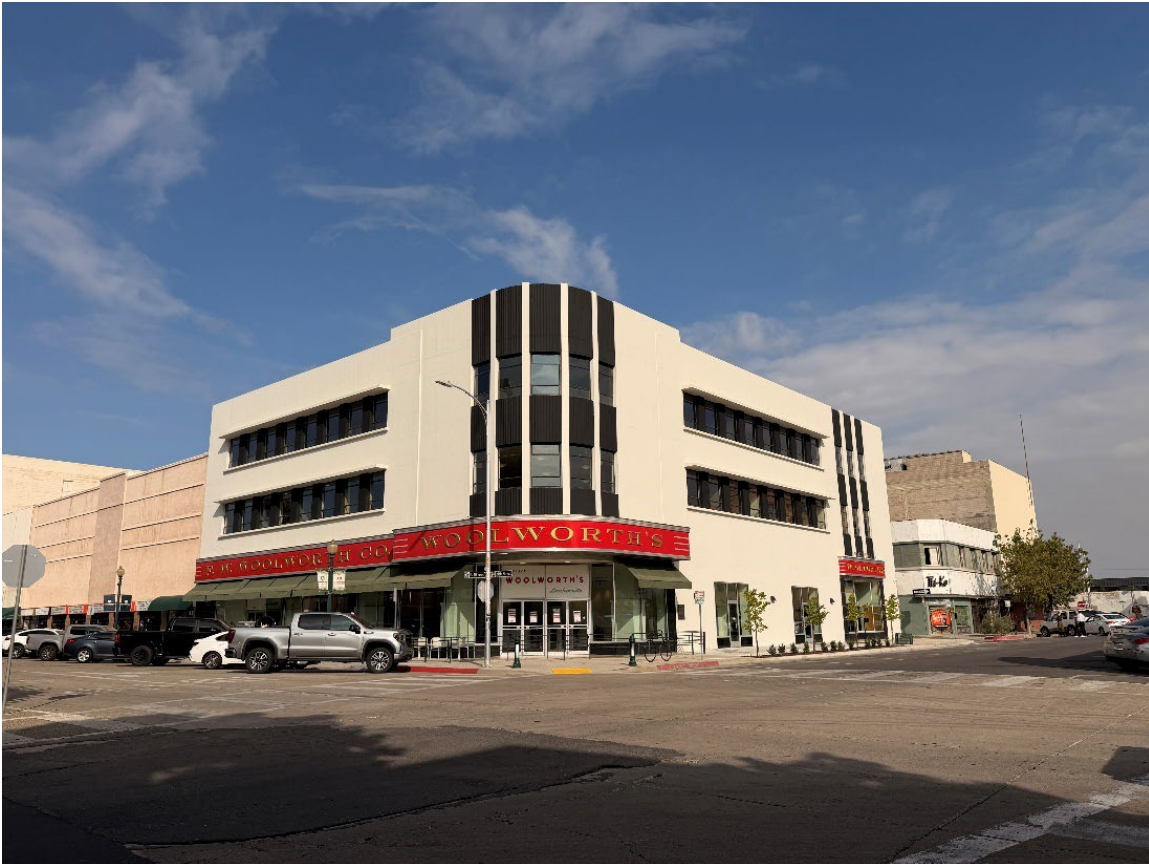
**Photograph 1** View of the Woolworth Building showing curved corner and both south and east primary façades. Looking northwest.

The corner at 19th and K streets anchors the building and is distinguished by its curved form. The curved corner section steps up at the roofline parapet and is very slightly recessed from the planar surfaces of the south and east façades. The second and third floors each have five steel sash windows at the curved corner with glazing arranged in a horizontal pattern. These windows feature a larger fixed center light with shorter operable transom and hopper sashes at both top and bottom of the fixed light. This window arrangement is standard for all windows on the second and third floors of the primary façades and are referred to henceforth as “typical windows” for both the south and east façades. Fluted concrete panels that are painted with an accent color are located below, above, and between the second and third floor windows. Narrow concrete piers with a smooth finish flank the windows and span from the top of the ground floor to the top of the parapet.

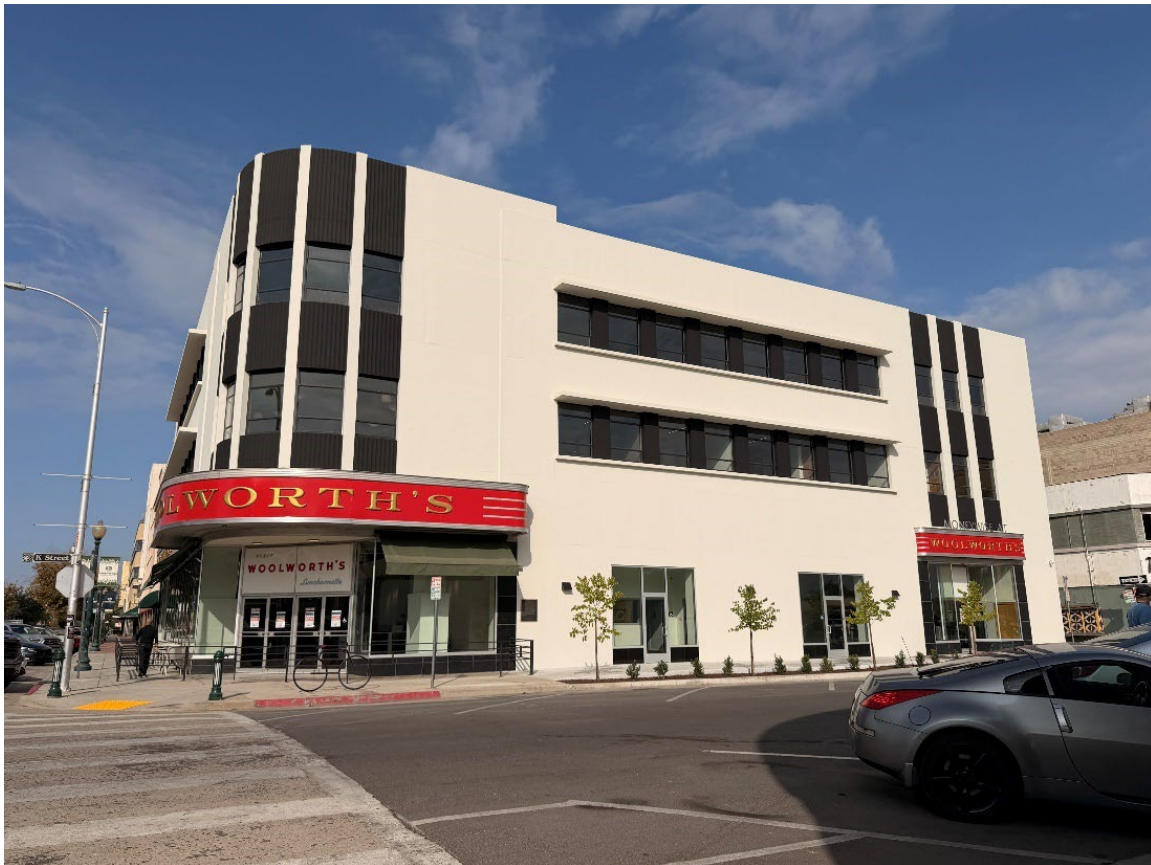
**Photograph 2** Woolworth Building, primary (east) façade, looking northwest.

The east façade contains three additional entries. The north end of the façade features a smaller original retail entrance with paired recessed entrance doors set between two glazed storefront windows. The transom over the paired entrance doors has a blank plastic panel at the exterior that has either replaced or covered an original Woolworth-branded transom panel. Two contemporary glazed aluminum storefront entries were added to the south of the original entry during the 2022-2025 rehabilitation.

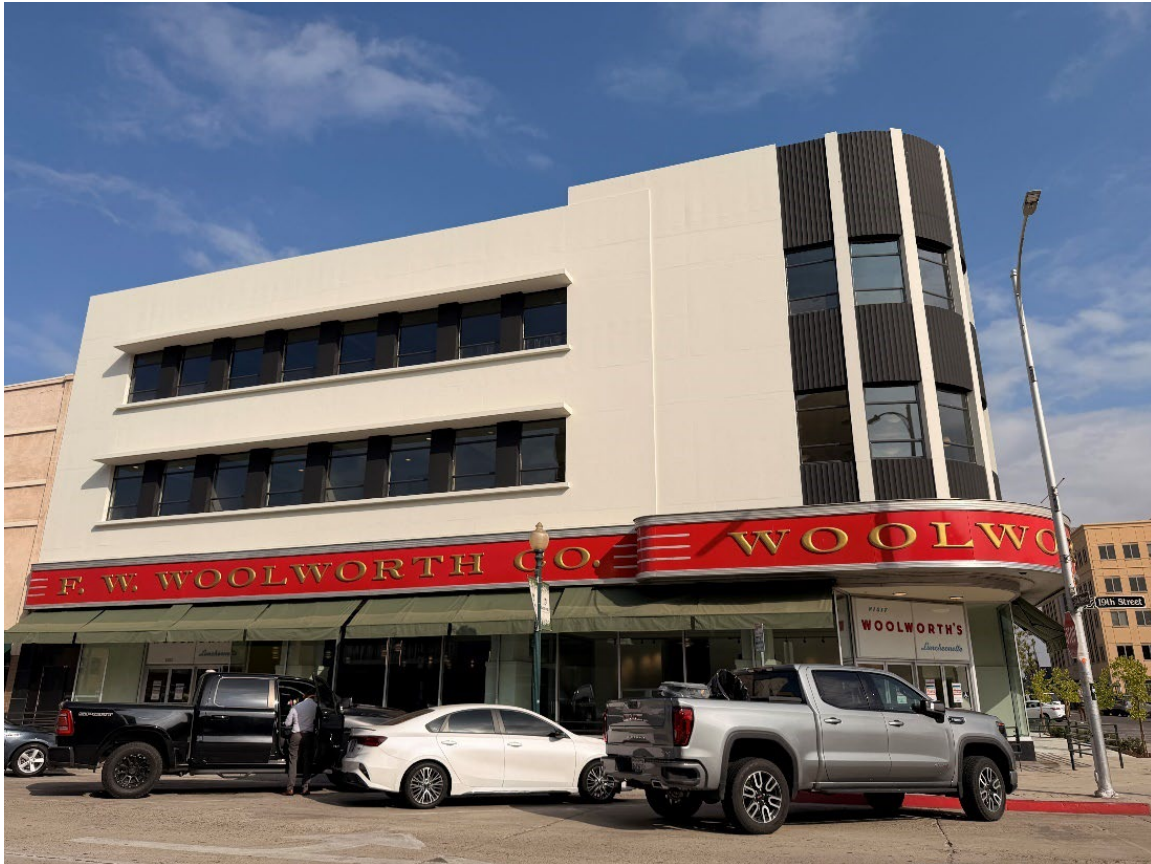
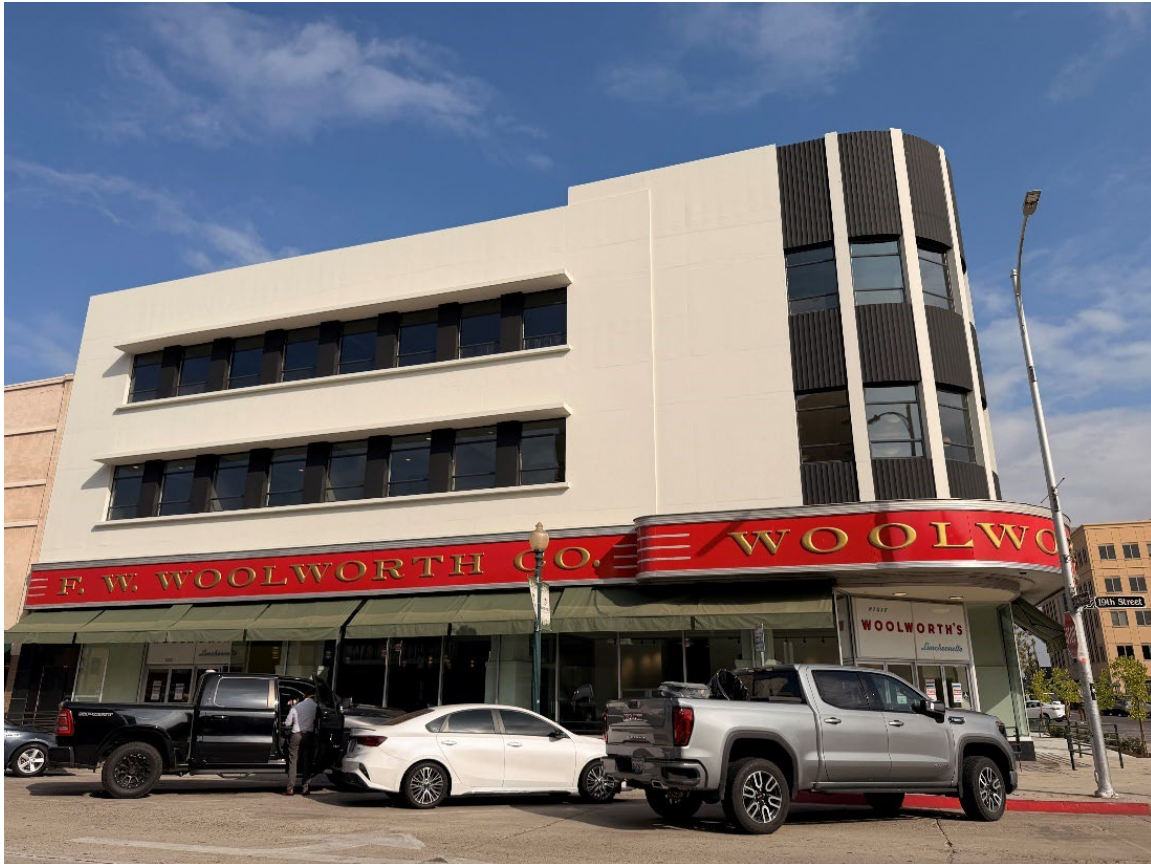
**Photograph 3** Woolworth Building, primary (south) façade, looking slightly northwest.

The ground floor of the south façade contains a single storefront system that is the length of the building and wraps the southeast corner. Storefront entrances at the south façade are located at the west end and the east end where an angled entrance is oriented towards the intersection of 19<sup>th</sup> and K streets. Both entrances consist of two sets of double leaf entrance doors beneath a plastic illuminated transom with branded signage, installed in 1960, which encourages patrons to “Visit Woolworth’s Luncheonette.” A metal exit door, added during the 2022-2025 rehabilitation, is located at the far west end of the façade.

Along the south façade (facing 19<sup>th</sup> Street), the second and third floors each feature a long horizontal section of grouped windows with a cantilevered concrete canopy and a projecting concrete sill. Each window grouping contains eight typical windows separated by piers of smooth painted concrete.

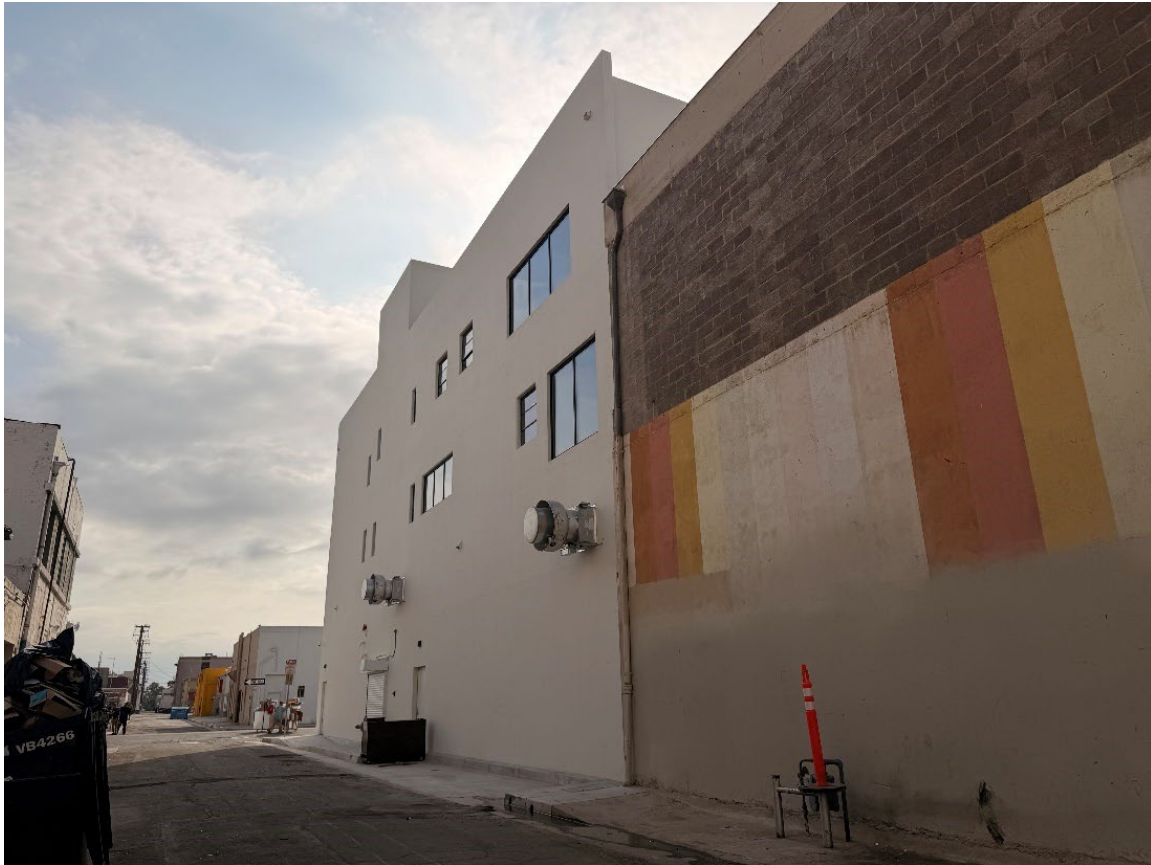
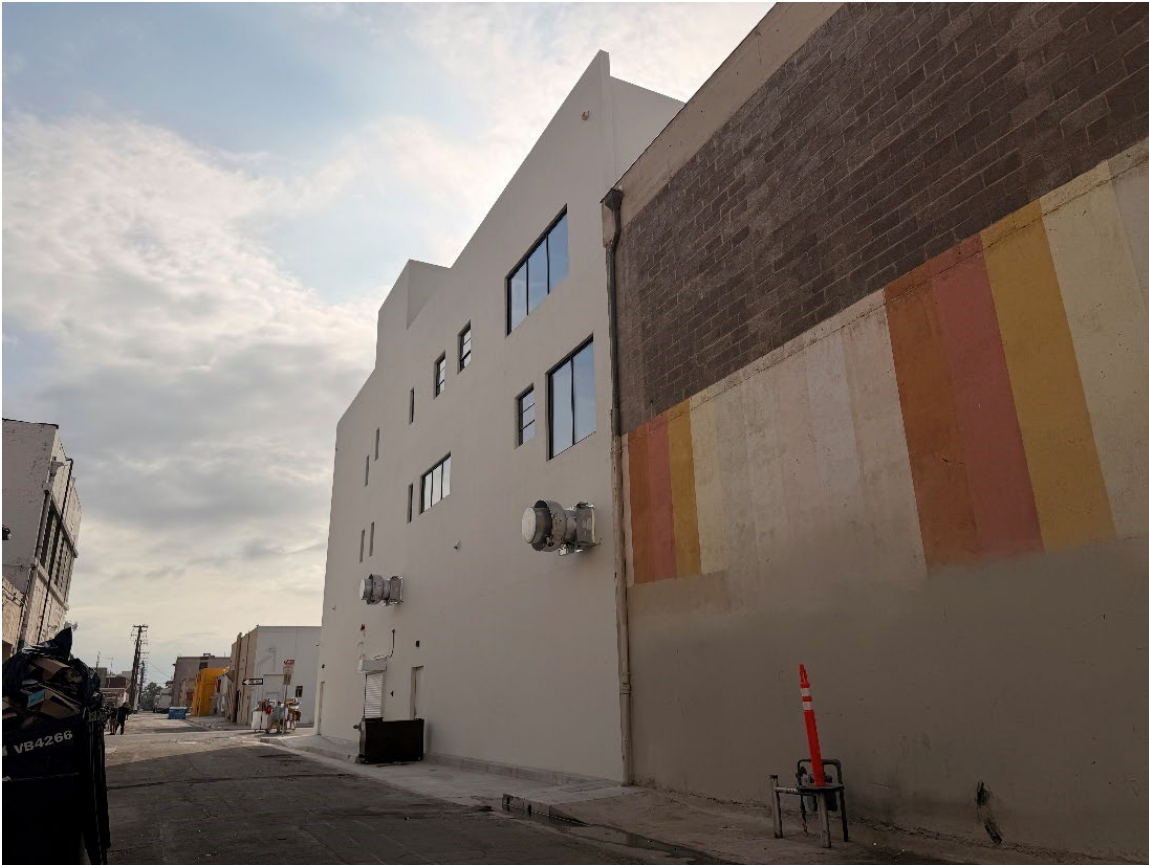
**Photograph 4** Woolworth Building, oblique view of rear (north) façade, looking southeast.

The north (rear) façade of the building faces a service alley named Service Street. This façade has no ornamentation other than windows and doors. At the first floor, openings consists of an original vertical sliding freight elevator door located to the east of the centerline of the façade and two contemporary metal exit doors, which were added during the 2022-2025 rehabilitation.

Typical windows along the second and third floor of the rear façade consist of steel sash windows with a two-lite awning sash over a fixed single lite sash in a horizontal pattern to match the windows of the primary façade. These windows are present in both a narrow version and a wide version, which is approximately twice the width of the narrow version. Three larger new metal framed storefront windows were added to the west half of the façade during the 2022-2025 rehabilitation.

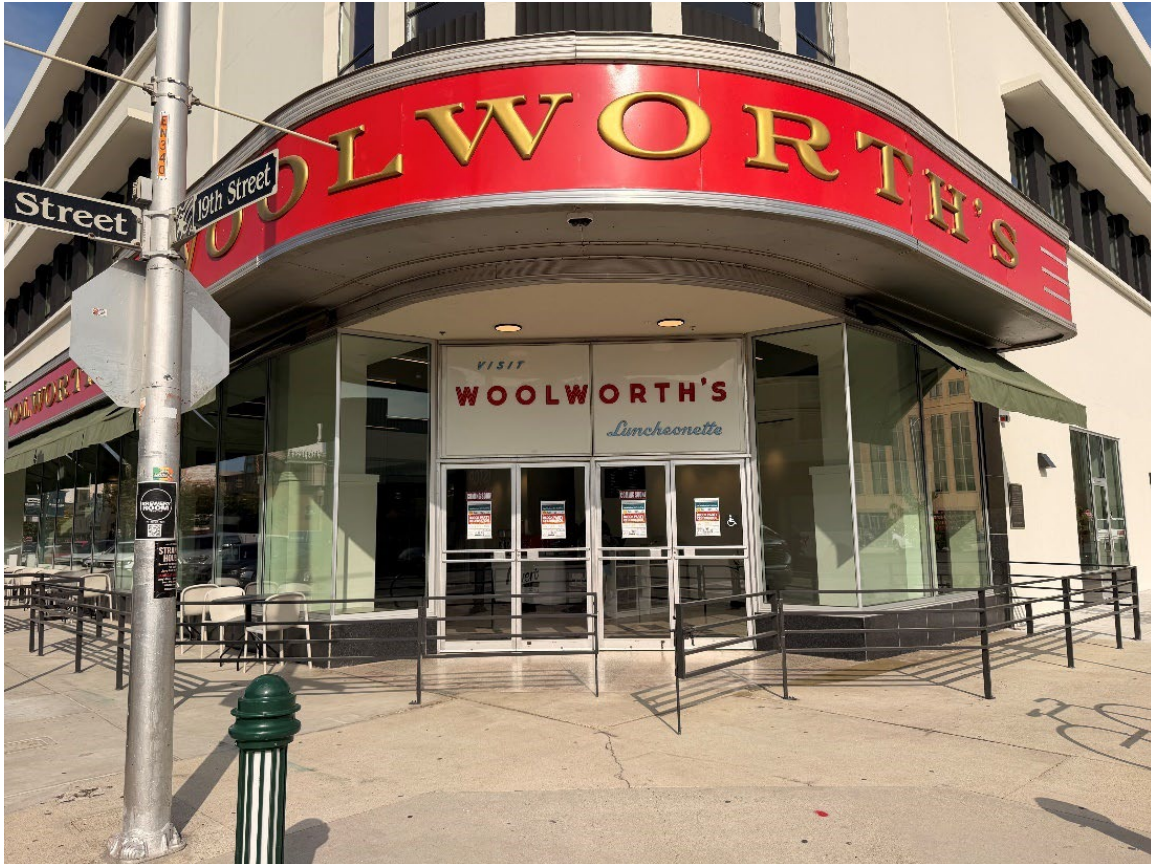
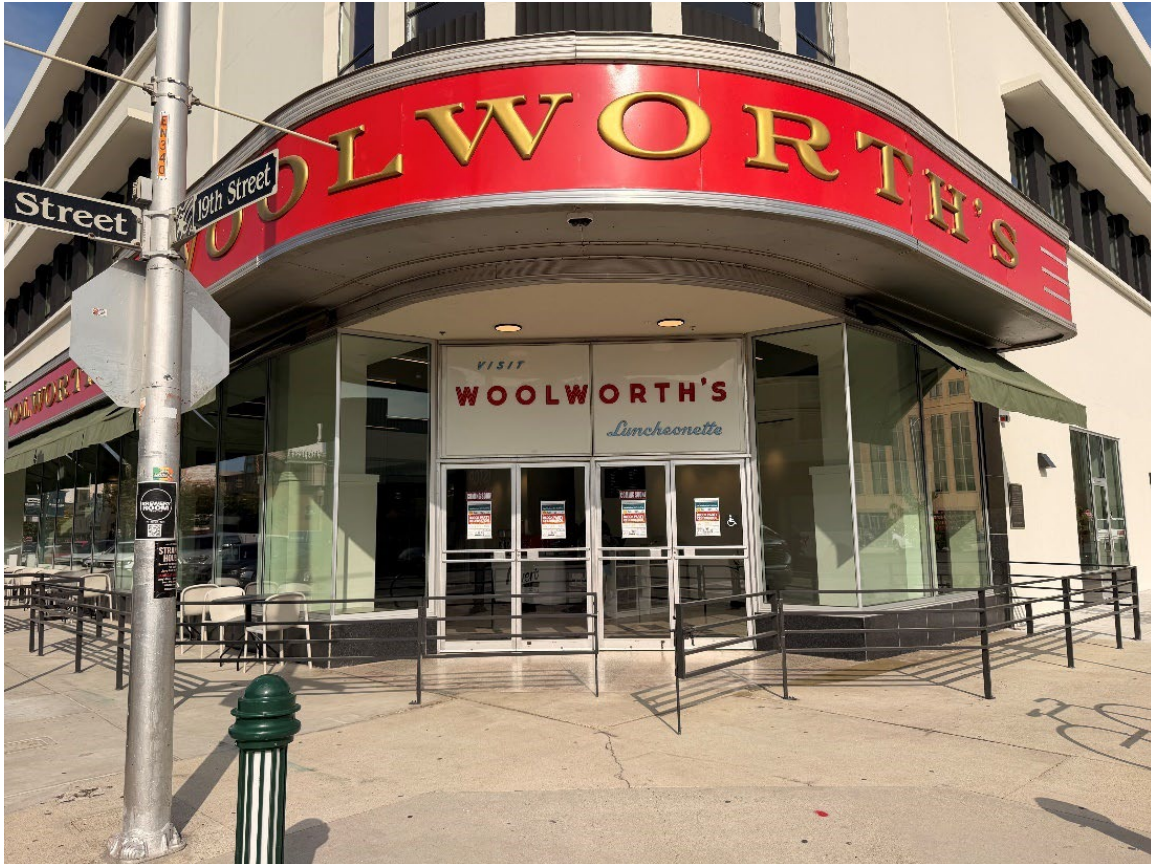
**Photograph 5** Woolworth Building, detail of corner entrance, looking northwest.

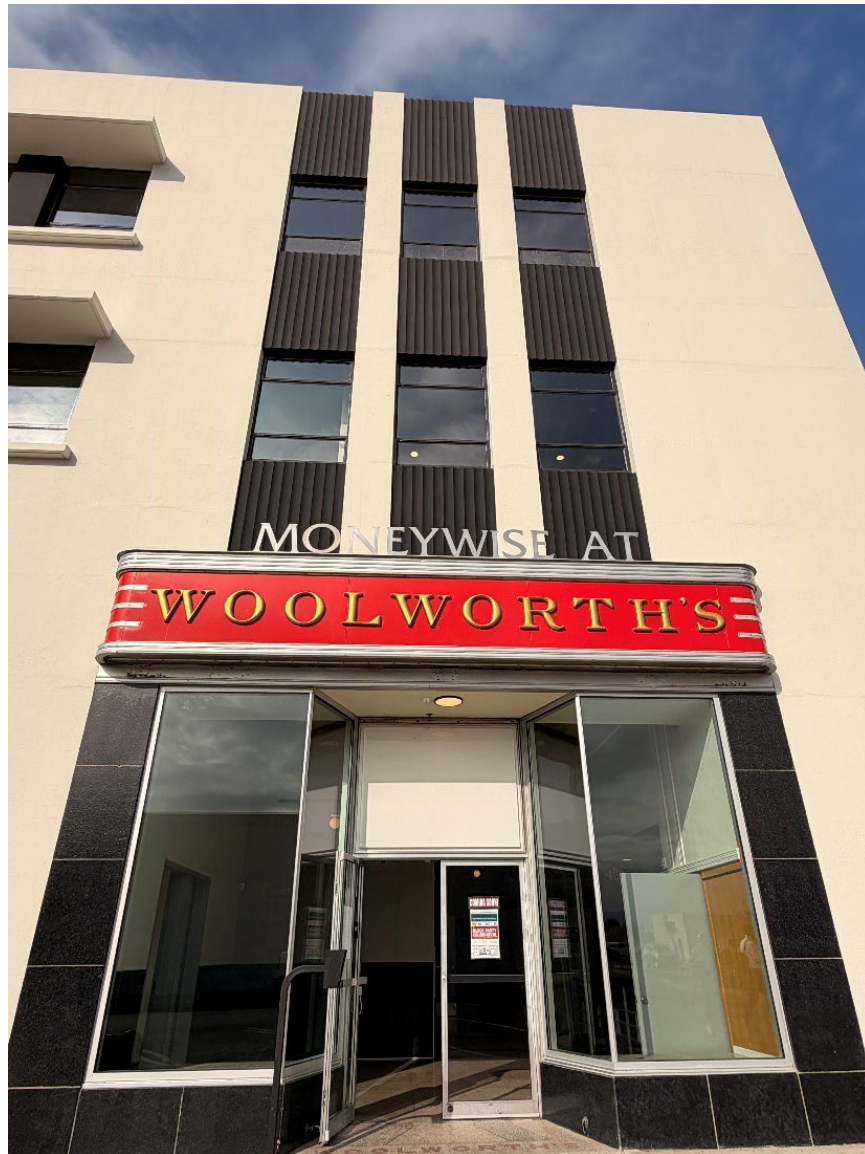
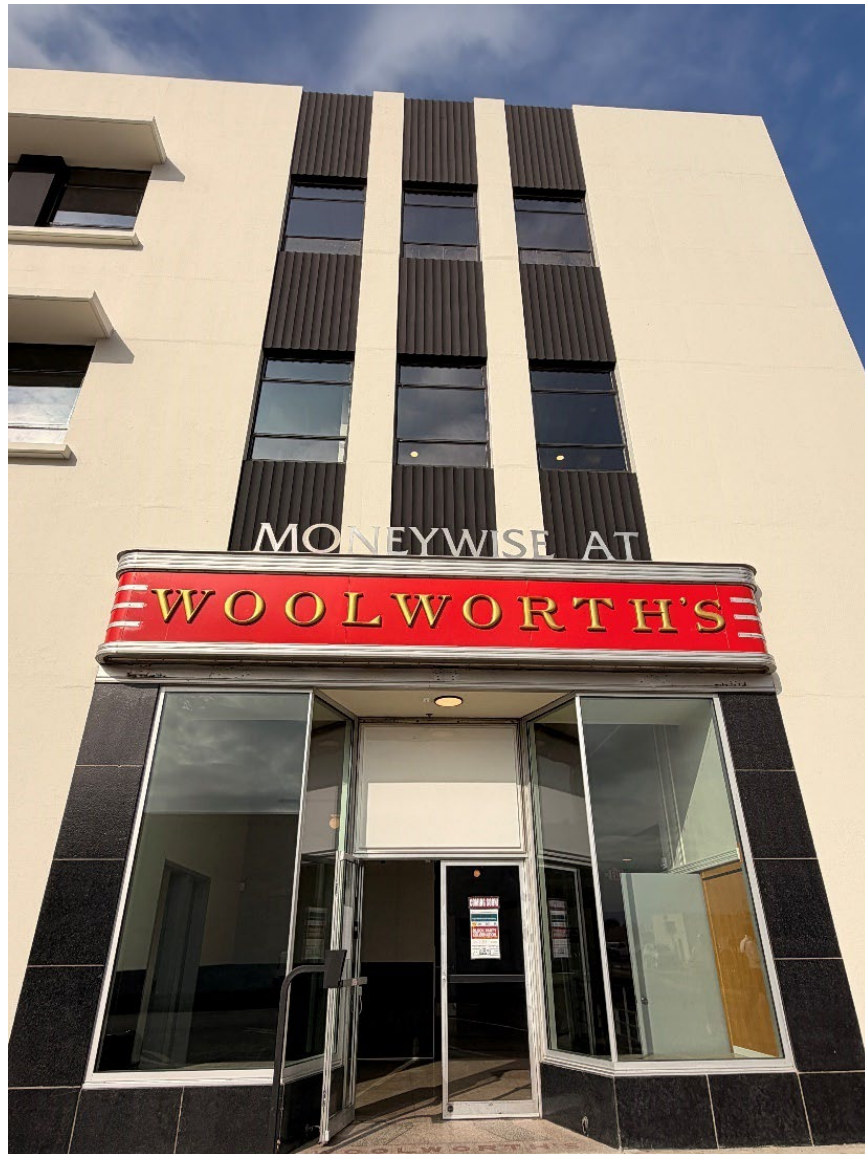
**Photograph 6**

Woolworth Building, detail of storefront windows and entrance at north end of east façade, looking west.

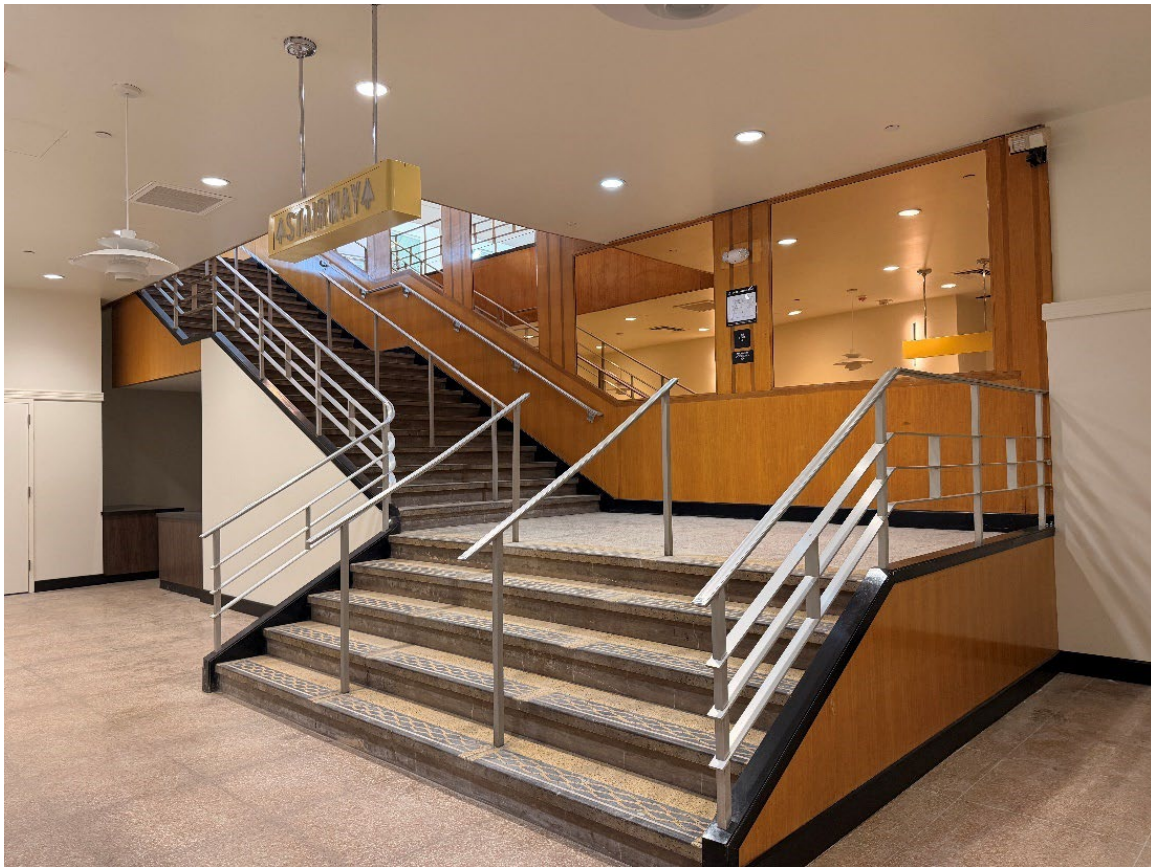
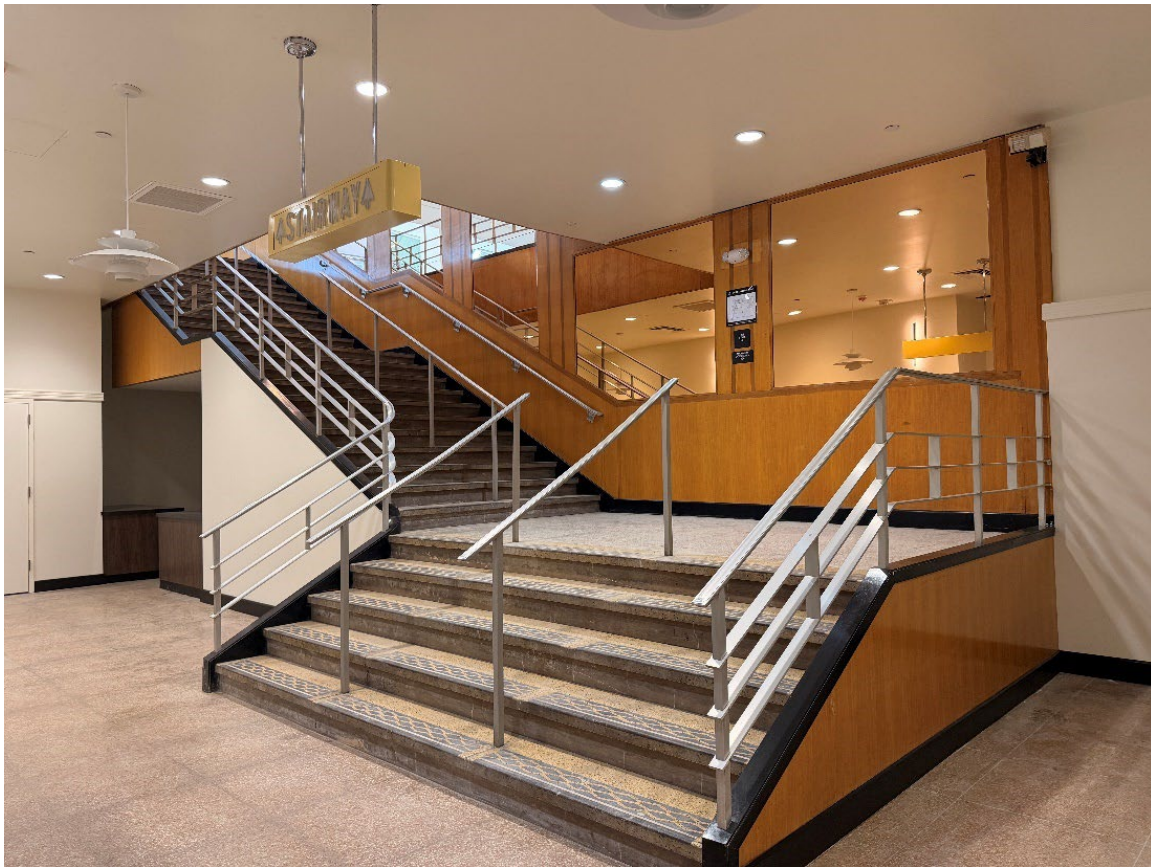
**Photograph 7** Woolworth Building, Basement Level. View of Stair 1 (along west wall), looking southwest.

Two original stairways lead from the first floor to the basement at the west and northeast sides of the building. The stair at the west side of the building has a double-width L-shaped configuration with a standalone railing installed down the center. The stair has terrazzo treads and marble risers. The wall on the west side of the stair is finished in wood paneling with regular openings containing rose-tinted mirrors above the railing. An aluminum railing that runs along the outer edge of the stair curves at each corner to provide a continuous run. It is comprised of evenly spaced vertical posts with a handrail at the top and a grouping of three horizontal rails spaced closer together under the handrail with smaller vertical posts at central points between each larger vertical post. Railings running down the center and along the wall for this stair have a simple, minimalist design.
