# National Register of Historic Places Registration Form

Historic name: Woolworth Building DRAFT

Street & number: 1400 19<sup>th</sup> Street

City or town: Bakersfield State: CA County: Kern

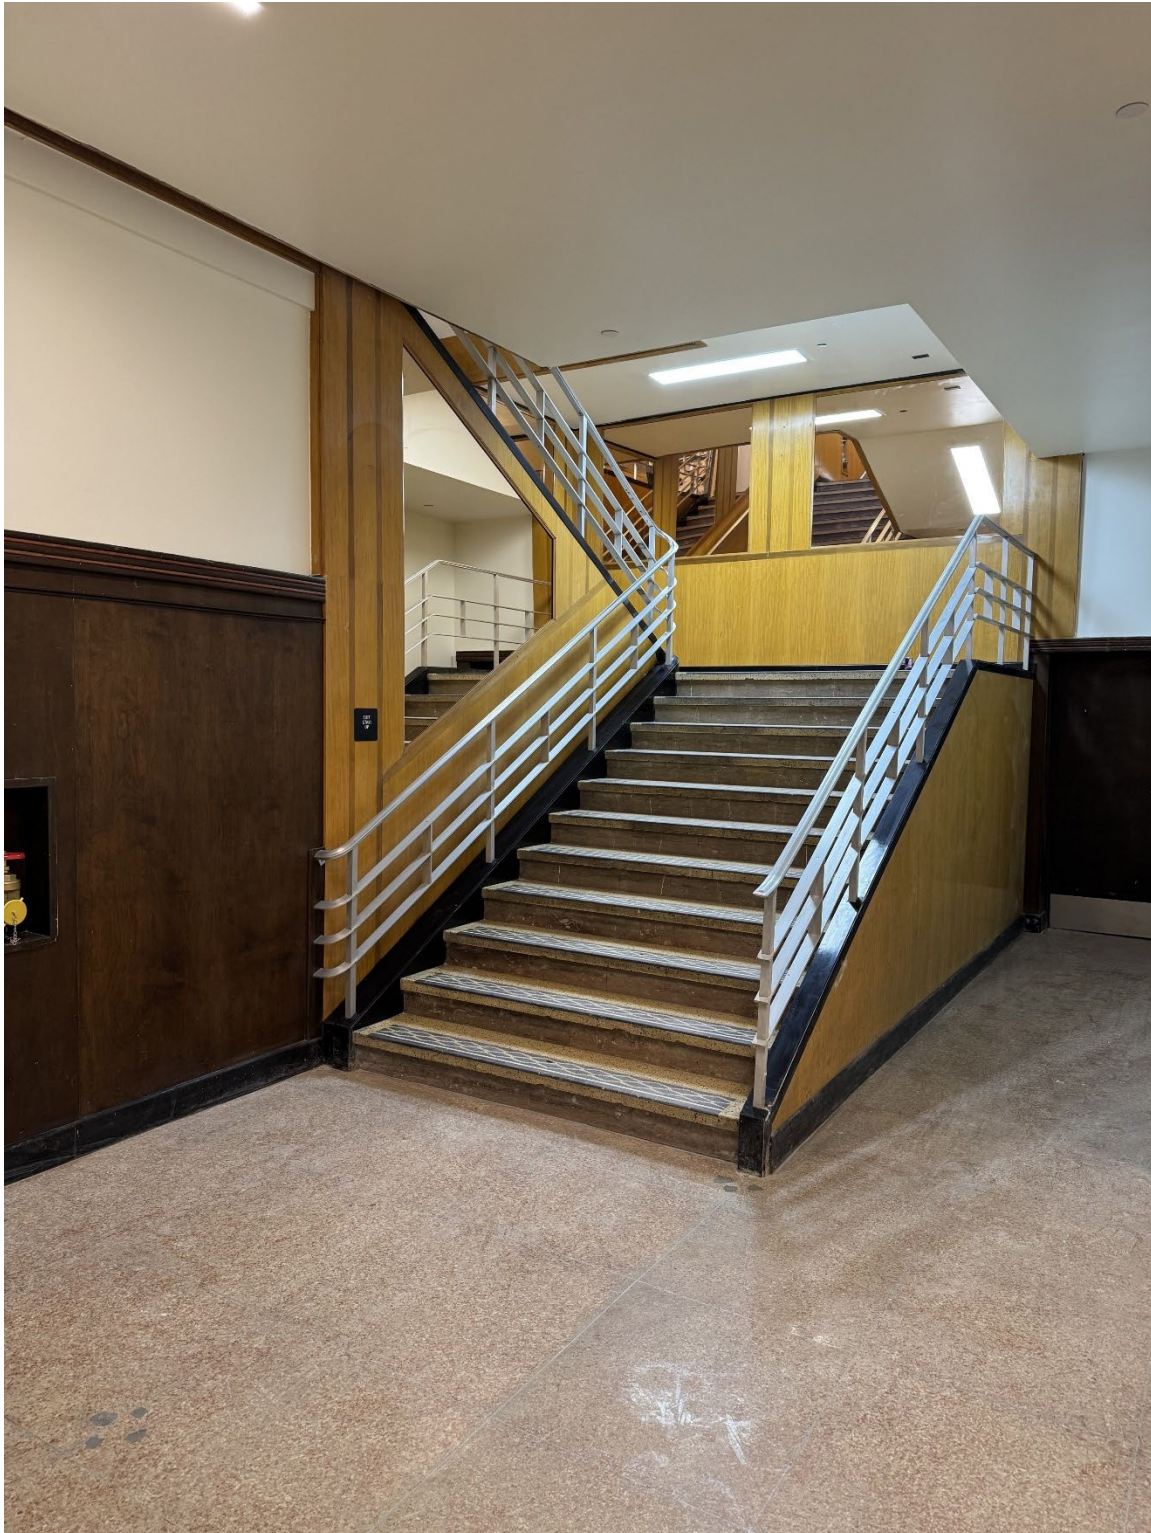
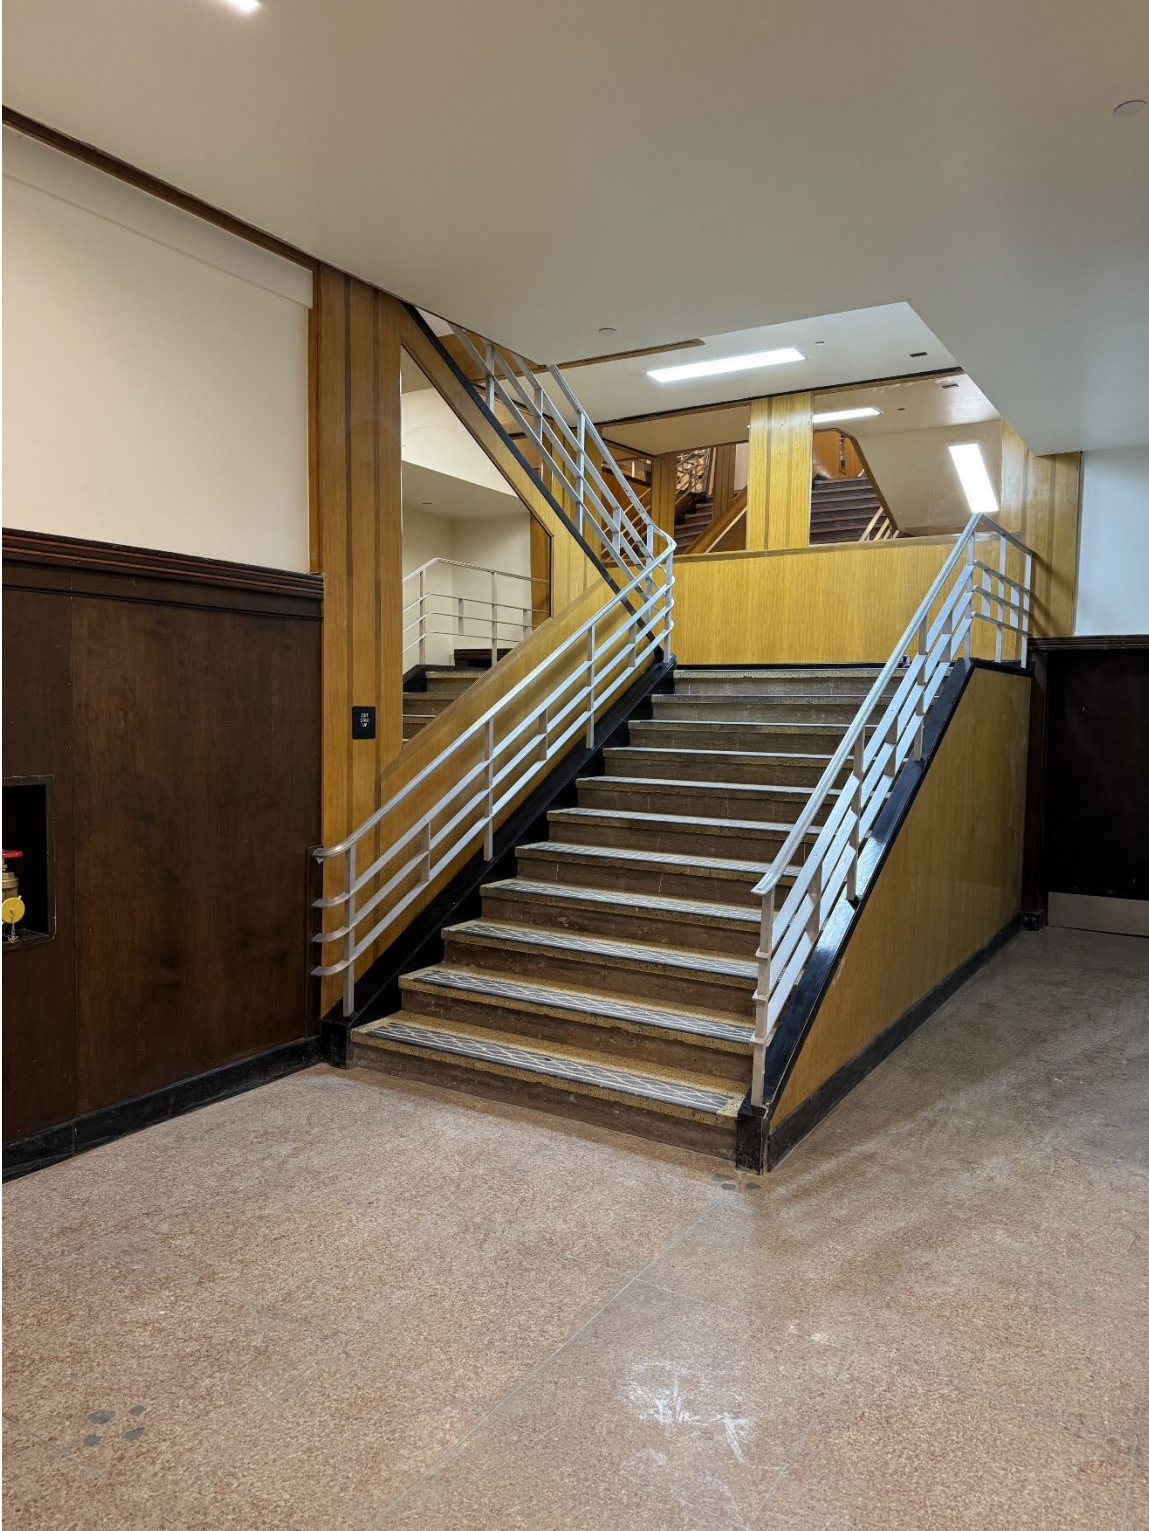
**Photograph 8** Woolworth Building, Basement Level. Detail of Stair 2, looking east.

Two original stairways lead from the first floor to the basement at the west and northeast sides of the building. The stair at the west side of the building has a double-width L-shaped configuration with a standalone railing installed down the center. The stair has terrazzo treads and marble risers. The wall on the west side of the stair is finished in wood paneling with regular openings containing rose-tinted mirrors above the railing. An aluminum railing that runs along the outer edge of the stair curves at each corner to provide a continuous run. It is comprised of evenly spaced vertical posts with a handrail at the top and a grouping of three horizontal rails spaced closer together under the handrail with smaller vertical posts at central points between each larger vertical post. Railings running down the center and along the wall for this stair have a simple, minimalist design.

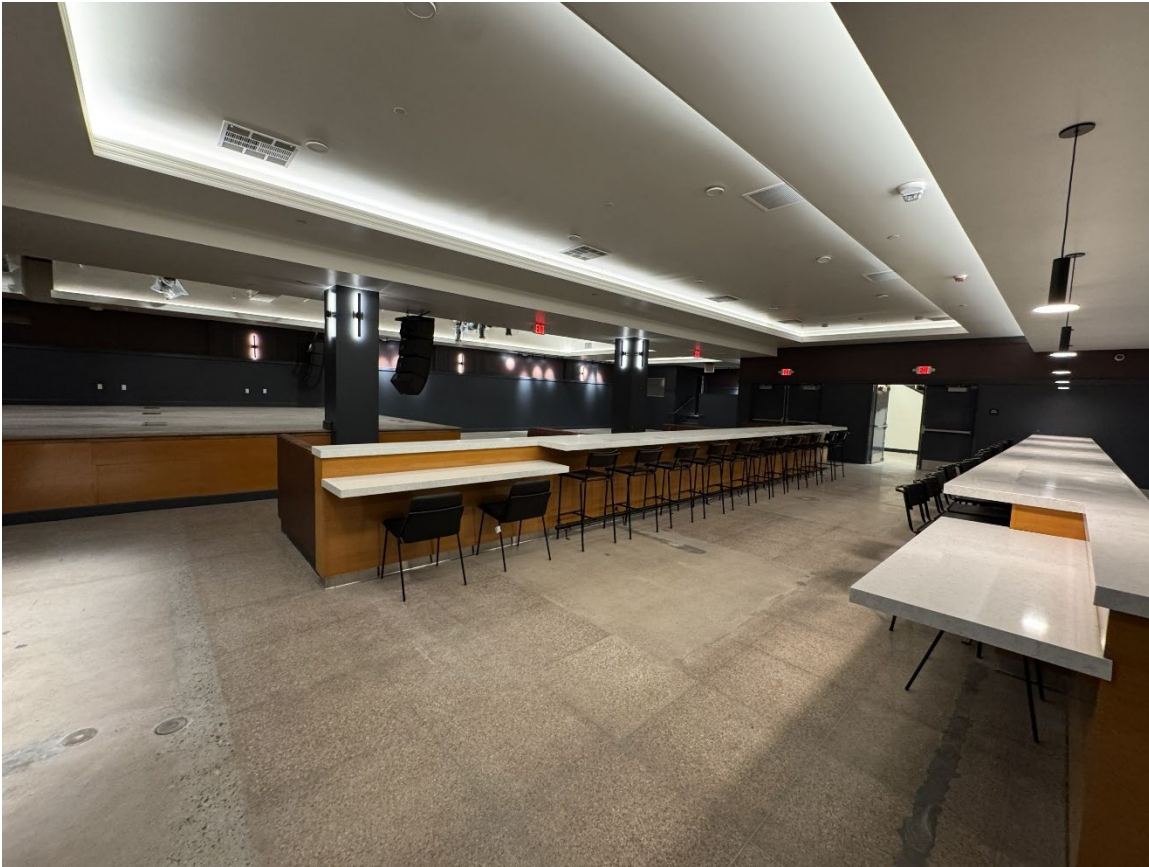
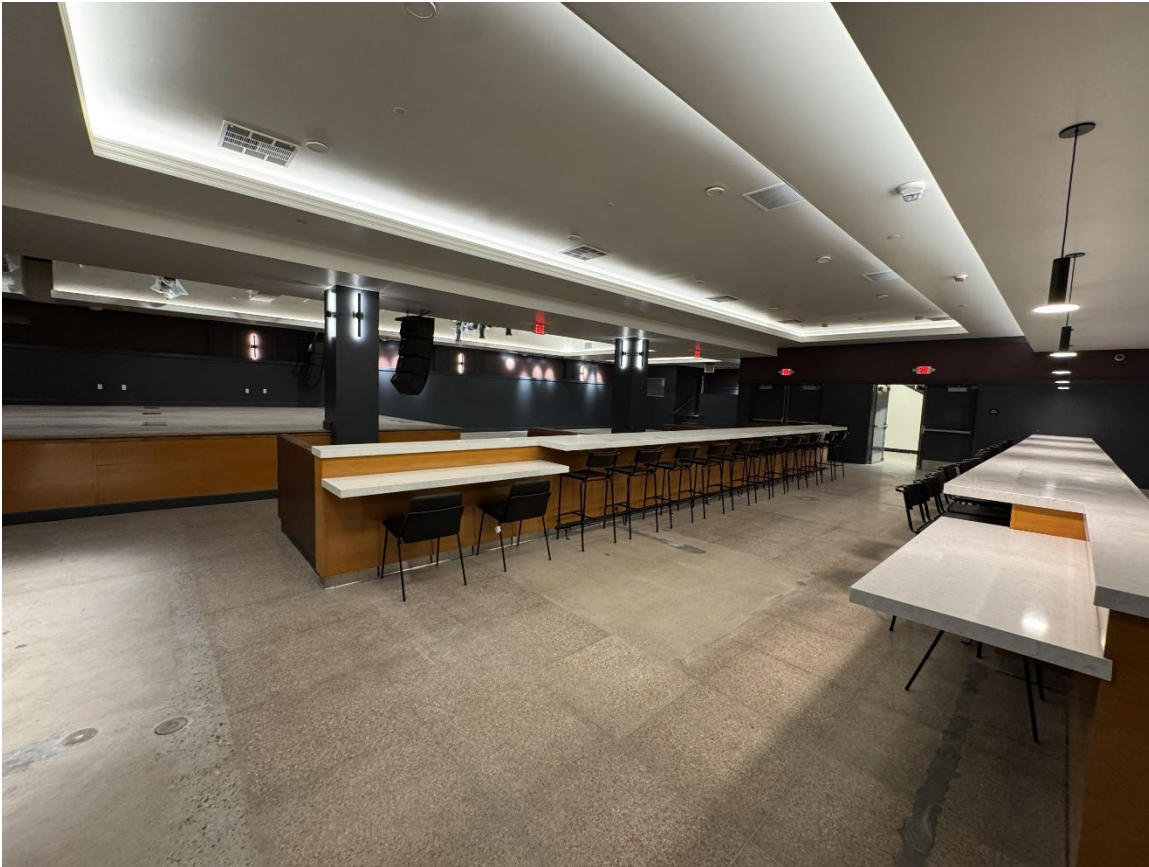
**Photograph 9** Woolworth Building, Basement Level. Event venue and bar, view southeast.

The performance venue, recording studios, practice rooms, restrooms, and other supporting spaces are divided by metal stud walls. The performance venue occupies most of the south half of the floor and has an open plan with an elevated stage with wood flooring. The performance area has a raised exposed concrete ceiling with integrated acoustical tile panels and a lower perimeter soffit. A bar with built-in booth and bar-style seating is located to the north of the performance area. The sound recording studio, artist practice rooms, and other spaces at the north half of the floor have gypsum board, acoustical tile, or lay-in tile ceilings. Restrooms have contemporary tile floors.

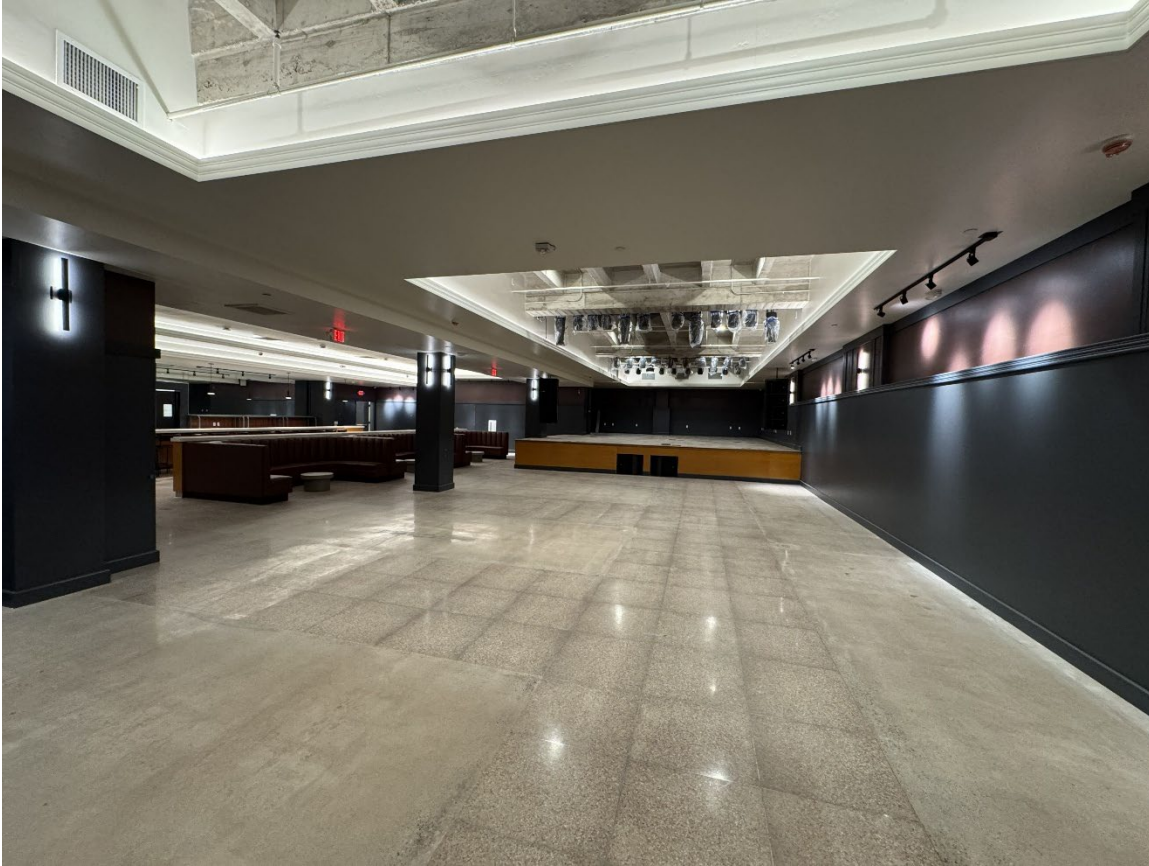
**Photograph 10**

Woolworth Building, Basement Level. Event space, view east.

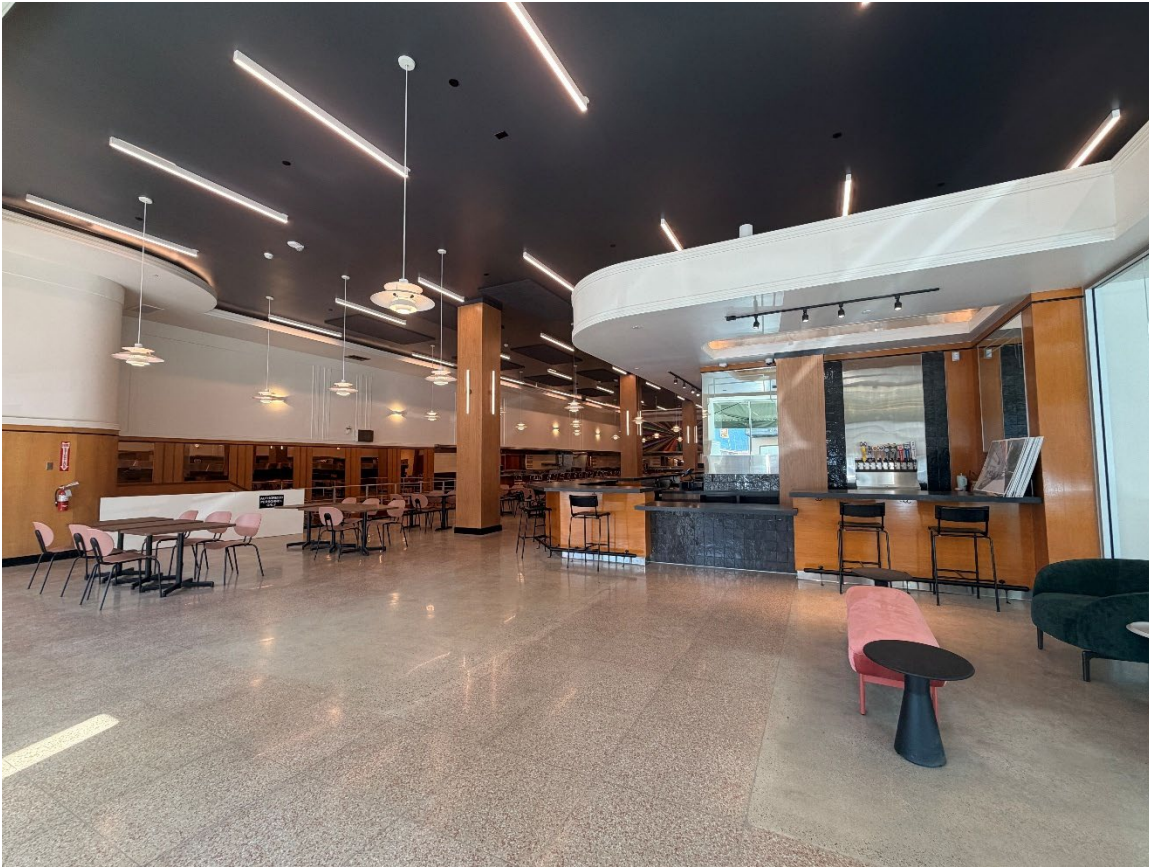
**Photograph 11** Woolworth Building, First Floor. Main Lobby, view northwest toward Bar and Woolworth Lunch Counter.

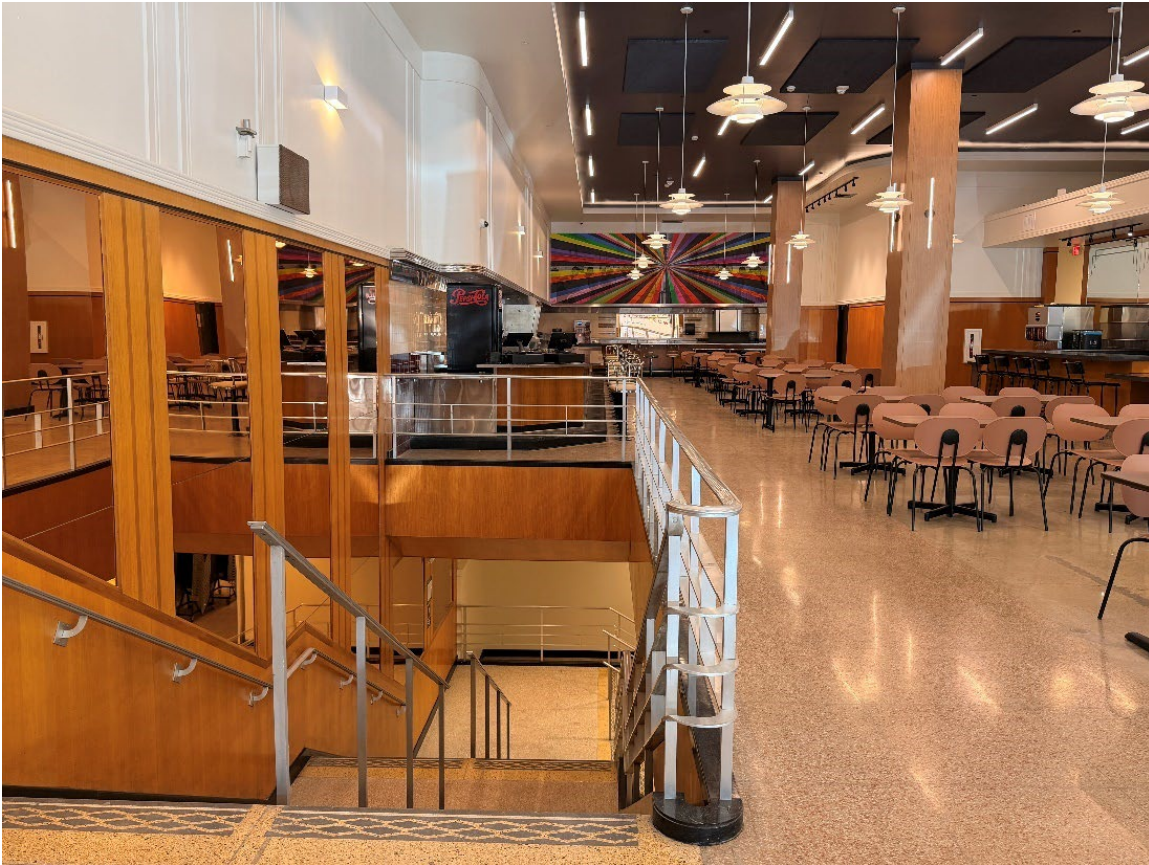
**Photograph 12** Woolworth Building, First Floor, view north towards Stair 1 (foreground) and Woolworth Lunch Counter (background).

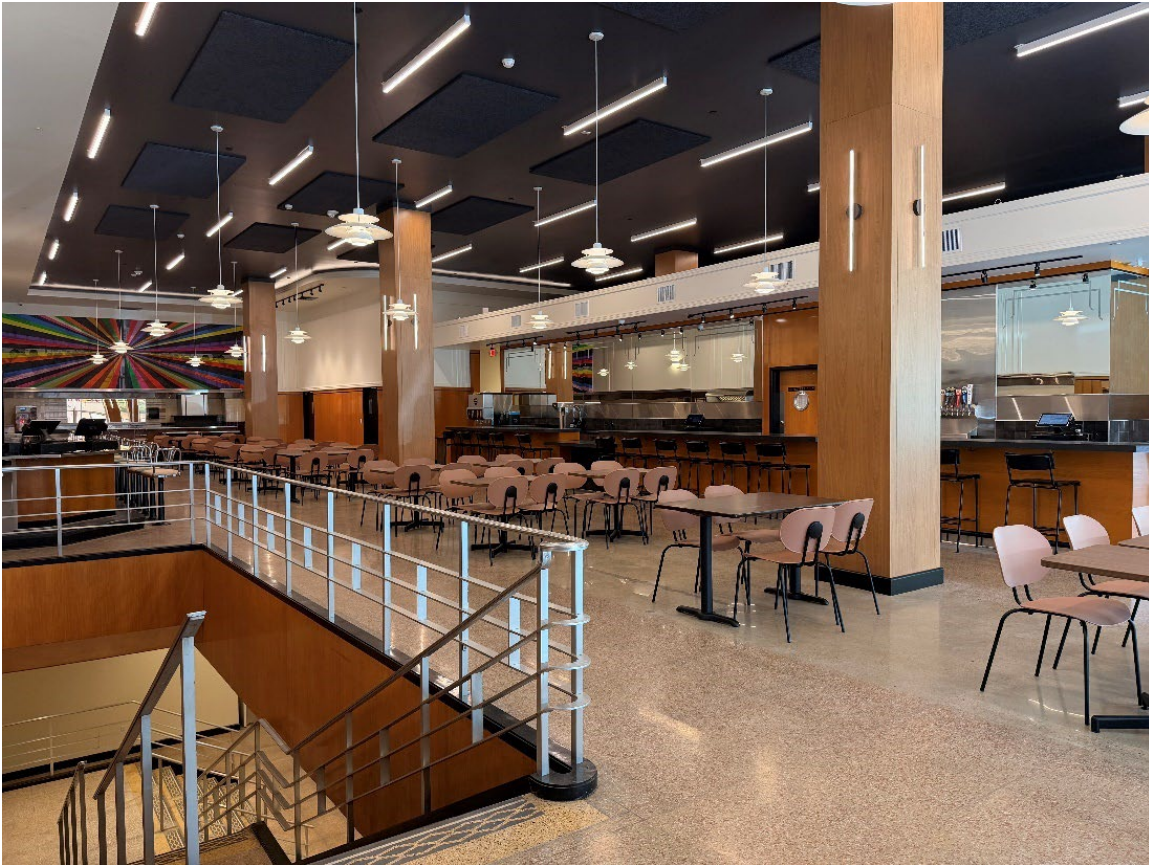
**Photograph 13** Woolworth Building, First Floor, view northeast toward bar (right) and Woolworth Lunch Counter (back left).

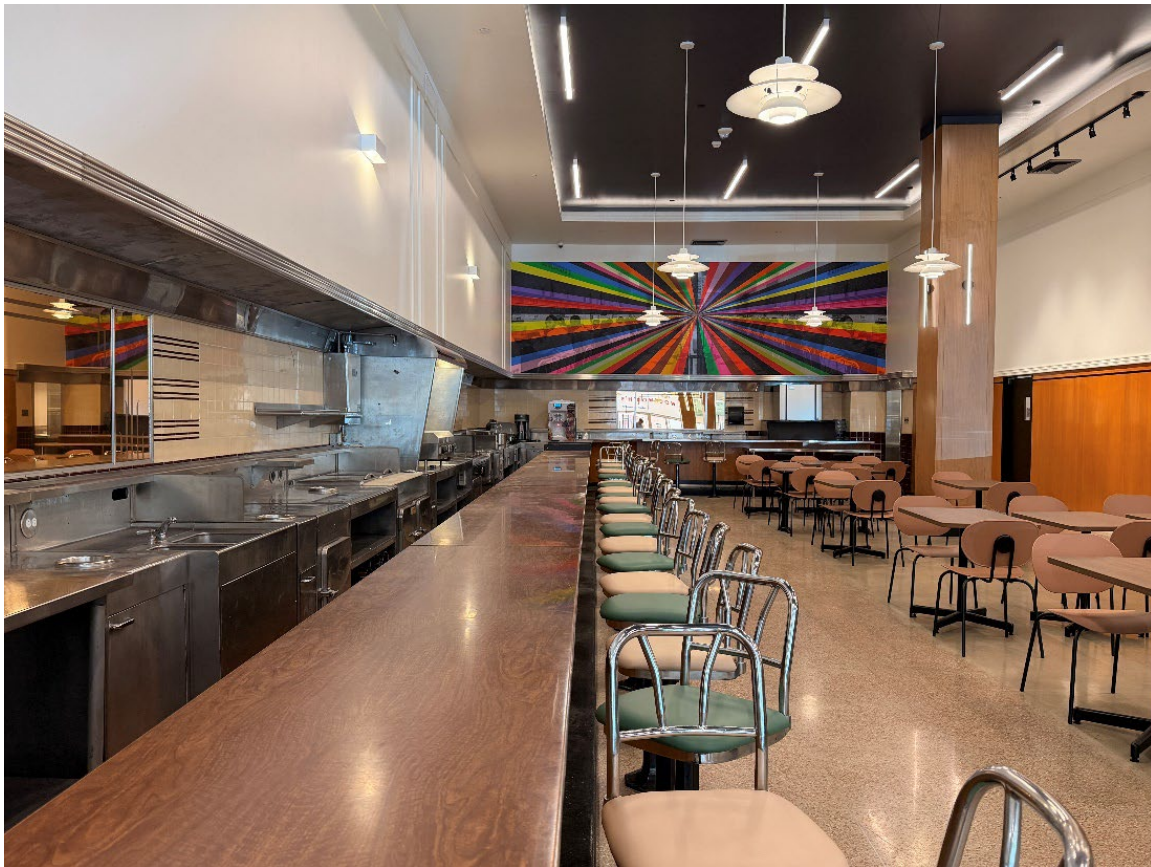
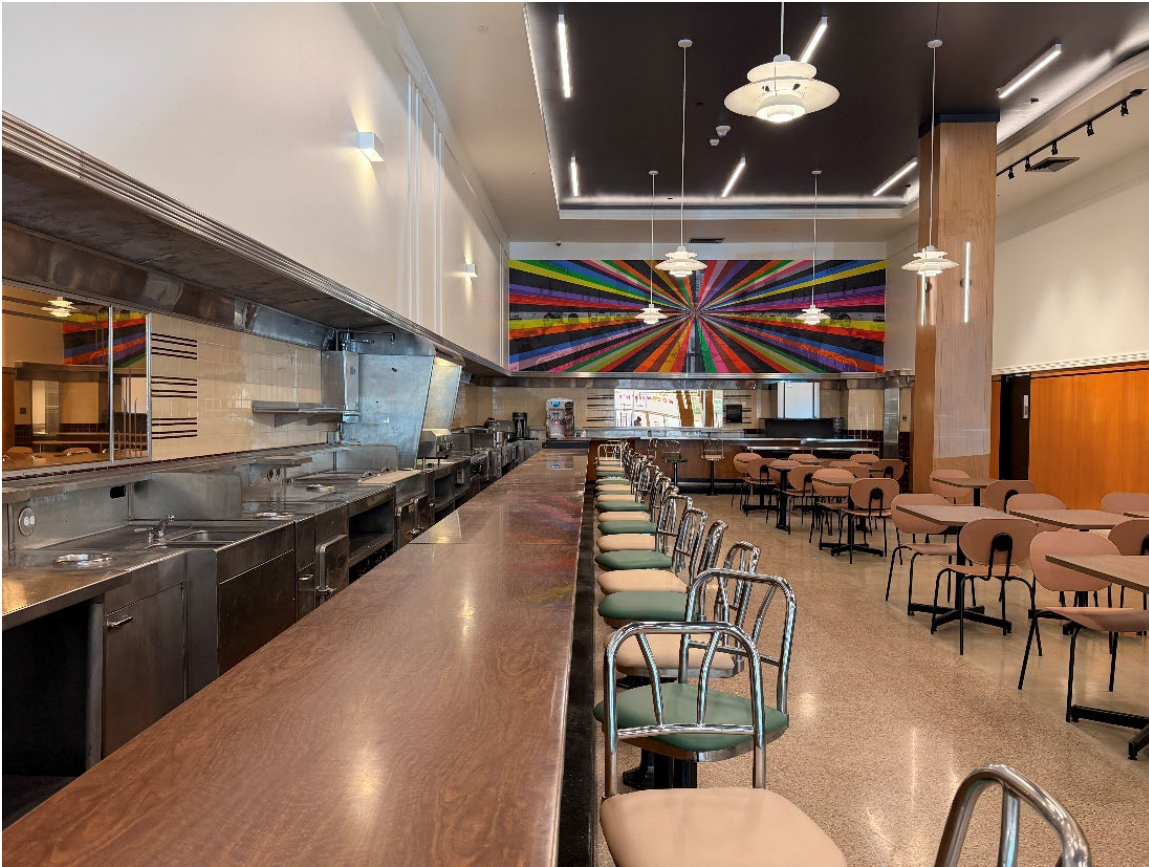
**Photograph 14** Woolworth Building, First Floor. South end of Woolworth Lunch Counter, view north.

Nine original square columns are evenly spaced throughout the floor. Floors in all spaces are original sealed terrazzo and concrete, except at the bar and some back-of-house spaces, which have contemporary tile floors. The luncheonette, main lobby, and front retail spaces have raised painted plaster ceilings with applied acoustical tile panels. Lower plaster soffits surround the perimeter at the floor's original ceiling height. The luncheonette has an original L-shaped stainless steel counter with stained wood veneer siding and black Formica base and features a row of original and salvaged metal stools with vinyl upholstery. The luncheonette's food preparation area has original rose colored mirrors and an original stainless steel backsplash and cornice. Walls running the span of the luncheonette are clad in original light yellow ceramic tile

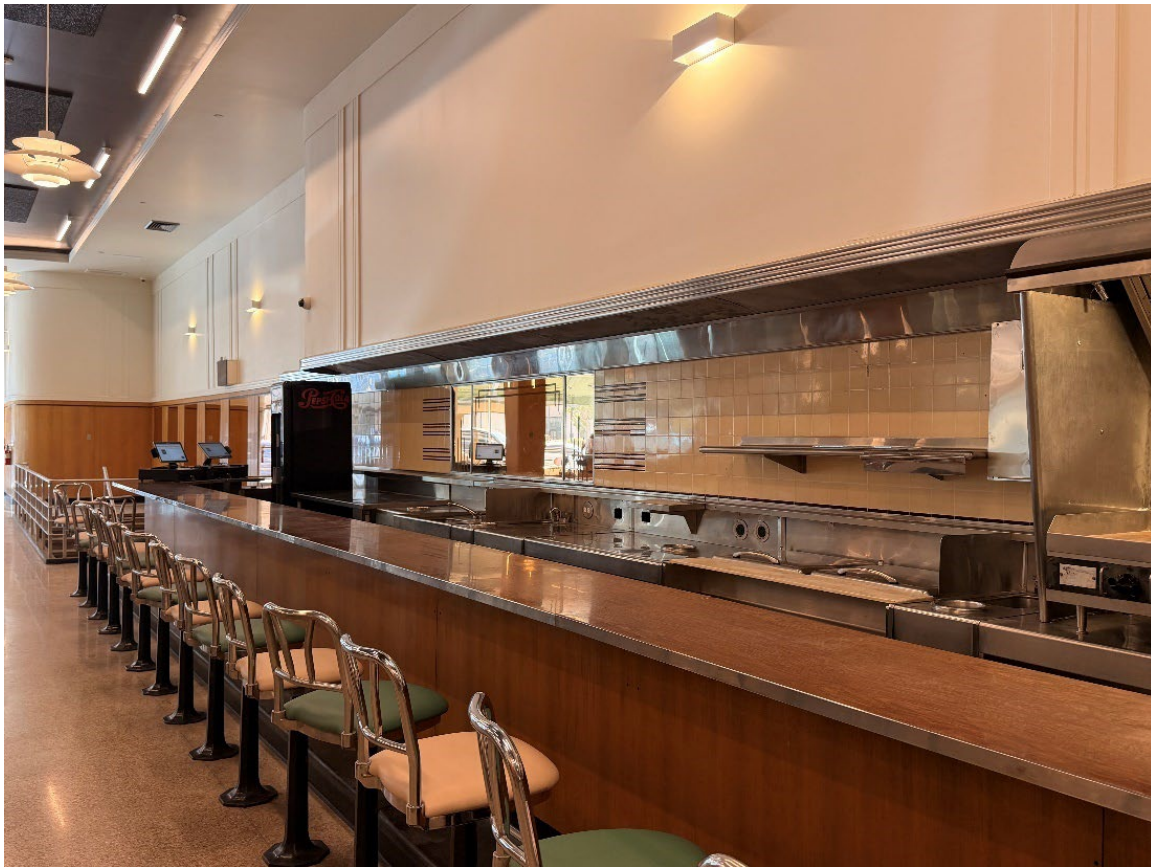
**Photograph 15** Woolworth Building, First Floor. Woolworth Lunch Counter, view southwest.

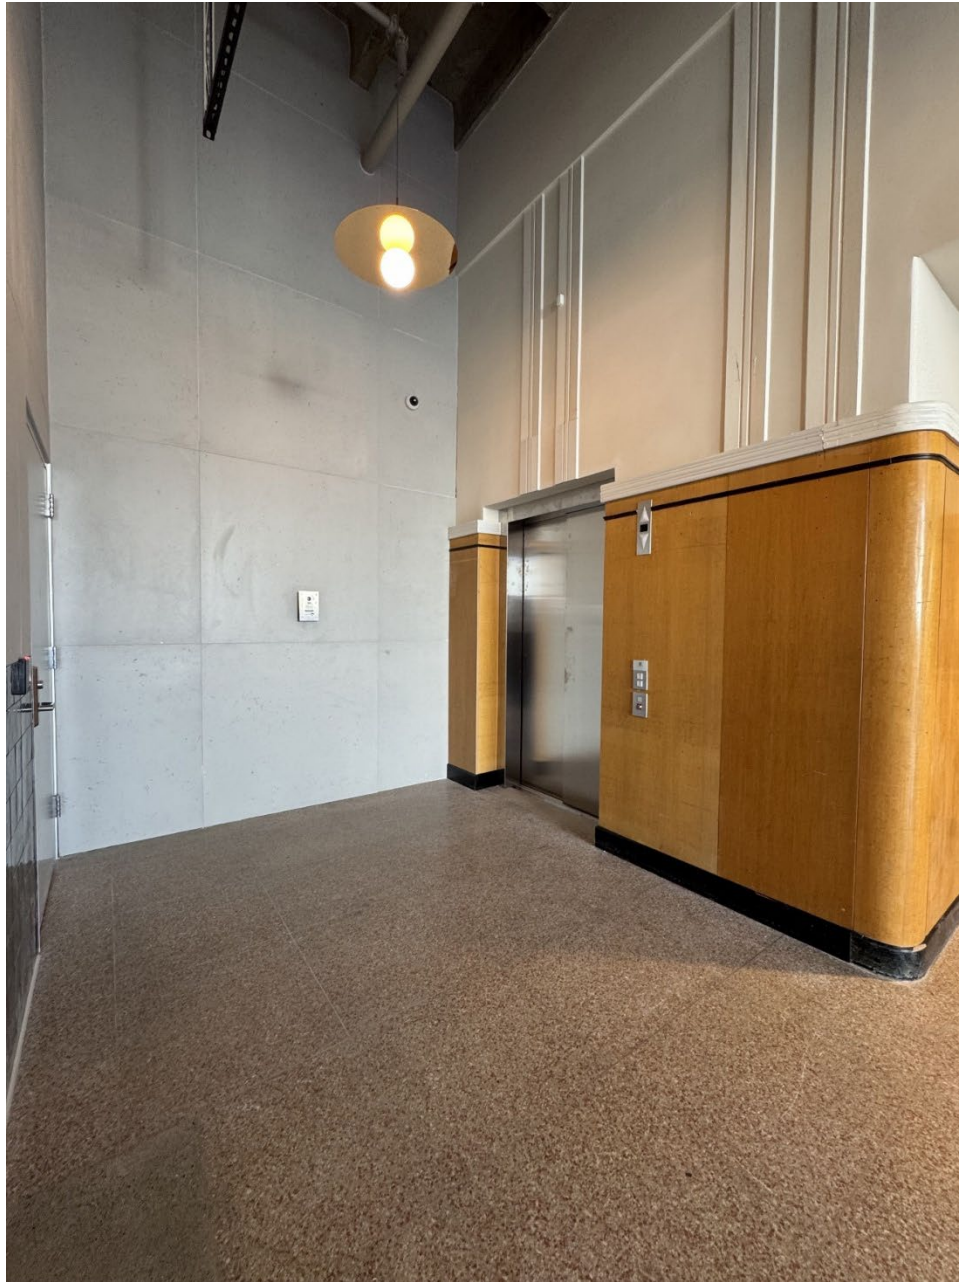
**Photograph 16**

Woolworth Building, First Floor. Elevator lobby, view northwest.

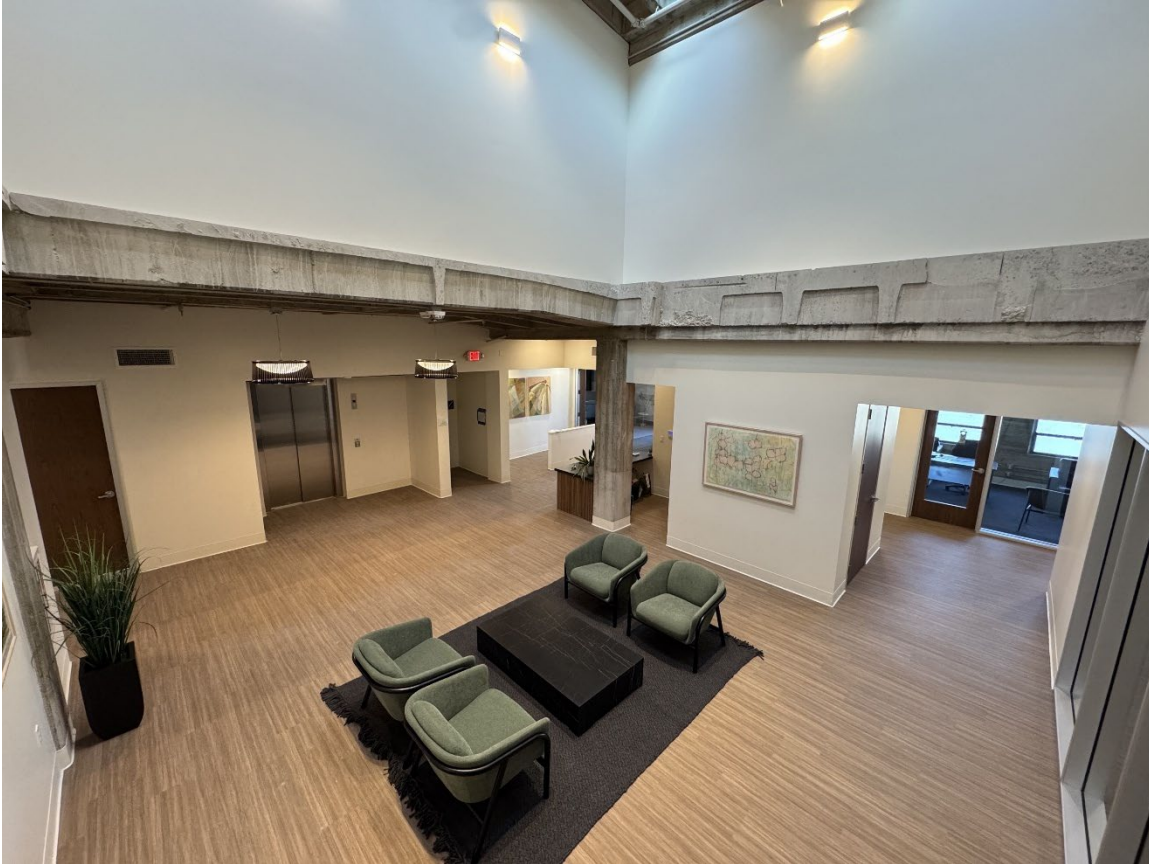
**Photograph 17**

Woolworth Building, Second Floor. Light Court and Elevator Lobby. view northeast.

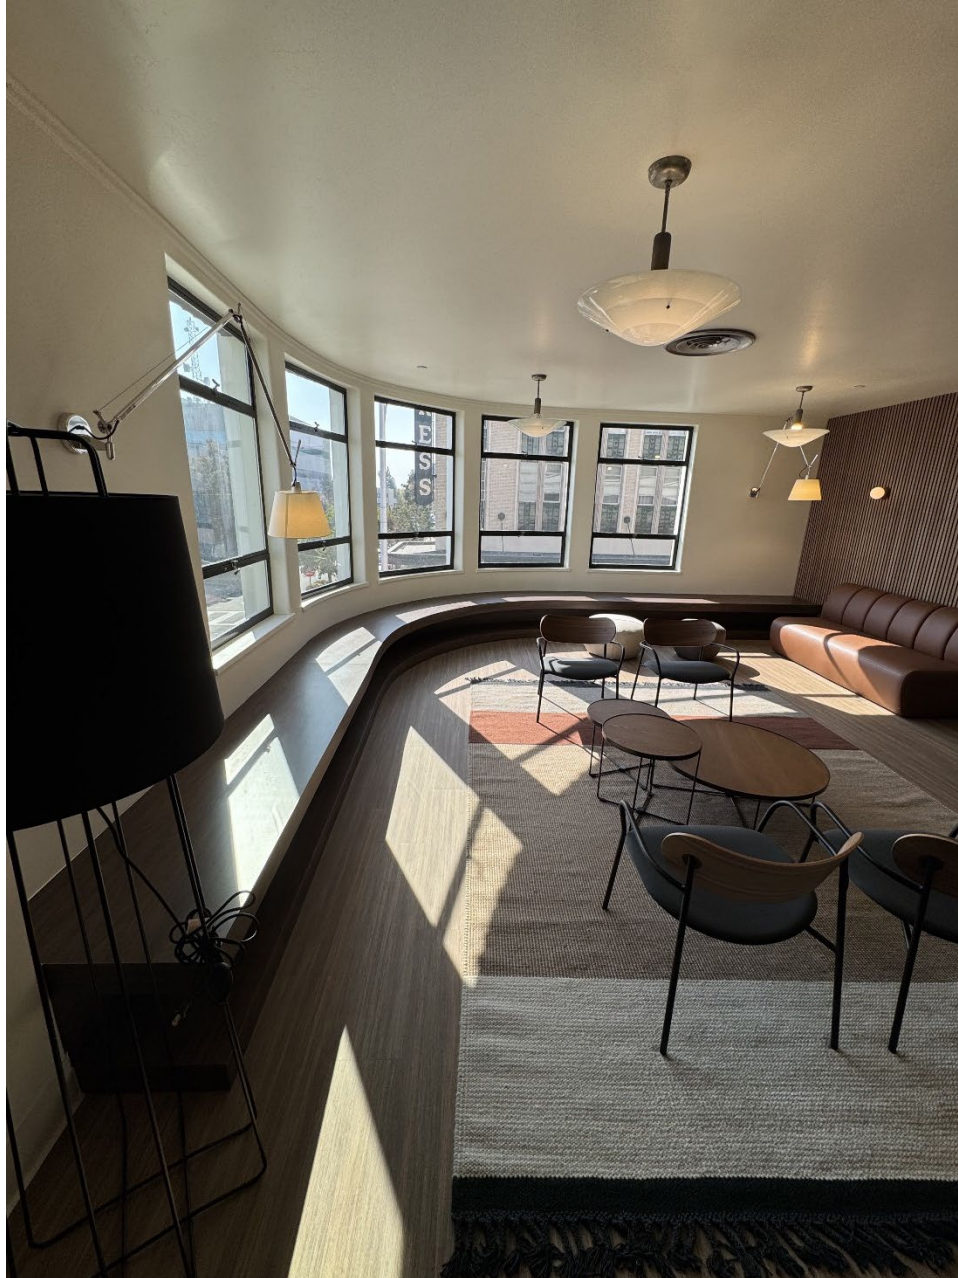
**Photograph 18** Woolworth Building, Second Floor. Break Room, view south.

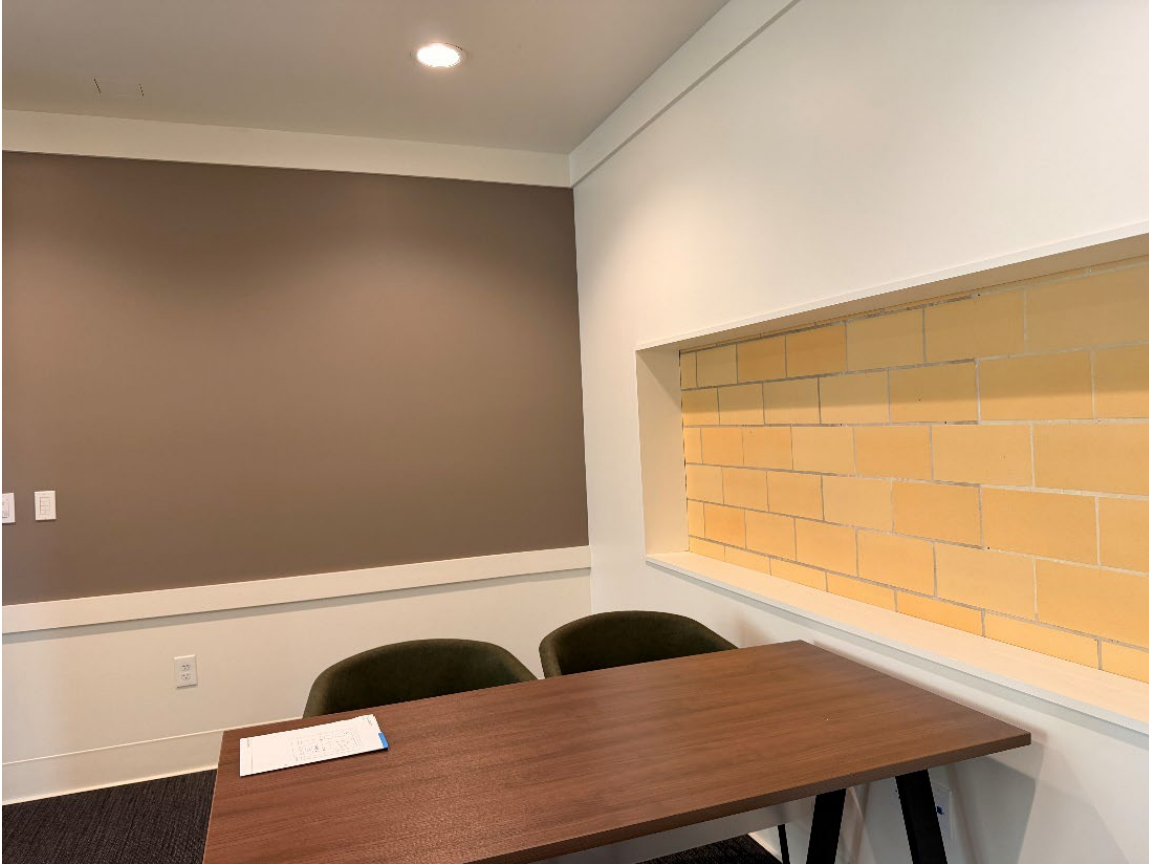
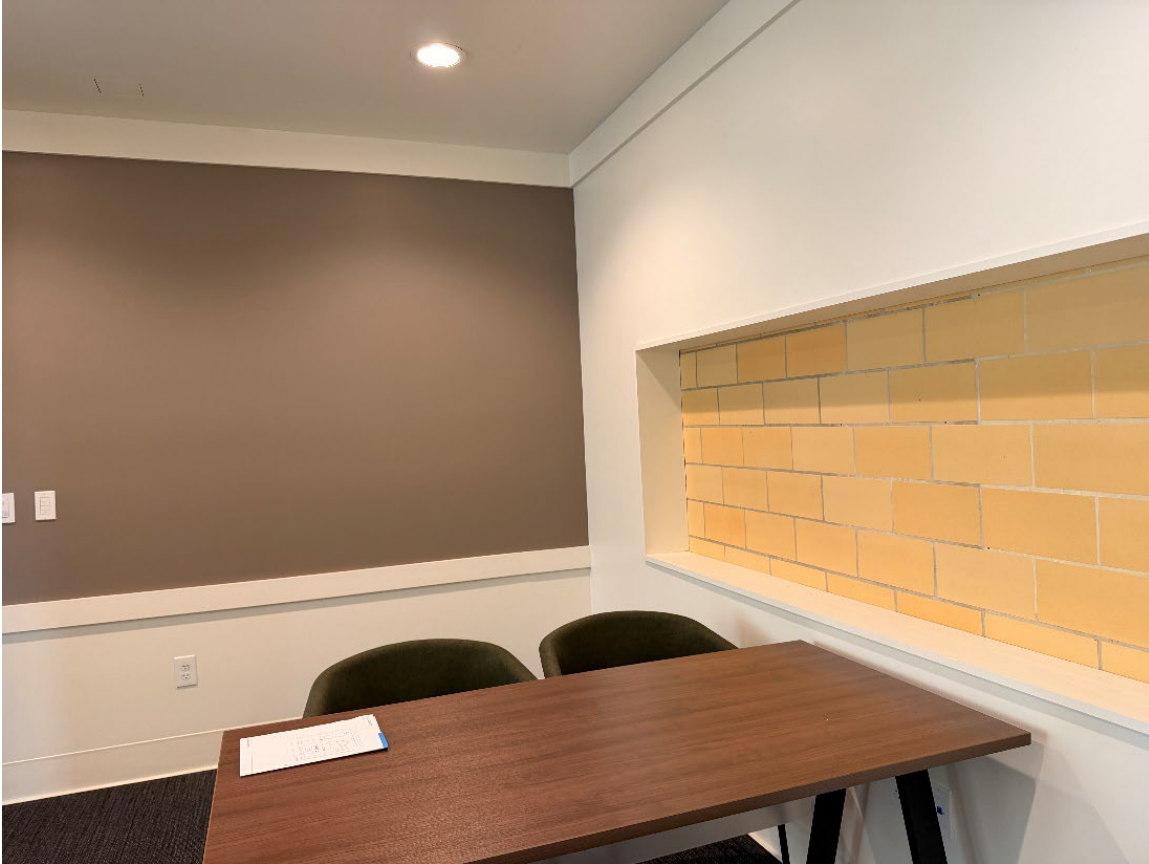
**Photograph 19**

Woolworth Building, Second Floor. Typical office with exposed hollow clay tile.

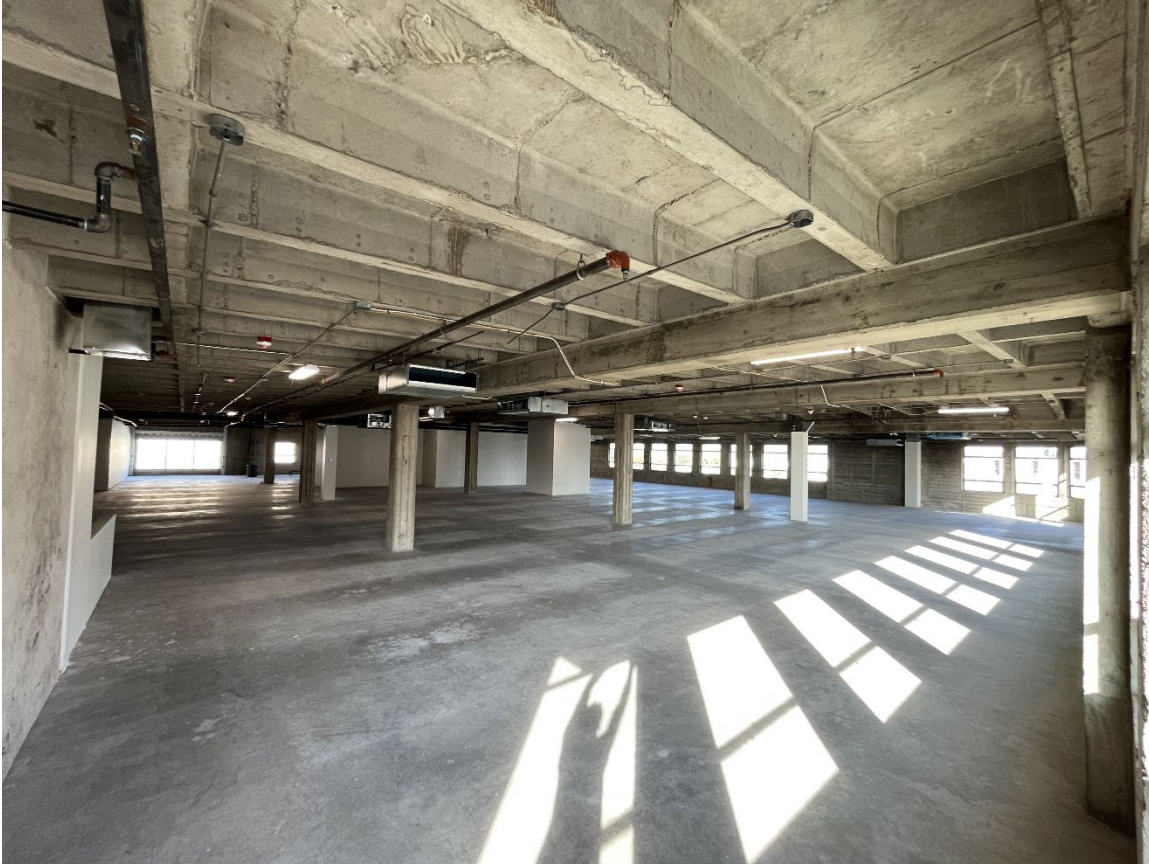
**Photograph 20** Woolworth Building, Third Floor, view northeast.

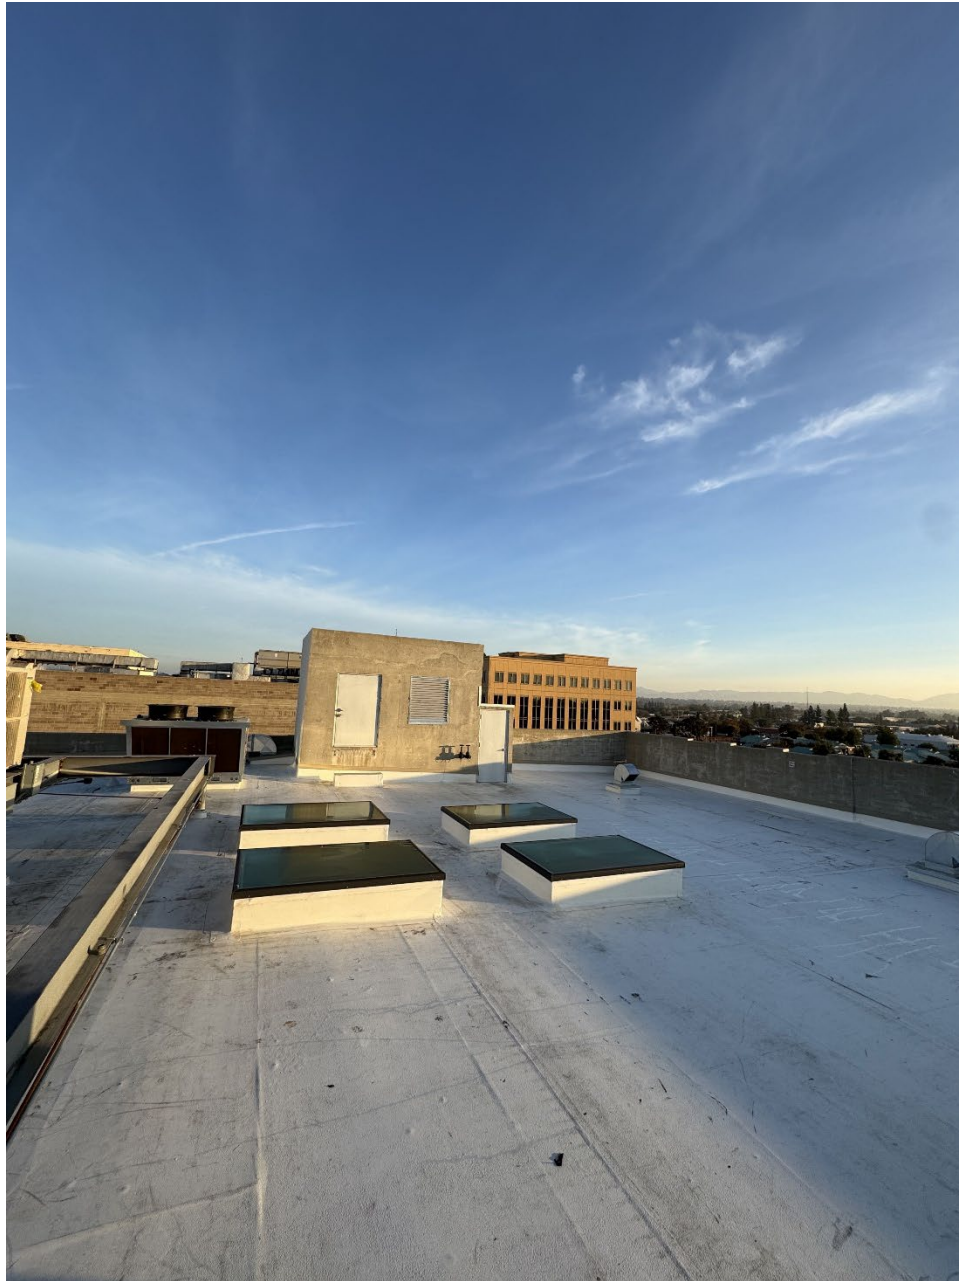
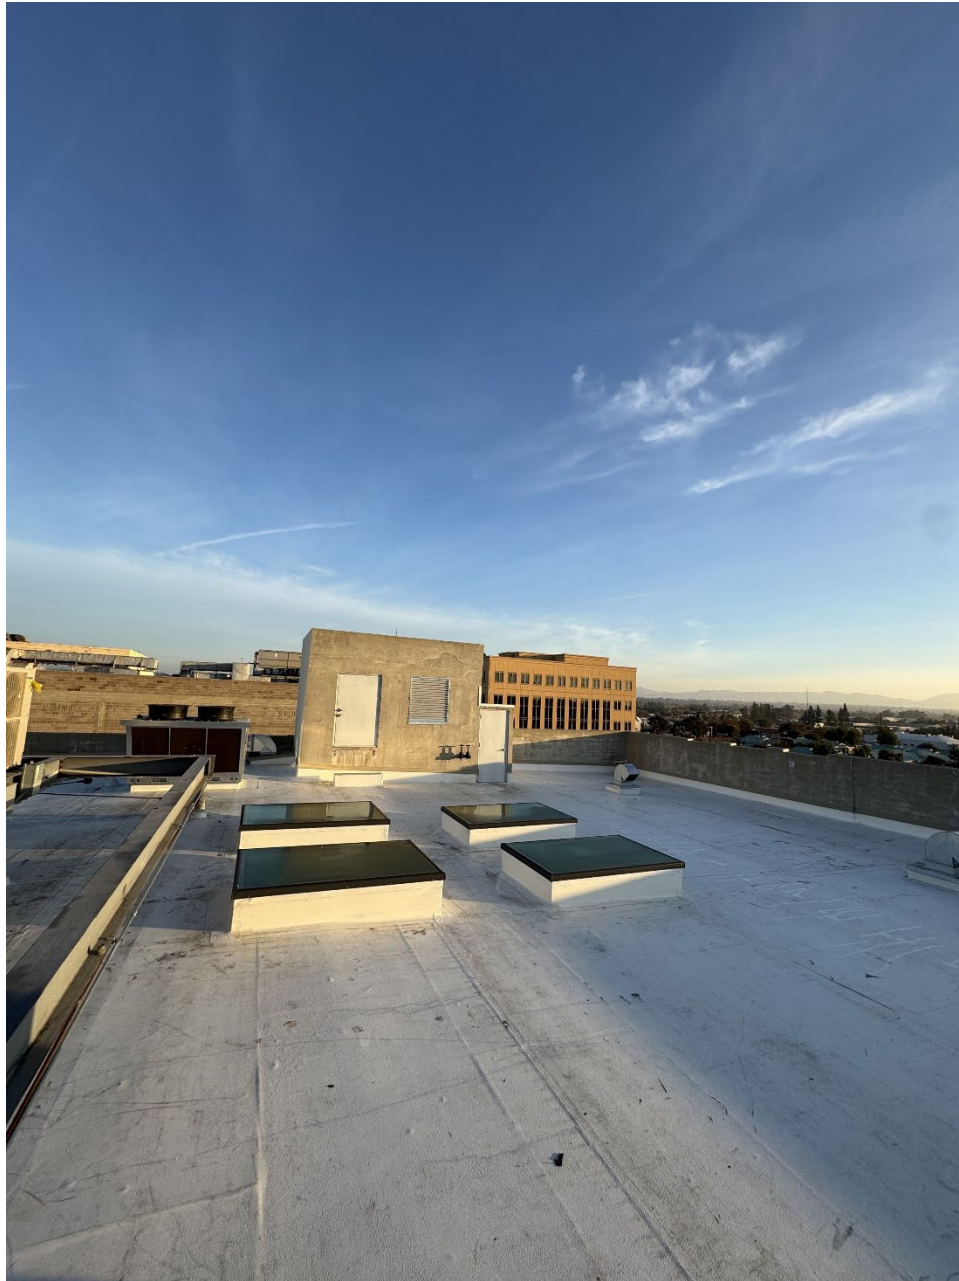
**Photograph 21** Woolworth Building, Roof. New skylights and exit stair penthouse, view northeast.

An elevator penthouse rises along the roof in line with the rear façade and features a smooth concrete stucco wall with no openings at its north-, east-, and west-facing walls. Along its south-facing wall, which is only visible from the roof of the subject building, the elevator penthouse has a metal door; a metal vent is located to the east. A small stair penthouse located along the east wall of the elevator penthouse is not visible from the public right-of-way and provides access to the roof with a metal single-leaf door. Four domed skylights were added to the roof during the 2022-2025 rehabilitation.
