# National Register of Historic Places Registration Form

Historic name: Woolworth Building DRAFT

Street & number: 1400 19<sup>th</sup> Street

City or town: Bakersfield State: CA County: Kern

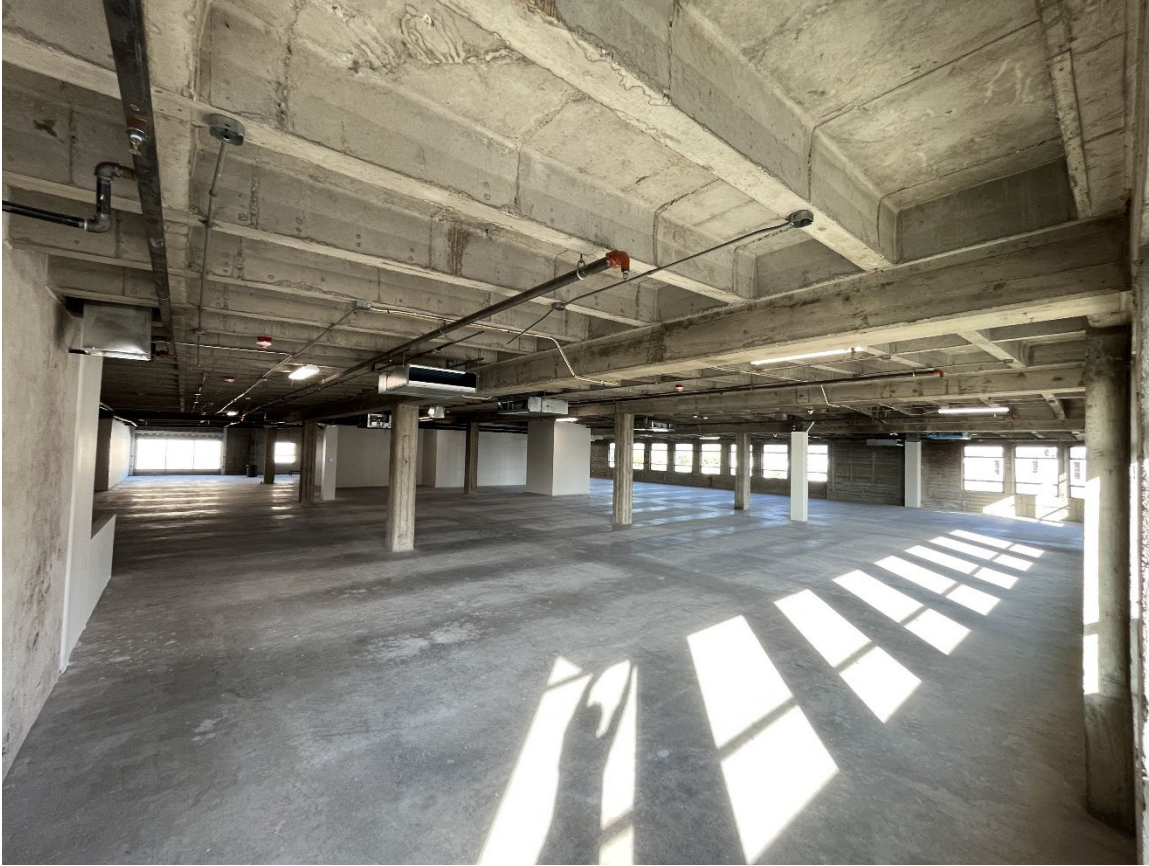
**Photograph 20** Woolworth Building, Third Floor, view northeast.
