National Register of Historic Places Registration Form

Historic name: Harrower Laboratory and Clinic DRAFT

Street & number: 912-920 E. Broadway; 117 S. Belmont Street

City or town: Glendale State: CA County: Los Angeles

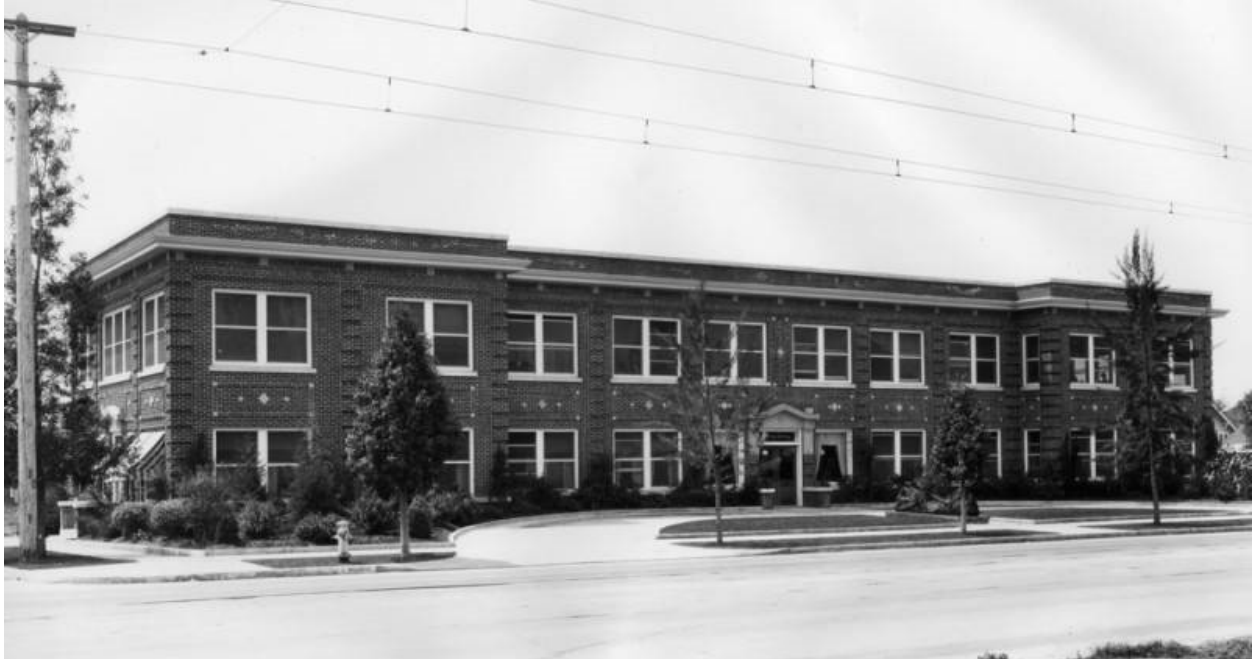
Figure 2 Historic photograph of 920 E. Broadway, north façade, showing original entrance doors, undated. Los Angeles Public Library.

The primary (north) façade faces Broadway. The east and west ends of the façade project slightly further than the rest. The façade features a center entrance surmounted by a concrete pediment. Within the pediment is an engraved letter "H" for the original occupant, Harrower Laboratory. The paired entrance doors are paneled and partially glazed (existing doors replaced non-original doors as part of the ongoing rehabilitation project). The doors are bounded by original brick cheek walls. The entrance is flanked by two non-historic single fixed metal windows. Other windows are single and (mostly) paired, one-over-one, double-hung, and wood.

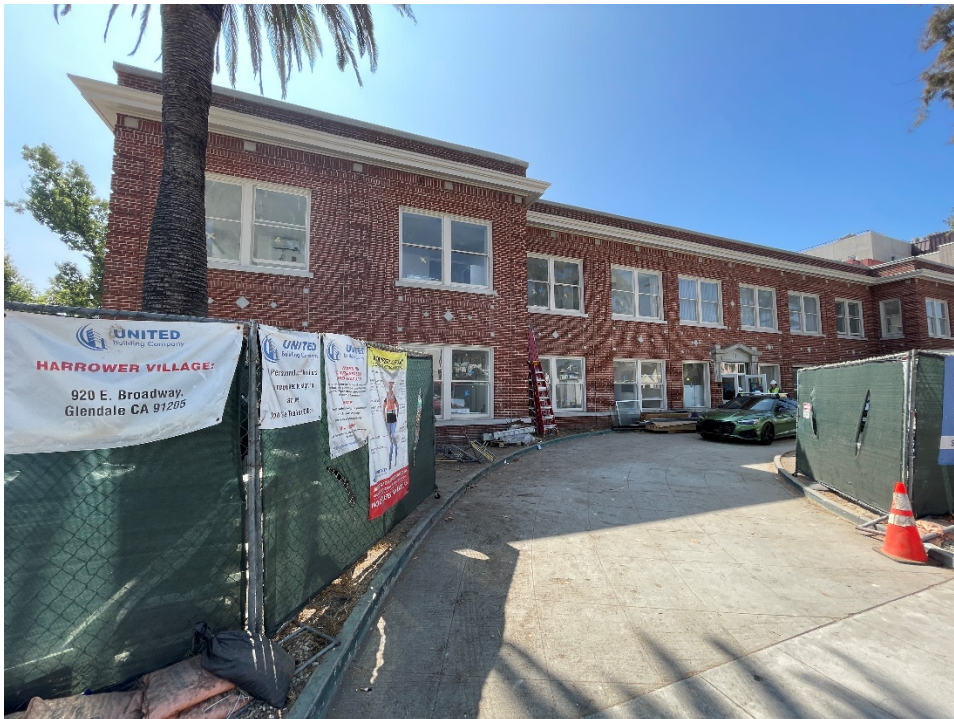
Photo 6 View southwest of 920 E. Broadway's north façade.

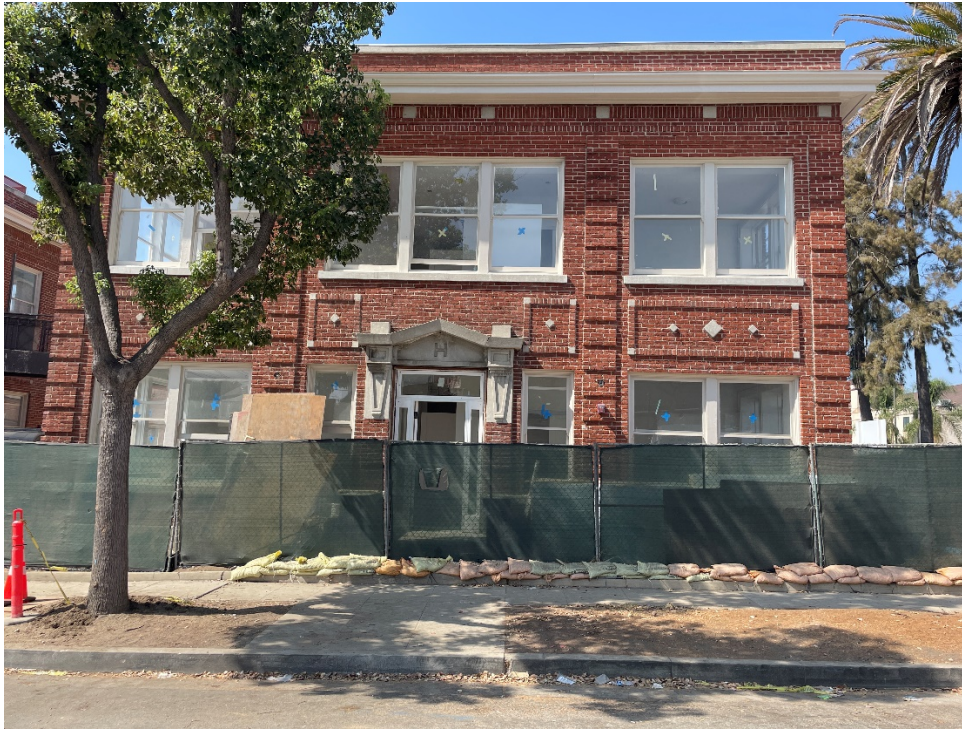
Photo 7 View west of 920 E. Broadway's east elevation.

The east elevation entrance, facing Belmont, is raised from street level and accessed by concrete steps bounded by brick cheek walls. The entrance is topped with a concrete pediment, the same as the entry at the north façade. The central entrance door is wood, paneled, and partially glazed; it is surmounted by a fixed transom and flanked by narrow sidelights (existing door, transom and

sidelights replaced a non-original metal door, transom and sidelight as part of the ongoing rehabilitation project). On either side of the entry is a single one-over-one double-hung wood window, and above the entrance, at the second story, are three grouped one-over-one double-hung wood windows. The other windows are paired and of the same material and configuration.

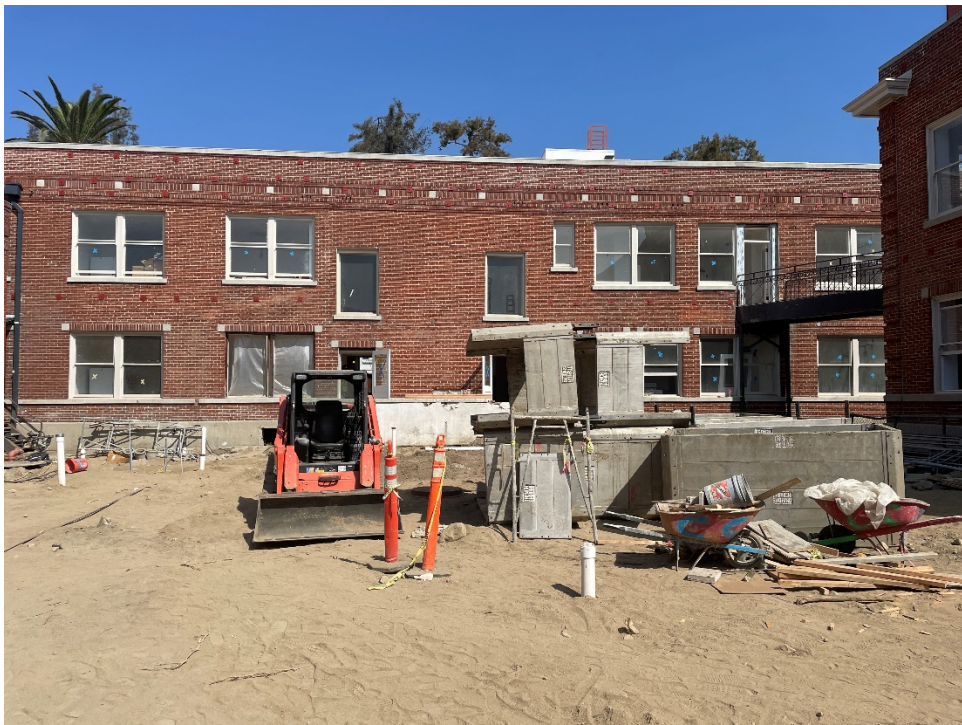
Photo 8 View north of 920 E. Broadway's south elevation.

The south elevation overlooks the courtyard shared with the other two buildings on the property. At the center of the elevation is a concrete stoop leading to two partially glazed wood doors (existing doors replaced non-original metal doors as part of the ongoing rehabilitation project). Windows are unevenly spaced along the elevation and include single and paired double-hung wood windows and non-historic fixed windows. At the south end, second story of the elevation is a partially glazed wood door leading to a concrete bridge with a decorative metal railing. The bridge connects to the former clinic building to the south. The pedestrian bridge is original, but has been altered with new railing in some portions and substantially reinforced with metal bracing/supports (likely in the 1990s during seismic upgrades).

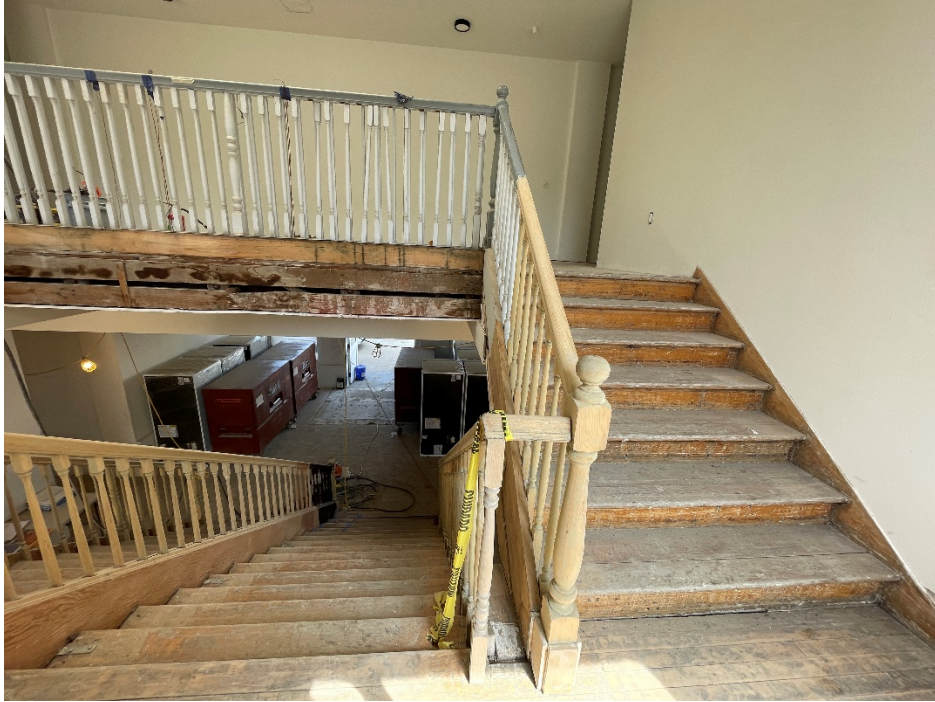
Photo 11 Interior view north of 920 E. Broadway's central staircase.

The first and second floors of 920 E. Broadway have double-loaded corridors lined with residential units on either side. The main (north) entrance to the building leads to a central lobby, which provides access to the rest of the interior. The lobby has a painted gypsum ceiling and walls. The existing subfloor will be finished in vinyl tile as part of the ongoing rehabilitation. The lobby features a central double wood staircase that accesses the second story. Non-historic carpet was removed from the staircase, and the original wood stairs and balustrade are currently being restored. Below the staircase, on the east side, is an original safe enclosed by a metal door (safe repurposed as an elevator equipment room). To the east and west of the lobby at the first floor and central stair landing at the second floor are corridors leading to individual apartment units. The corridors' ceilings and walls are finished in painted gypsum; the existing subfloor will be covered in vinyl as part of the ongoing rehabilitation. Residential units are currently being built out and will have painted gypsum ceilings and walls, vinyl or tile flooring, and simple cabinetry and fixtures.

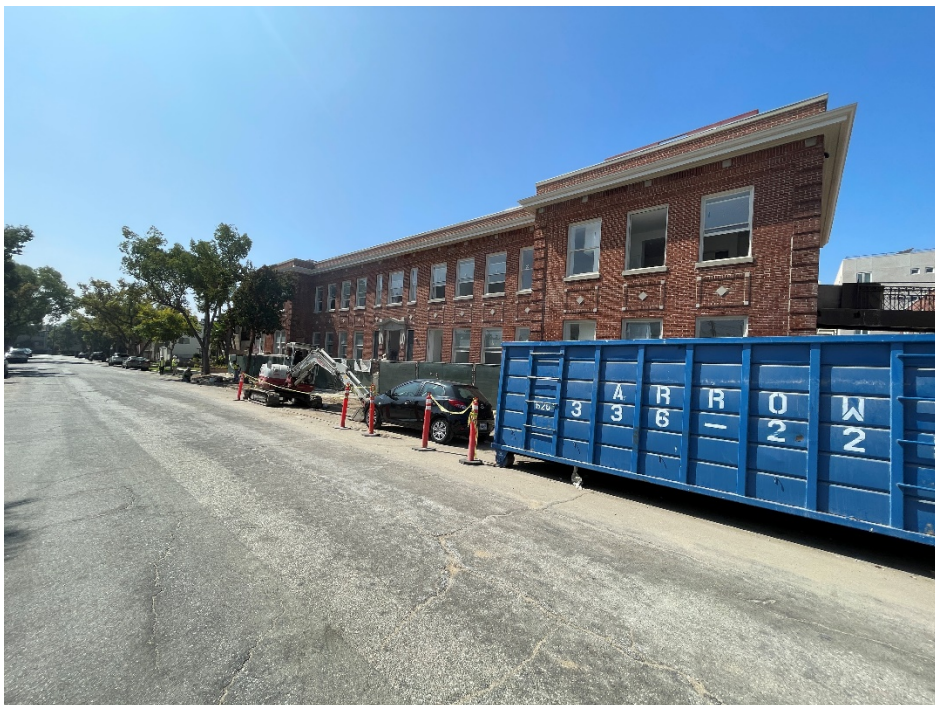
Photo 12 View southwest of 117 S. Belmont's east façade.

The building's east (primary) façade fronts Belmont Street. The north and south ends project slightly further than the rest of the façade. At the center of the façade is the main entrance reached by a series of concrete steps bounded by cheek walls. The main entrance door is wood, paneled, and partially glazed, and is topped with a transom and flanked by sidelights (existing door, transom and sidelights replaced a non-original metal door, transom, and sidelight as part of the ongoing rehabilitation project). Above the door is a concrete pediment, and at the center of the pediment is an engraved letter "H". On either side of the entry is a non-historic fixed window. Perpendicular to and facing the main entrance, near the north and south end volumes, are single partially glazed wood doors accessed by concrete steps. To the south of the main entrance stoop are concrete steps leading to the basement door. At the center of the second story, above the main entrance, is a single one-over-one double-hung wood window flanked by narrower double-hung windows. The majority of windows are single one-over-one double-hung wood with a few paired windows in the north and south volumes.

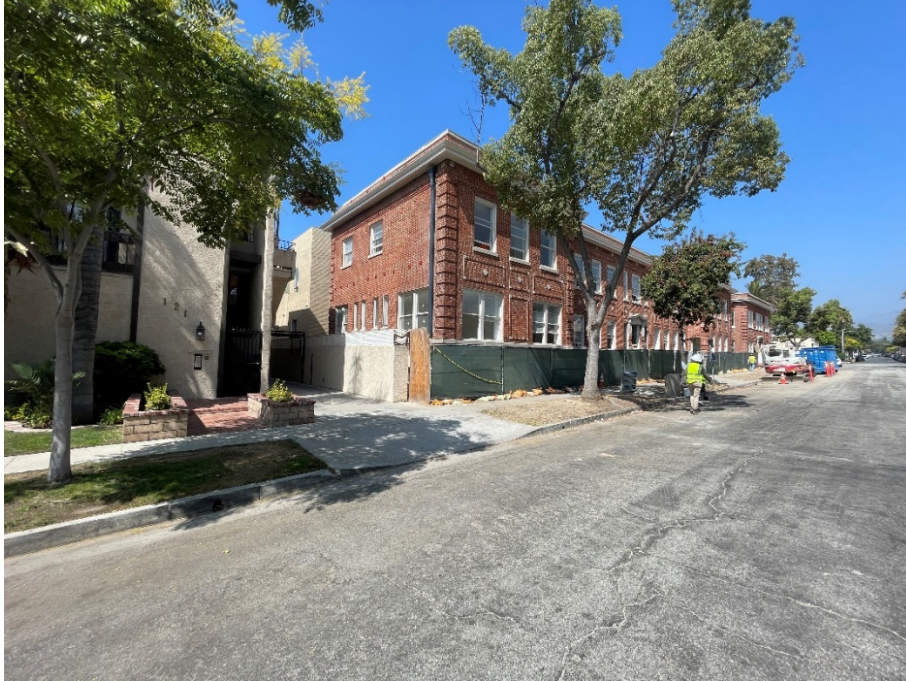
Photo 13 View northwest of 117 S. Belmont's east façade and south elevation.

The south elevation fronts a vehicular driveway belonging to the neighboring apartment building to the south. The elevation has unevenly spaced single and paired double-hung wood windows and narrow fixed windows.

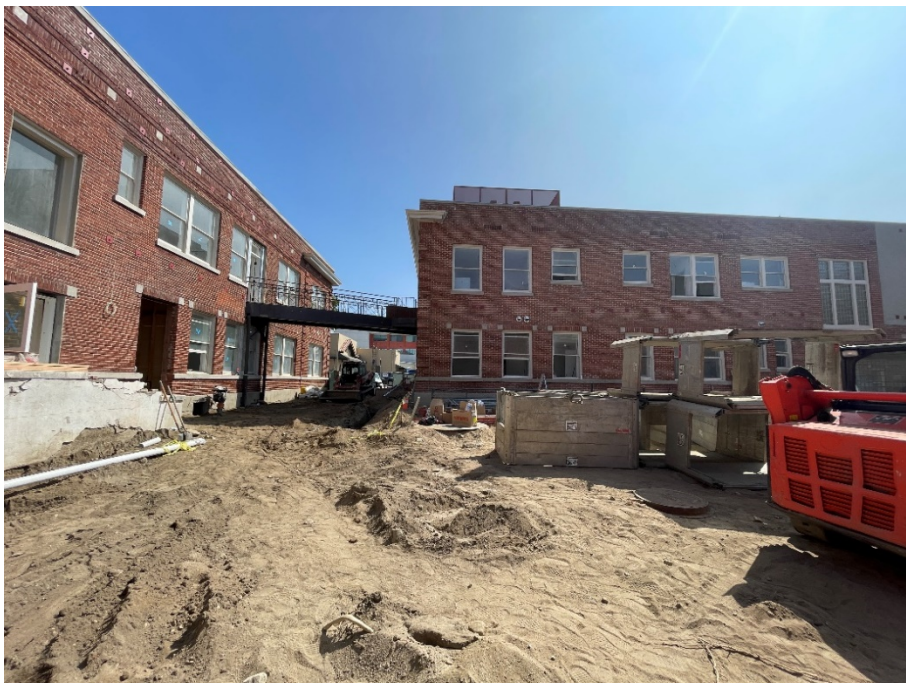
Photo 14 View east of 117 S. Belmont's west façade and bridge connecting to 920 E. Broadway.

The west elevation overlooks the center courtyard. At the south end of the elevation is a two-story open stairwell that connects to an addition that will hold additional residential units. (The stairwell replaced a non-original enclosed stair in the same location as part of the current rehabilitation.) In a few areas on the elevation, rows of brick have been replaced with vertical and horizontal sections of concrete, for reasons unknown. An entrance at the center of the elevation provides access to a stair leading to the main lobby. Above the entrance is a group of six non-historic glass block windows. Other fenestration includes single and paired one-over-one double-hung wood windows.

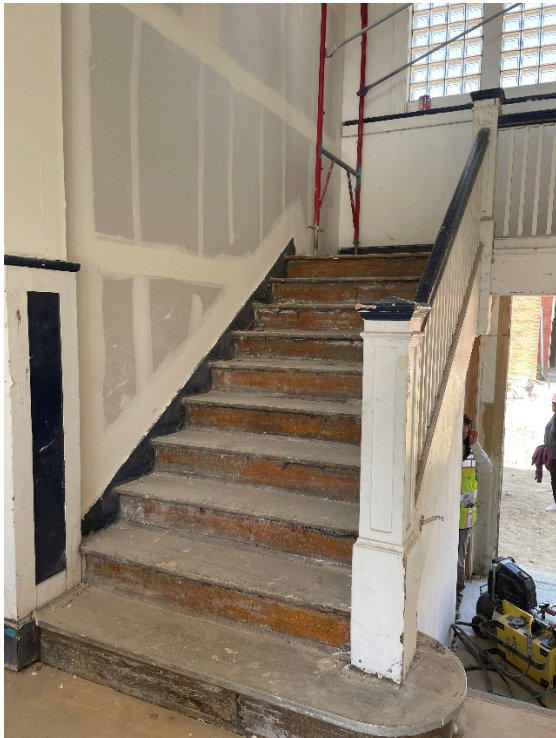
Photo 16 Interior view west of 117 S. Belmont's central staircase.

The building at 117 S. Belmont Street features double-loaded corridors at the first and second stories and basement with residential units on either side. At the center of the first floor is a small lobby with a single wood staircase that provides access to the second story. The lobby has a painted gypsum ceiling and walls. The existing subfloor will be finished in vinyl tile as part of the ongoing rehabilitation. To the east and west of the lobby at the first floor and central stair landing at the second floor are corridors that lead to individual apartment units. The corridors' ceilings and walls are finished in painted gypsum; the existing subfloor will be covered in vinyl as part of the ongoing rehabilitation. Residential units are currently being built out and will have painted gypsum ceilings and walls, vinyl or tile flooring, and simple cabinetry and fixtures.

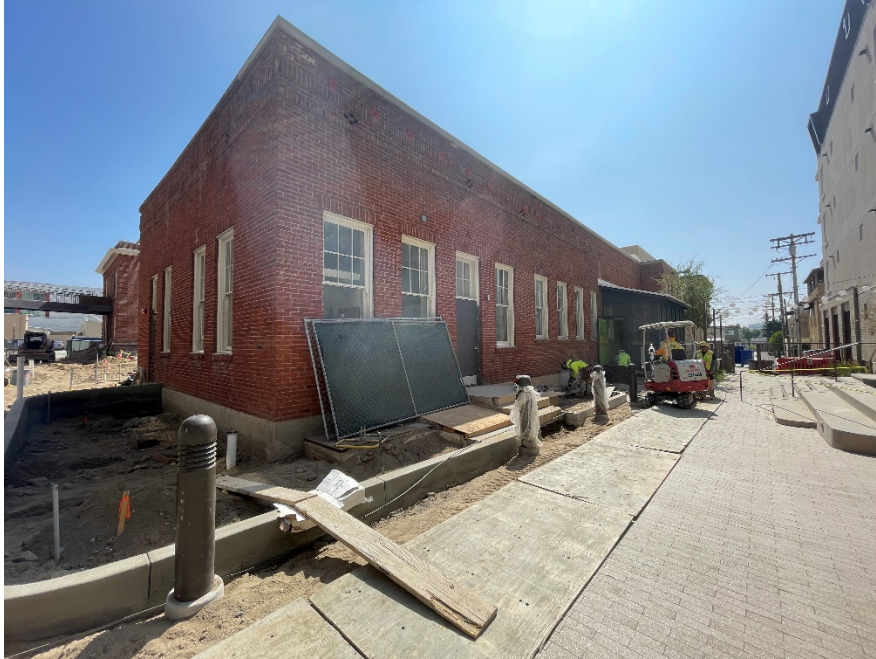
Photo 17 View southeast of 912 E. Broadway's north and west elevations.

The building's primary (west) façade fronts the alley. At the north end of the façade is a non-original flush metal door surmounted by a multi-light transom and accessed by concrete steps. A shed roof addition (constructed as a porch in the 1940s; enclosed after the mid-1990s), clad in wood and lined with multi-light wood windows, has an entrance perpendicular to the one at the north end. The entry consists of a flush door with a concrete stoop and steps. At the south end of the façade, in the two-story volume, is a single flush door. Most of the façade is lined with double-hung wood windows with three lights in the top sash and a single light in the bottom. Two-over-one double-hung wood windows are located at the second story of the two-story volume.

The north elevation has three-over-one double-hung wood windows and a partially glazed wood door surmounted by a multi-light transom (existing door replaced a non-original fully glazed metal door as part of the rehabilitation).

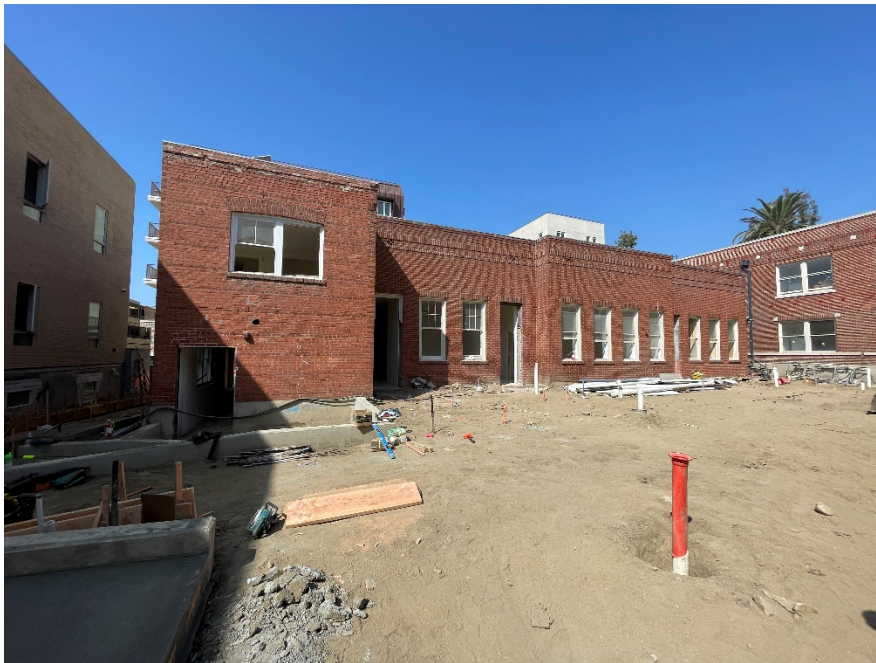
Photo 18 View northwest of 912 E. Broadway's east elevation.

The east elevation faces the courtyard. The elevation is lined with three-over-one, one-over-one, and two-over-two double-hung wood windows with brick sills. There are four door openings

without doors at the writing of this nomination. The proposed doors are partially glazed and wood.
