State of California ¾ The Resources Agency
DEPARTMENT OF PARKS AND RECREATION
PRIMARY RECORD

*Resource Name or #: Cambria Chinese Temple

***P10. Survey Type:** California Point of Historical Interest Nomination

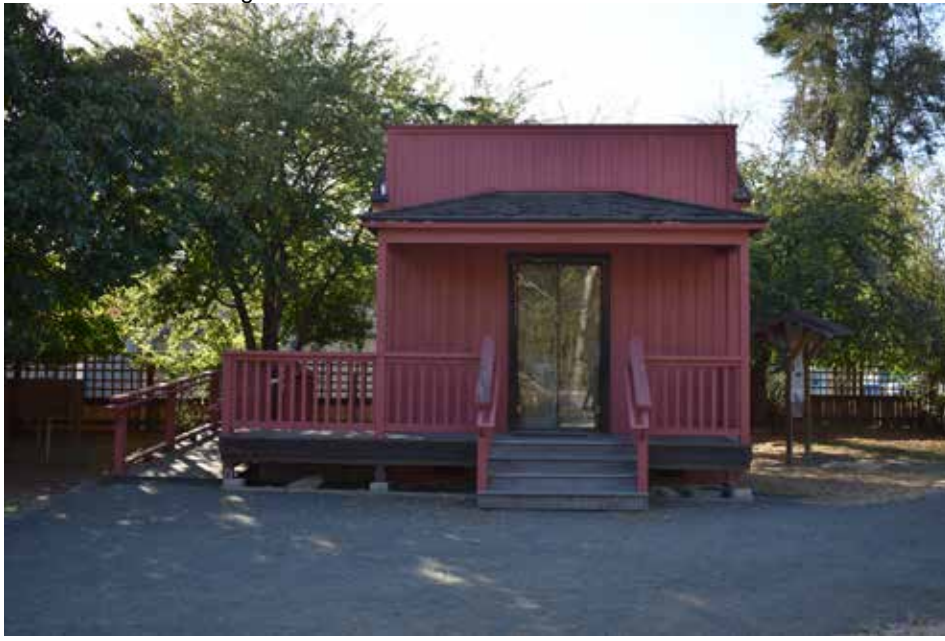
P5a. Photo or Drawing

P5b. Description of Photo: Primary (east) elevation of the Cambria Chinese Temple-view facing west; photo taken 10/18/2019

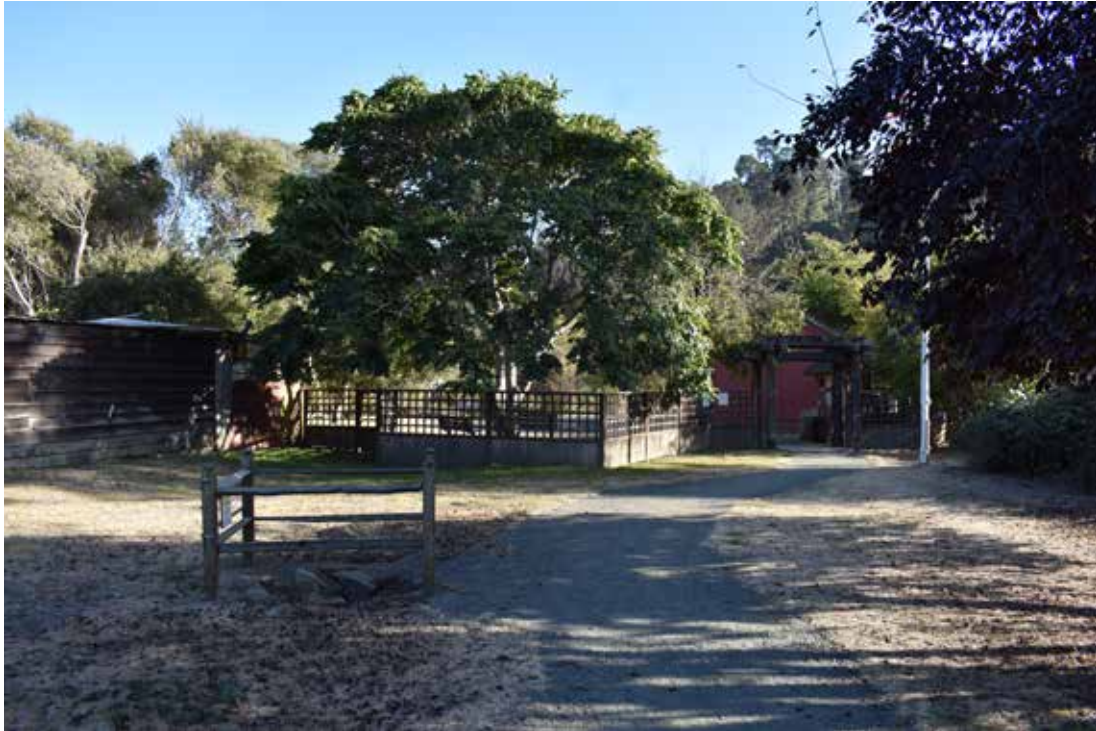
Approach to Cambria Chinese Temple from Center Street Parking Area with Temple in Background
South-Facing View; Photo Taken 10/18/2019

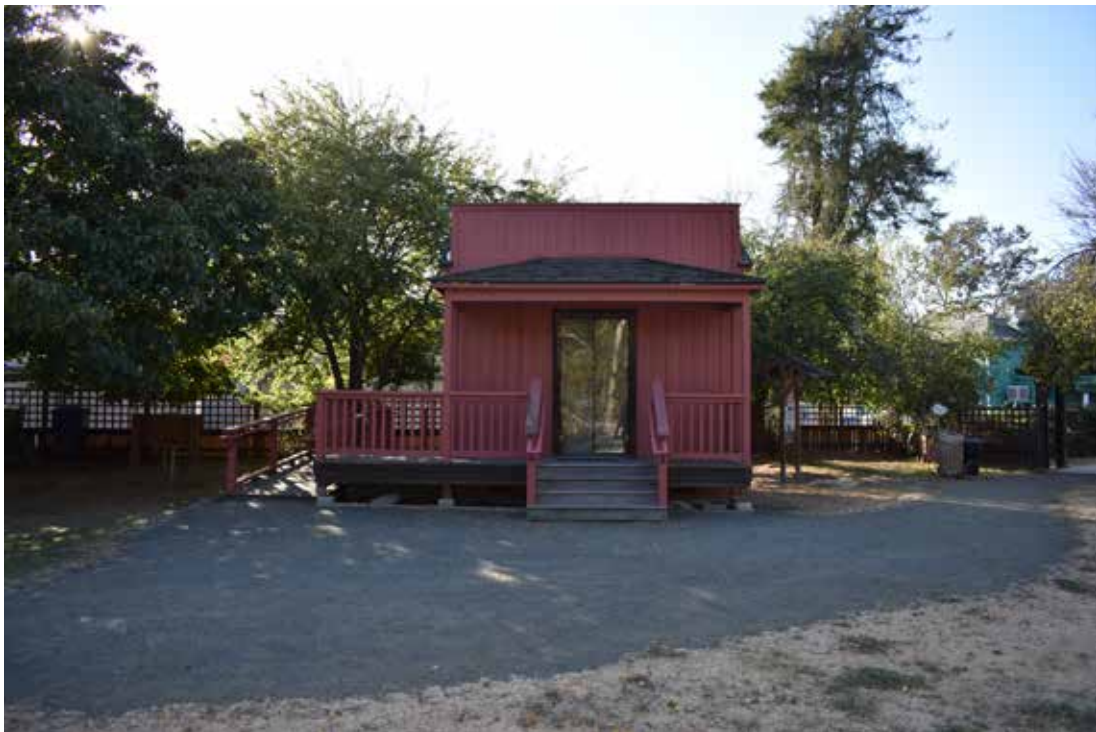
It is topped with a medium-pitched side-gabled roof featuring narrow to moderate boxed eaves that intersects with a false-front parapet over the primary (east) elevation. The roof is clad in wooden shingles. Openings are limited to wooden gable vents, offset on the north and south elevations, and a set of double wooden doors placed centrally on the primary elevation. A narrow, full-width, wood-framed porch, accessible via a set of three wooden steps, extends across the primary elevation. The porch is sheltered by a shallow-pitched hipped roof covered in wood shingles extending from the parapet, supported by two square wooden posts and surrounded with a simple balustrade. The porch extends beyond the building to the south to accommodate a ramp, (non-original) added to increase accessibility, off the south elevation.

Primary (East) Elevation of Cambria Chinese Temple
West-Facing View; Photo Taken 10/18/2019

- § Reconstruction of previously removed false front parapet based on physical evidence and historic-era photographs
- § In-kind replacement of previously removed battens (east exterior wall)

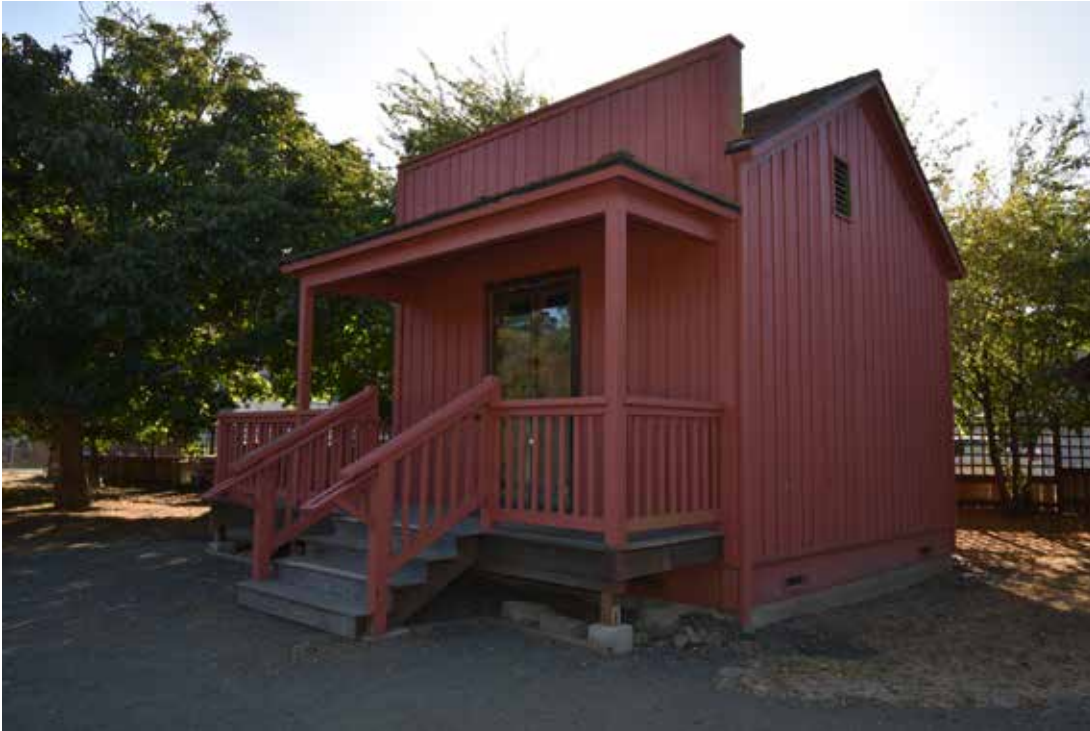
Oblique Shot of Secondary Cambria Chinese Temple-Primary (East) and Secondary (North) Elevations Visible South-Facing View; Photo Taken 10/28/2019

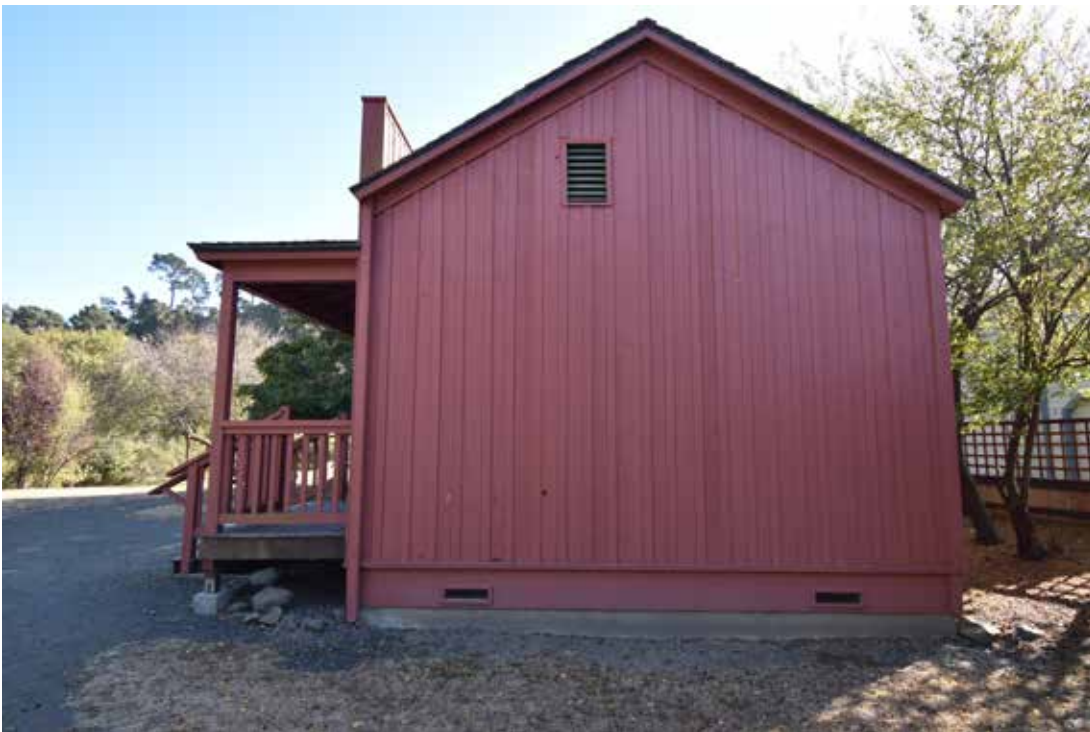
Secondary (North) Elevation of Cambria Chinese Temple South-Facing View; Photo Taken 10/28/2019

- § Removal and infill of two non-original window openings (south and west walls) with in-kind board and batten materials
- § Removal and infill of non-original door opening (north wall) with in-kind board and batten materials

- § Reconstruction of previously removed eave on north side of building with in-kind materials
- § Replacement of deficient roof framing with in-kind materials (remaining original roof framing is estimated at 85 %)
- § Application of wood shingle roof (believed to be original roofing material)
- § Addition of a cricket at rear of false front parapet to minimize water issues in this area
- § Application of paint in accordance with regional trends (physical evidence and historic photographs were unable to determine original exterior paint colors)
- § Installation of two downspouts

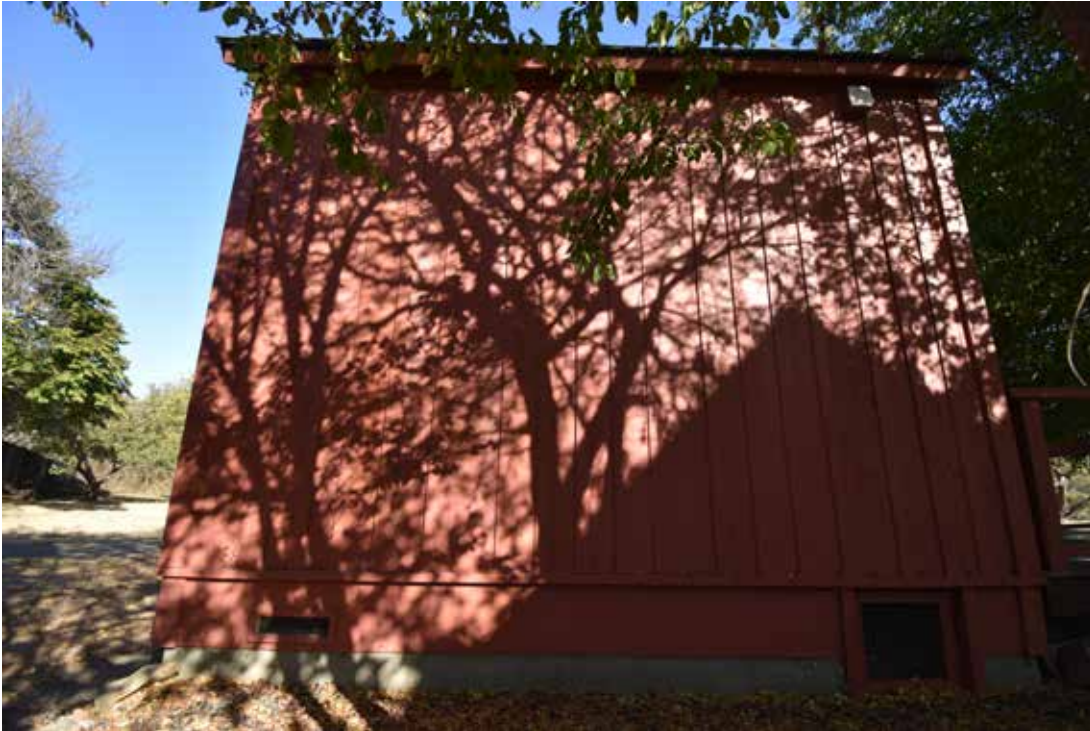
Rear (west) Elevation of Cambria Chinese Temple
East-Facing View; Photo Taken 10/28/2019

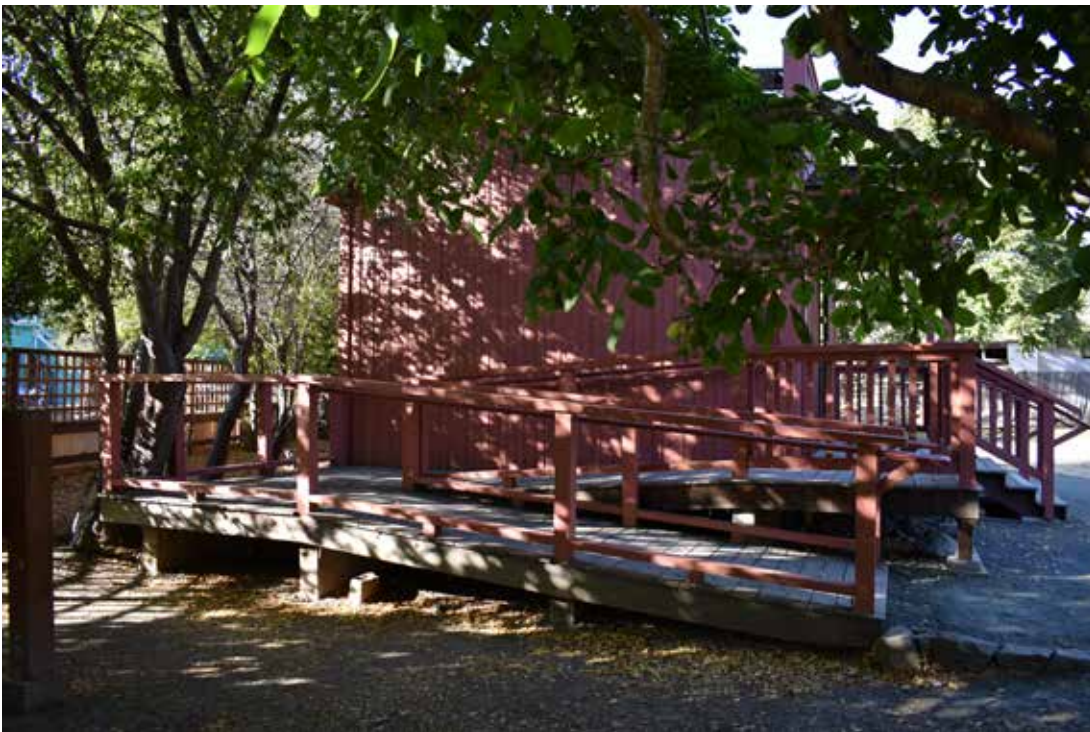
Secondary (South) Elevation of Cambria Chinese Temple
North-Facing View; Photo Taken 10/28/2019

- § Addition of wood-framed accessible ramp to the south of the building.

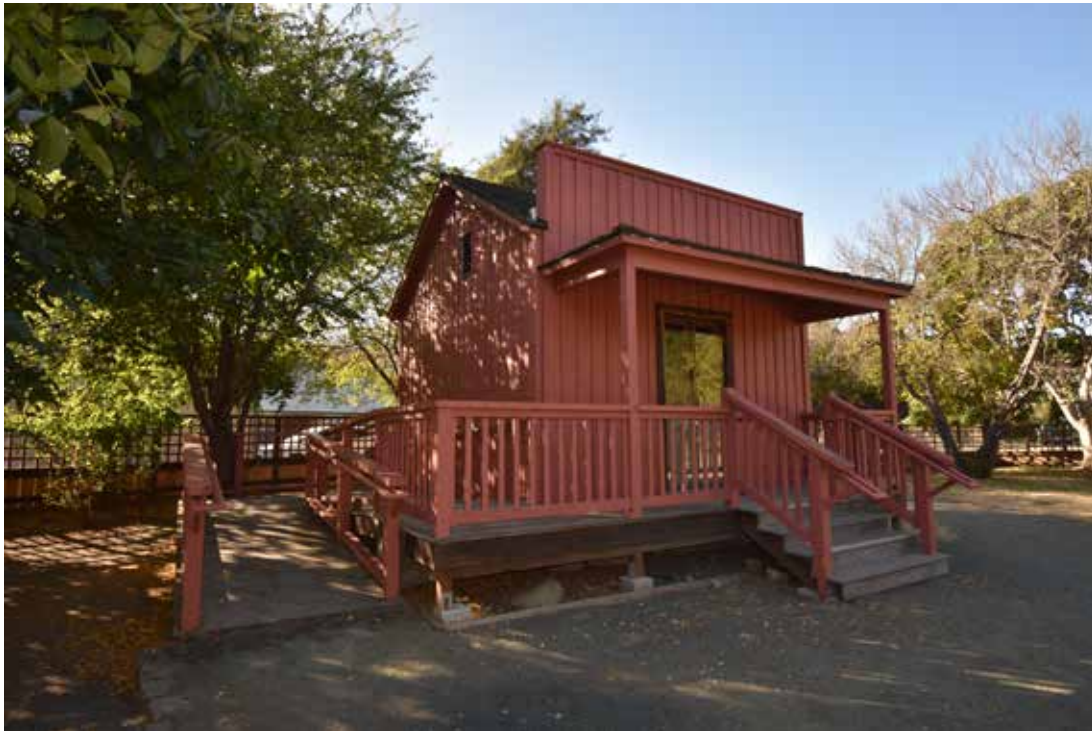
Oblique Shot of Cambria Chinese Temple; Primary (East) and Secondary (South) Elevations Visible
Northwest-Facing View; Photo Taken 10/18/2019

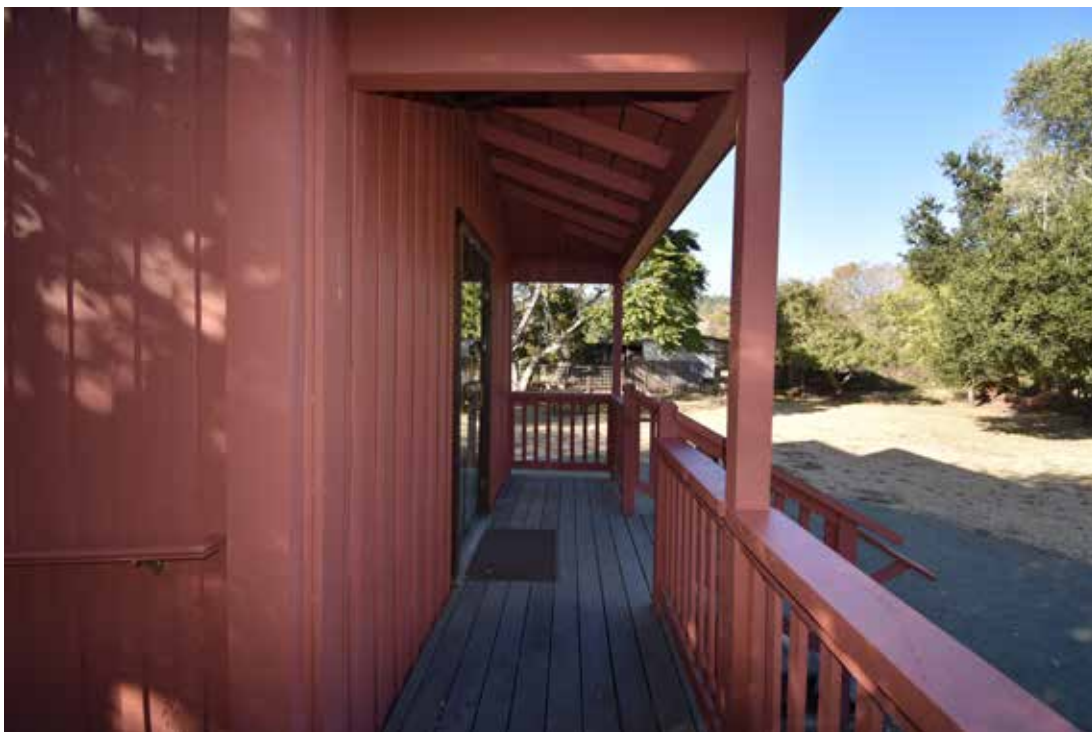
Porch of Cambria Chinese Temple
North-Facing View; Photo Taken 10/18/2019

- § Reconstruction of previously removed porch (while the historical record indicates that the building original features a full-length front porch, available information regarding original porch design was not abundant)

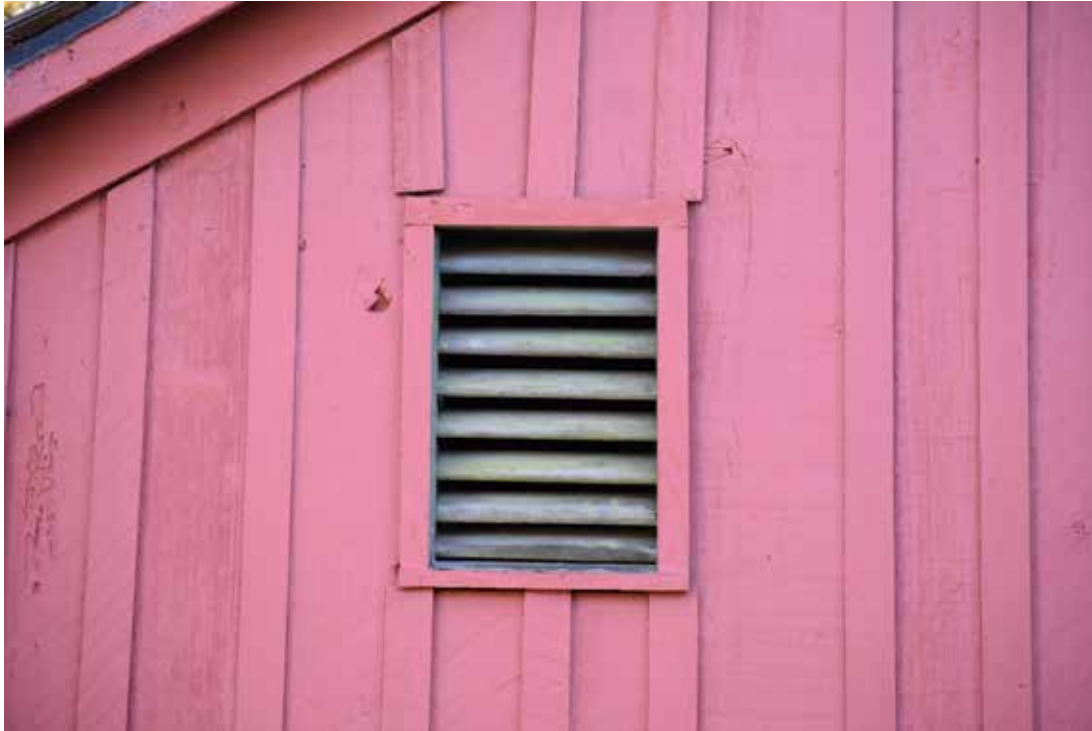
Close-up of Cambria Chinese Temple Gable Vent and Siding; Secondary (North) Elevation South-Facing View; Photo Taken 10/18/2019

- § Installation of earthquake hold-downs (metal) to secure building to new concrete foundation
- § Replacement of exterior siding, barge, corner and trim boards deteriorated beyond repair (due primarily to insects and wood rot) with in-kind material; it is estimated that 80% of the exterior siding material is original

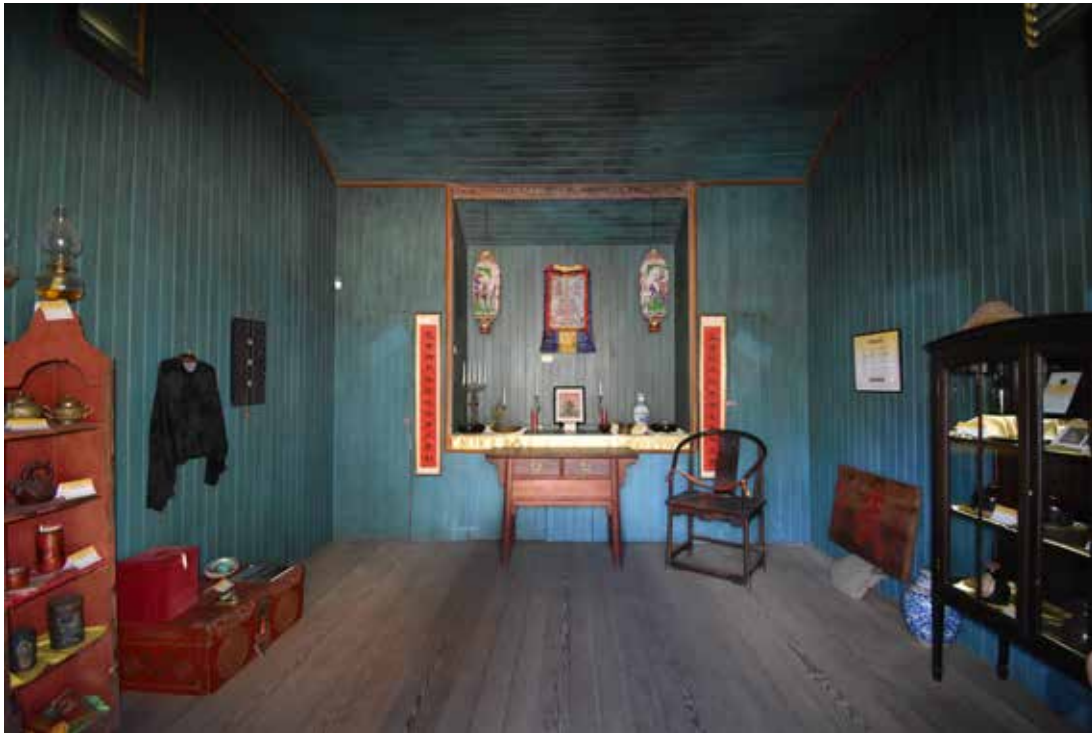
The west interior wall is dominated by a large (roughly 2'2" deep, 6' 10" wide, and 7' at front/6' at back in height) alcove thought to have been historically used as an altar (Greenwood and Associates [Greenwood] 2001). The alcove features a sloped ceiling and extends from approximately 36" above the floor to the wall-ceiling junction. All alcove surfaces are clad and finished in a manner consistent with walls. The recess is framed with the same simple trim found at wall-ceiling junctions. It is surrounded with cabinets; a floor to ceiling cabinet flanks the alcove to either side and two additional cabinets occupy the space below it. Cabinet doors are constructed of beaded tongue and groove boards. The interiors of two of the cabinet doors are whitewashed; otherwise, cabinet interiors are unfinished.

Interior View of Cambria Chinese Temple; Photo taken from Doorway
West-Facing View; Photo Taken 10/18/2019

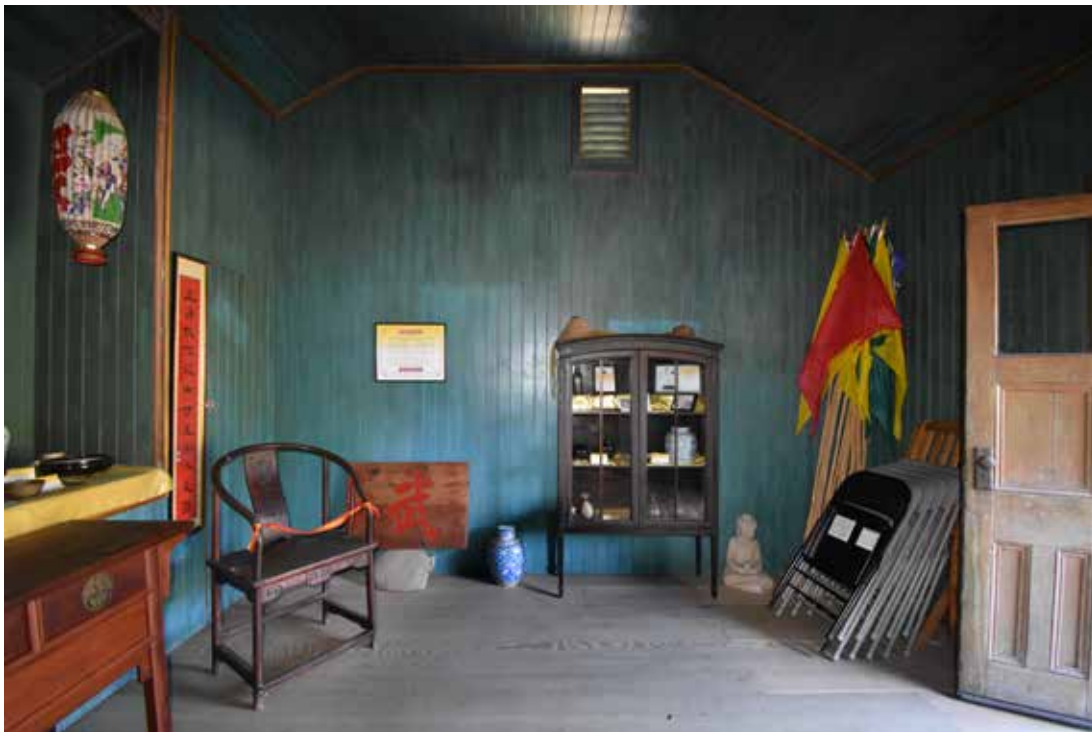
Interior View of Cambria Chinese Temple
North-Facing View; Photo Taken 10/18/2019

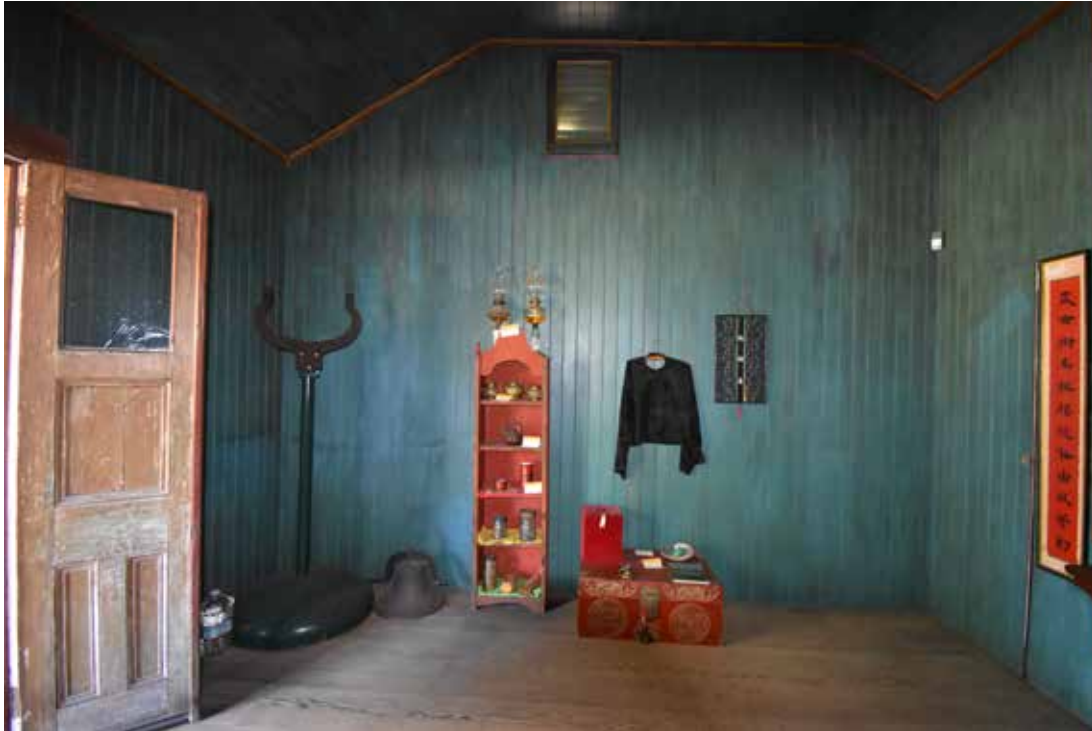
Interior View of Cambria Chinese Temple
South-Facing View; Photo Taken 10/18/2019

- § Replacement of south wall gable vent horizontal louvers that were previously removed
- § Removal of non-original wall boards (east wall only) to expose original interior wall cladding

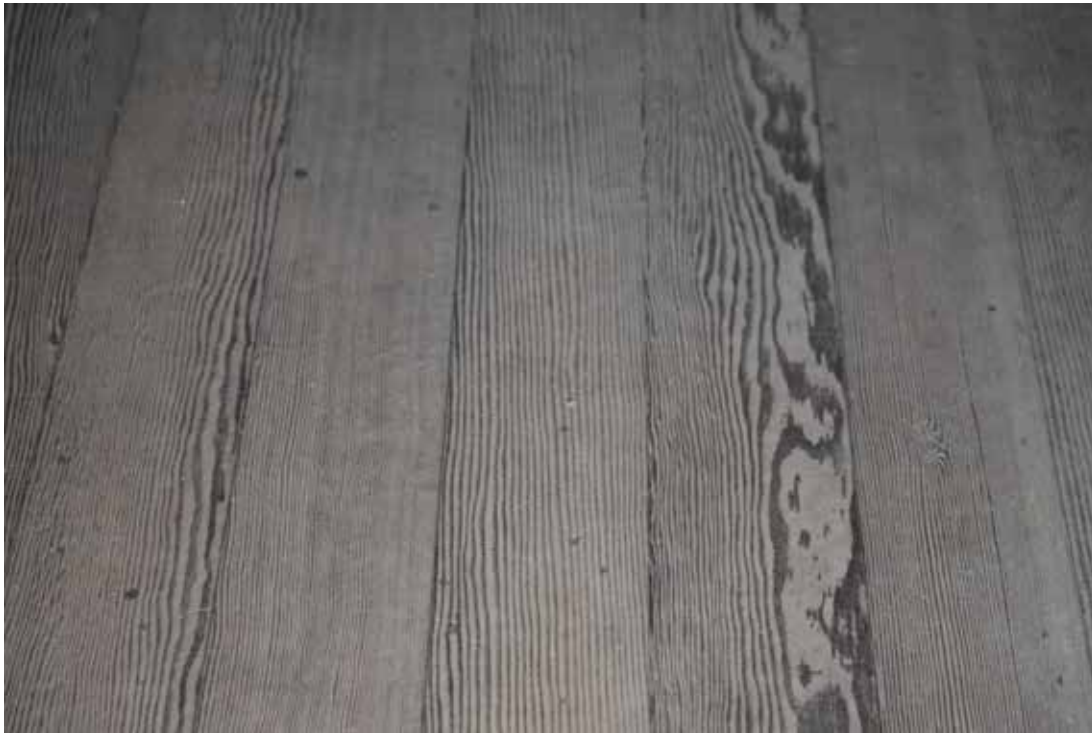
Consistent with its exterior, the interior of the subject building is simple in design with little ornamentation. Floor surfaces are covered in 5 ¼" tongue and groove boards run east-west. Floor material appears to be unstained or finished Douglas Fir or Pine. All wall surfaces are clad in 3 ¼" wide beaded tongue and groove redwood boards; wall boards are vertically laid and painted a blue-green throughout (finish is original and was restored by Ethos Conservation in 2011-2012 [see *The Chinese Temple in Cambria Restoration of the Interior Paint* included in Supplemental Materials folder]). Shadow lines are visible on walls in several locations throughout the building.

Close-up of Floorboards on Interior of Cambria Chinese Temple
Photo Taken 10/18/2019

- § Removal and infill of door opening created (north wall) during Warren family use of the building with in-kind interior wall cladding materials
- § Removal of linoleum flooring to expose original wood flooring; replacement of flooring deteriorated beyond repair with in-kind material (flooring replacement was isolated in the area just inside double doors; flooring is estimated to be 85 % original material)

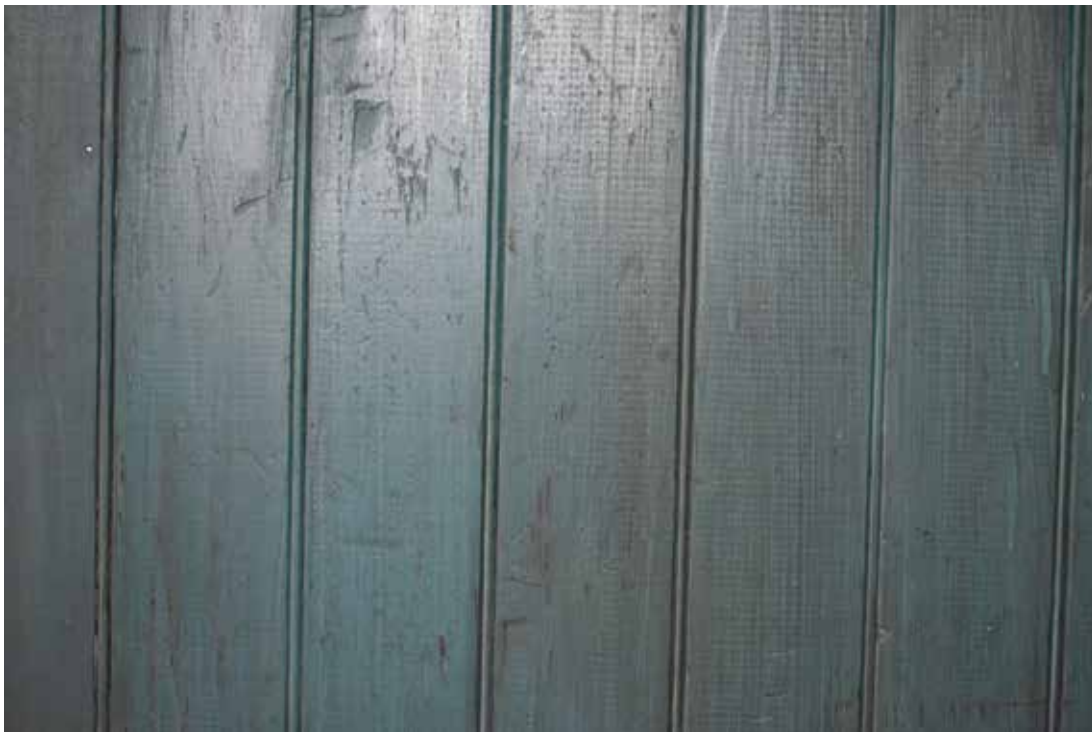
Close-up of Wall Boards on Interior of Cambria Chinese Temple
Photo Taken 10/18/2019

- § Restoration of interior wall finishes (on all walls and ceiling including trim) by Ethos Conservation (*The Chinese Temple in Cambria Restoration of the Interior Paint* included in Supplemental Materials folder)

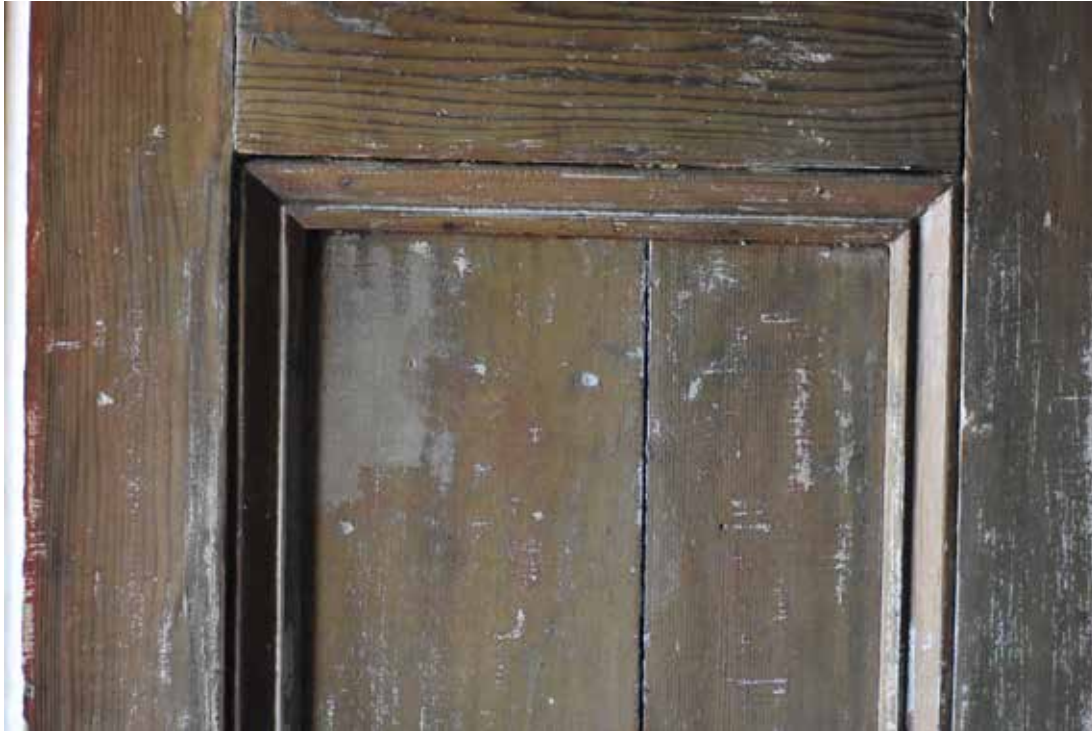
Close-up of Exterior of Cambria Chinese Temple Front Door
Photo Taken 10/18/2019

- § Replacement of head trim over front doors (which was missing) with in kind material; although extant trim was believed to be installed by the Warrens, the style of original trim is unknown, therefor trim was left in place and a missing piece milled in kind

- § Rehabilitation of door (including cabinet) hardware; exceptions: replacement of front door foot bolt and one cabinet strike plate
- § Removal of non-original light fixtures

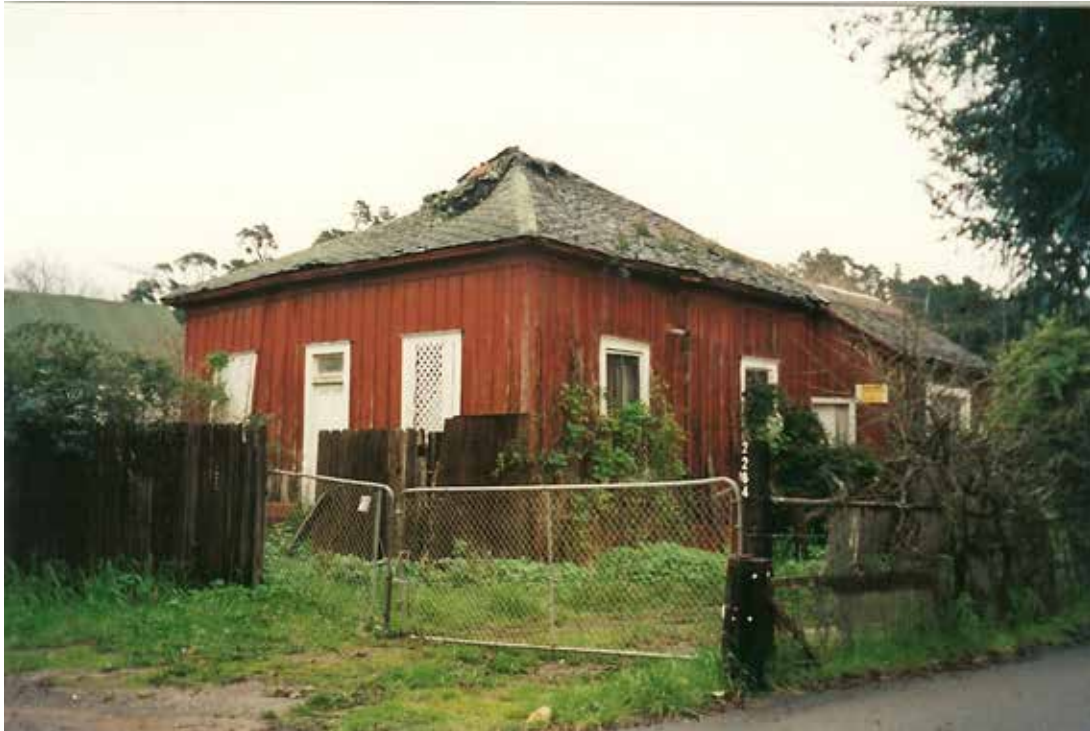
The building was again relocated ca. 1925, approximately 150-feet northwest of its second location, and attached to the residence known locally as the "Red House"/Warren Family Residence (Warren Residence). While in use as a portion of the Warren Residence, the building functioned variously a dining room, living room, and office (Greenwood 2001). The following is a list of the known alterations undertaken following the building's ca. 1925 relocation by the Warren family (outside the period of significance). The list was compiled based on the following: a review of the several reports which document the history of the Cambria Chinese Temple (all of which are listed in *B12 and included in the Supplemental Materials Folder), additional archival and background research that was performed for this effort and personal communication between Rachel Perzel and Wayne Attoe and Rick Hawley of Greenspace, who has owned and cared for the building since 1999.

The Red House with Cambria Chinese Temple Attached at Rear
Photo Taken ca 1999, Prior to Demolition of Warren Residence

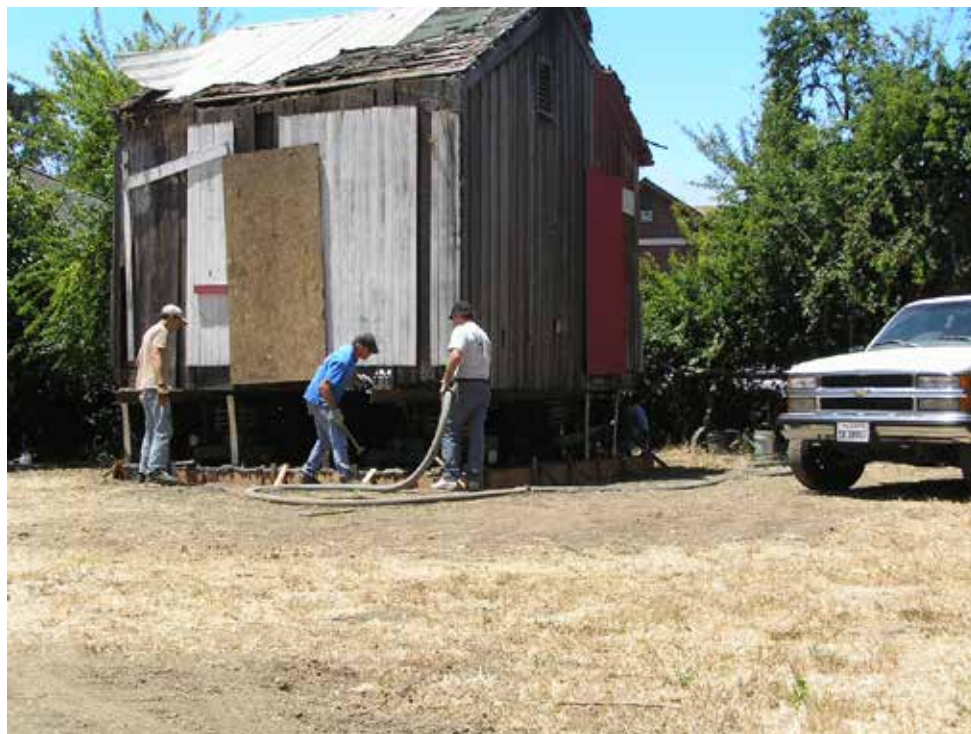
Cambria Chinese Temple Following its Relocation, Prior to its Placement on New Foundation
Photo Taken July 6, 2007

- § Relocation of building closer to its original location/placement consistent with the principles of feng shui
- § Placement of building on foundation meeting current building code- 4 x 4 posts resting on concrete perimeter foundation (with simple solid base skirt); original foundation form and material remains unverified, however physical evidence suggests that it did not sit directly on the ground

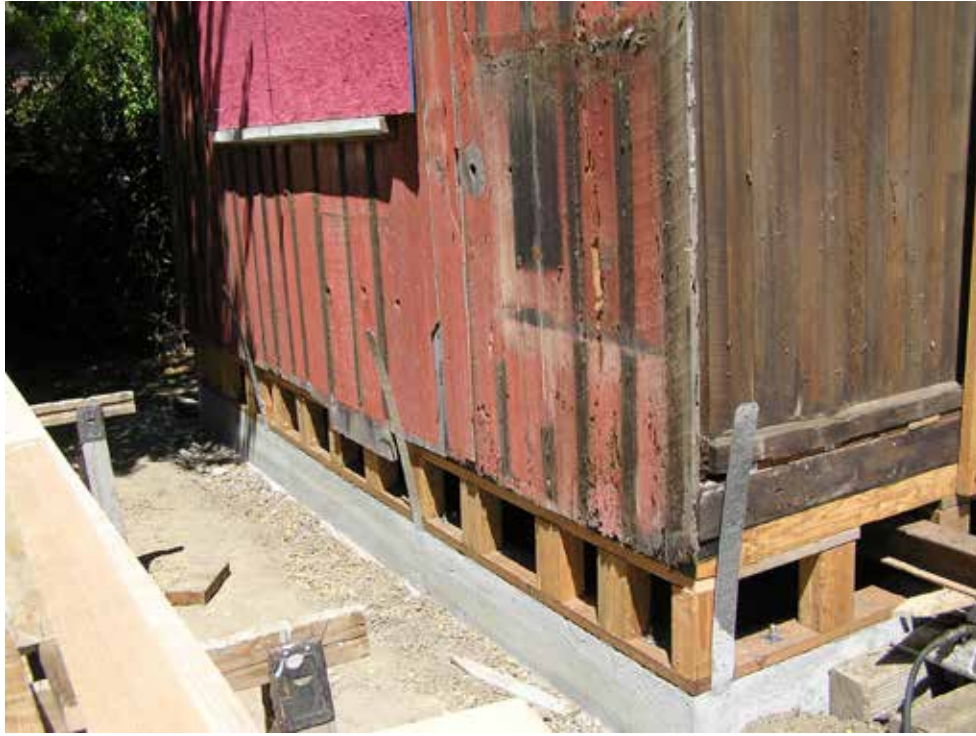
Cambria Chinese Temple Following its placement on New Foundation
Photo Taken Ca 2007

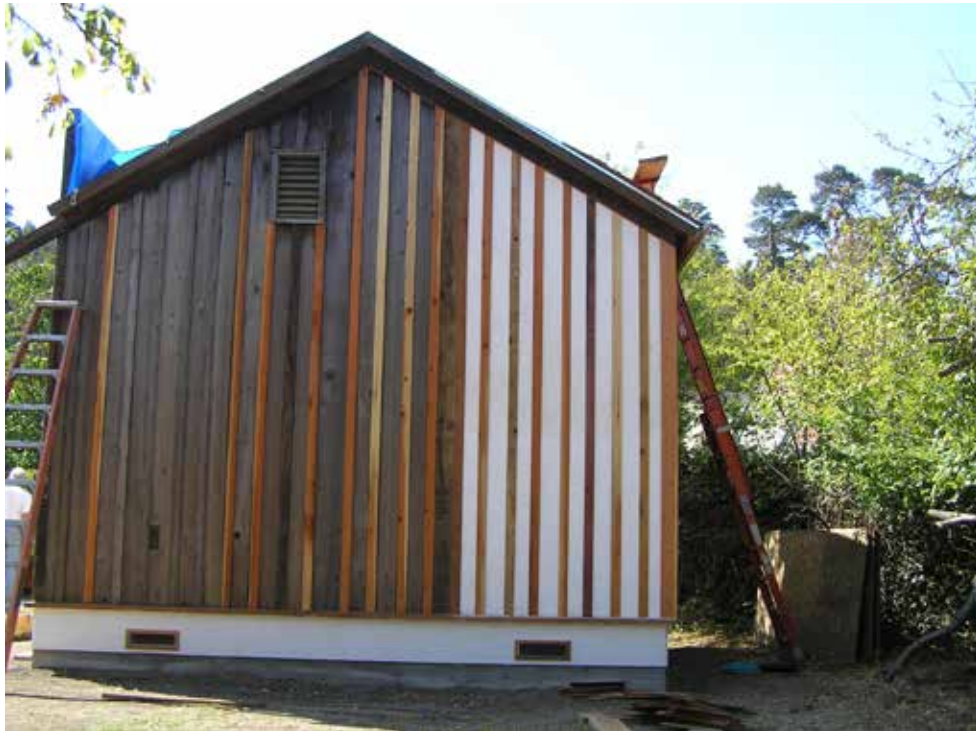
North Elevation of Cambria Chinese Temple Following Siding Repair
Photo Taken Ca 2007

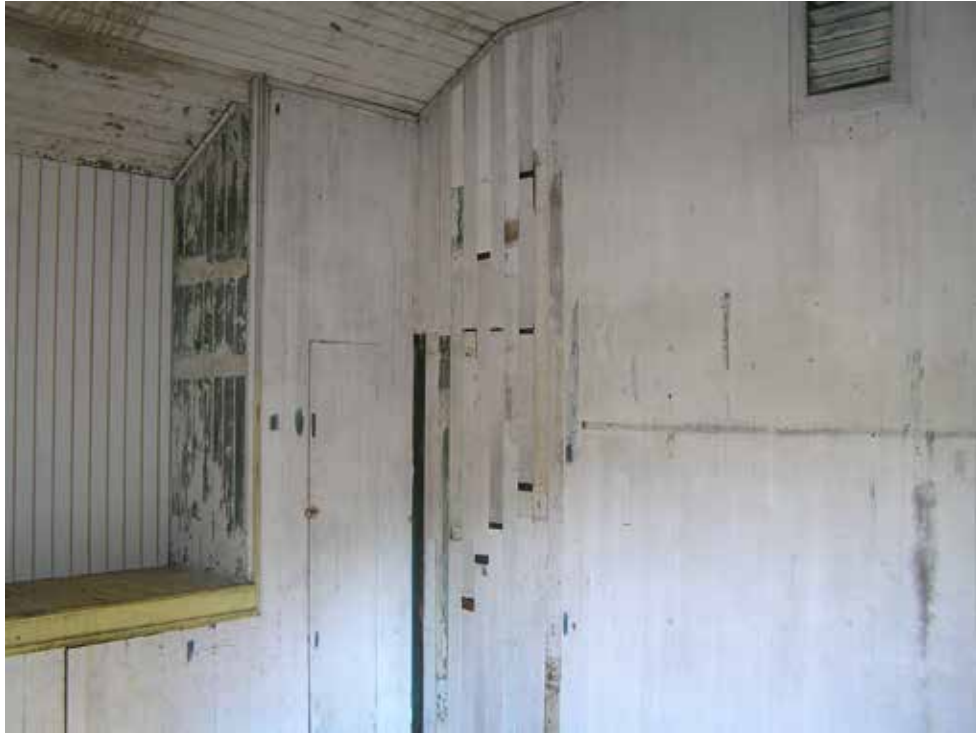
Interior View of Cambria Chinese Temple (North and West Walls) Following Wall Cladding Repairs and Prior to Paint Restoration
Photo Taken Ca 2007

- § Removal and infill of two window openings (south and west walls) created during Warren family use of the building with in-kind interior wall cladding materials

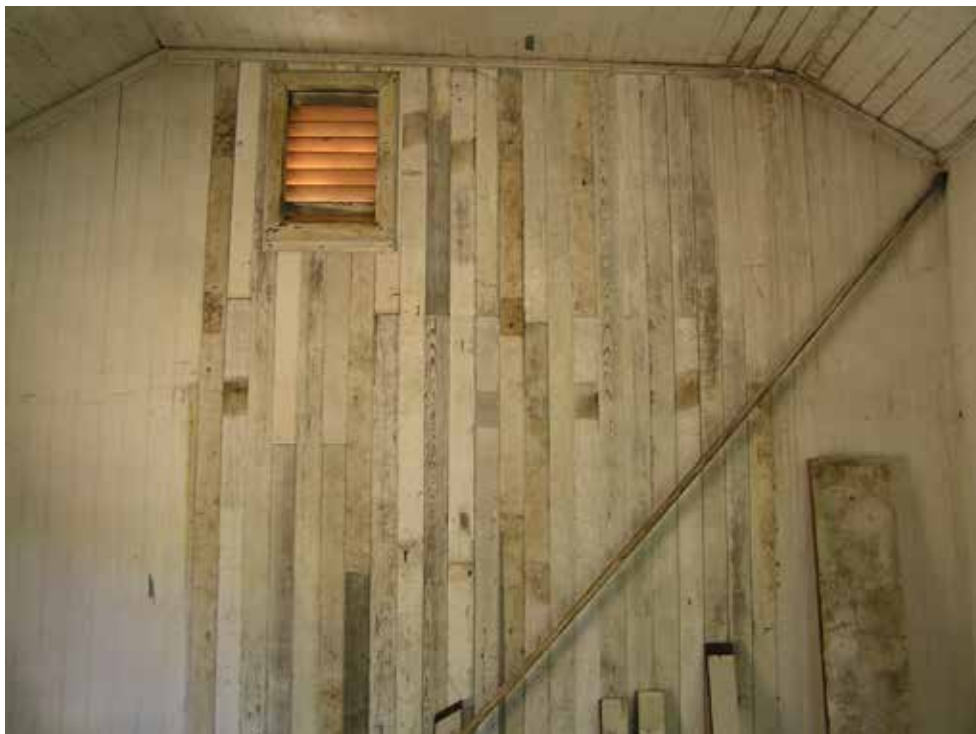
Interior View of Cambria Chinese Temple (South Wall) Following Wall Cladding Repairs and Prior to Paint Restoration
Photo Taken Ca 2007

- § Removal of small-scale interior features remaining from Warren family (including wooden shelf with metal brackets, wooden hood and a board which were all mounted on south wall and light fixtures and corresponding wiring throughout); minor wall cladding repair was performed due to removal of these items
