PRIMARY RECORD

Page 1 of 19 *Resource Name or #: (Assigned by recorder) SITE OF CHINA SLIDE FS #05-14-54-88

B1. Historic Name: CHINA SLIDE
B2. Common Name: CHINA SLIDE
B3. Original Use: n/a

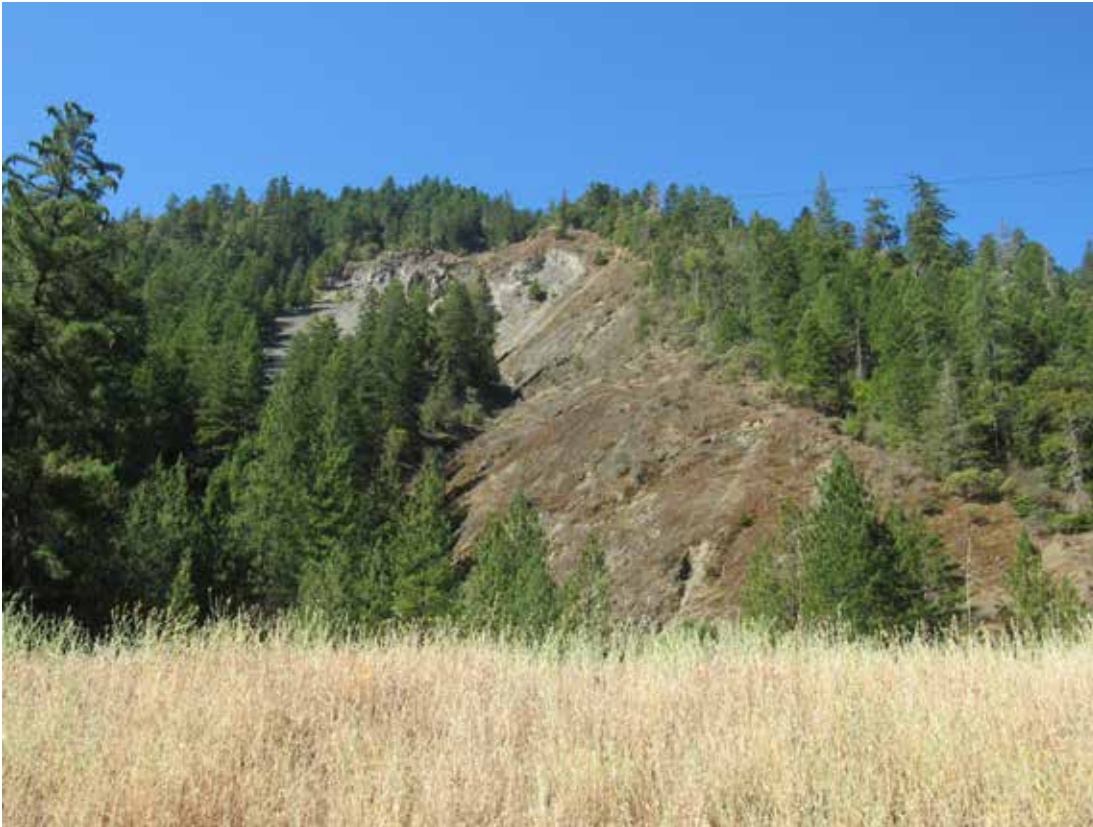
Photo 1.

1 of 11 View west, landslide “scar” about highway. (Photo #48) The “face” of the slide as seen from just below Highway 299.

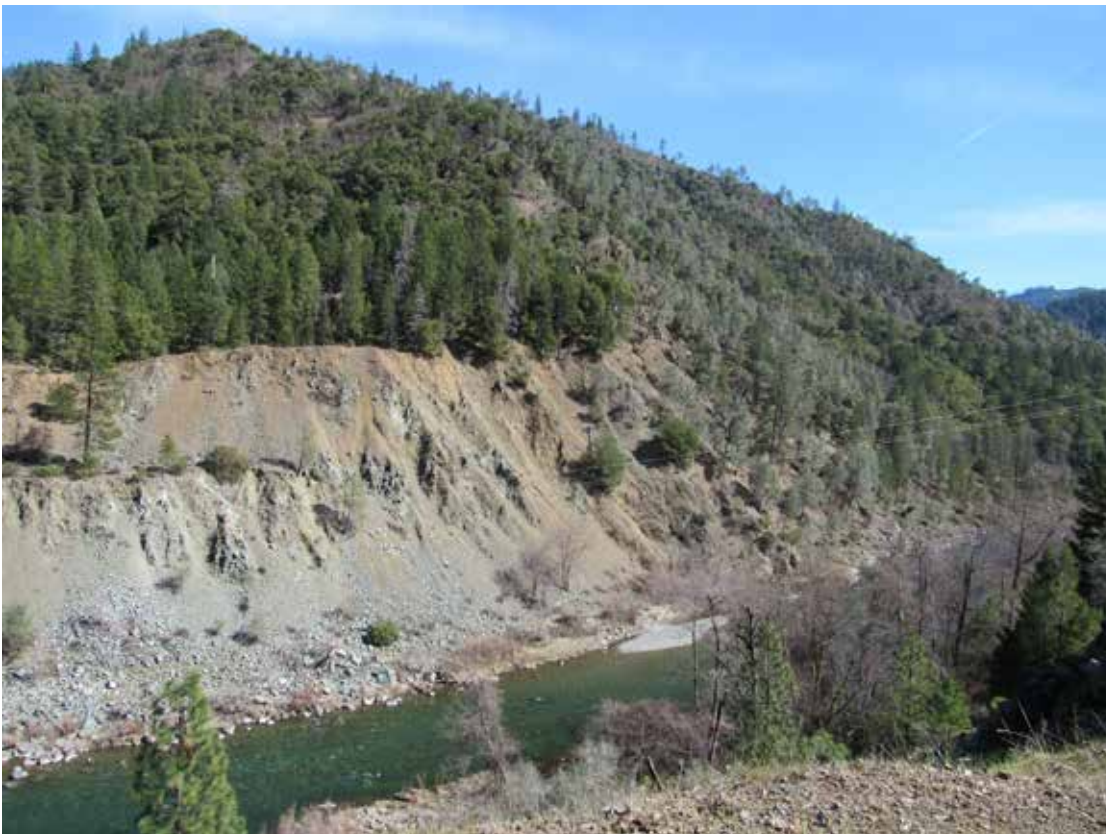
Photo 2.

2 of 11 View east, upriver portion of dam remains. (Photo #29) High level of dam still evidenced as seen from just below highway.

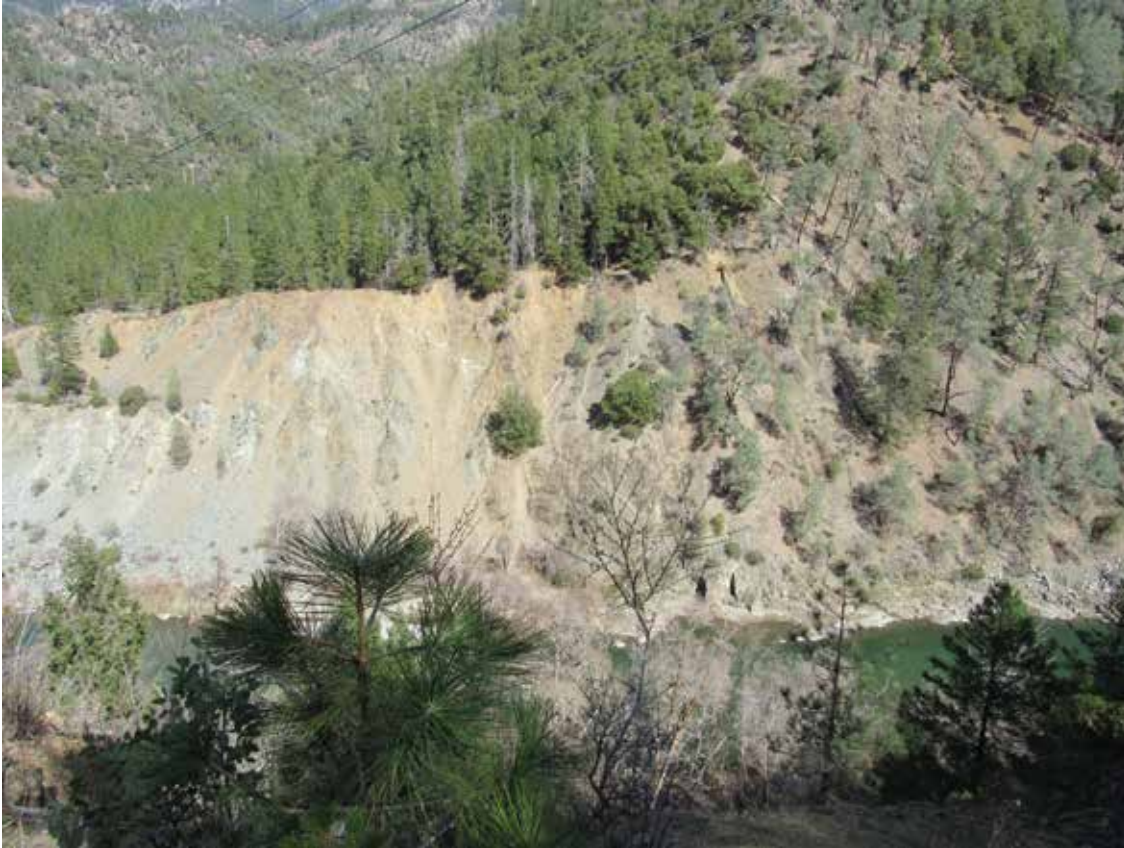
Photo 3.

3 of 11 View east, portion of dam remains, looking downriver from previous photo. (Photo #30) This view just upstream from above photo.

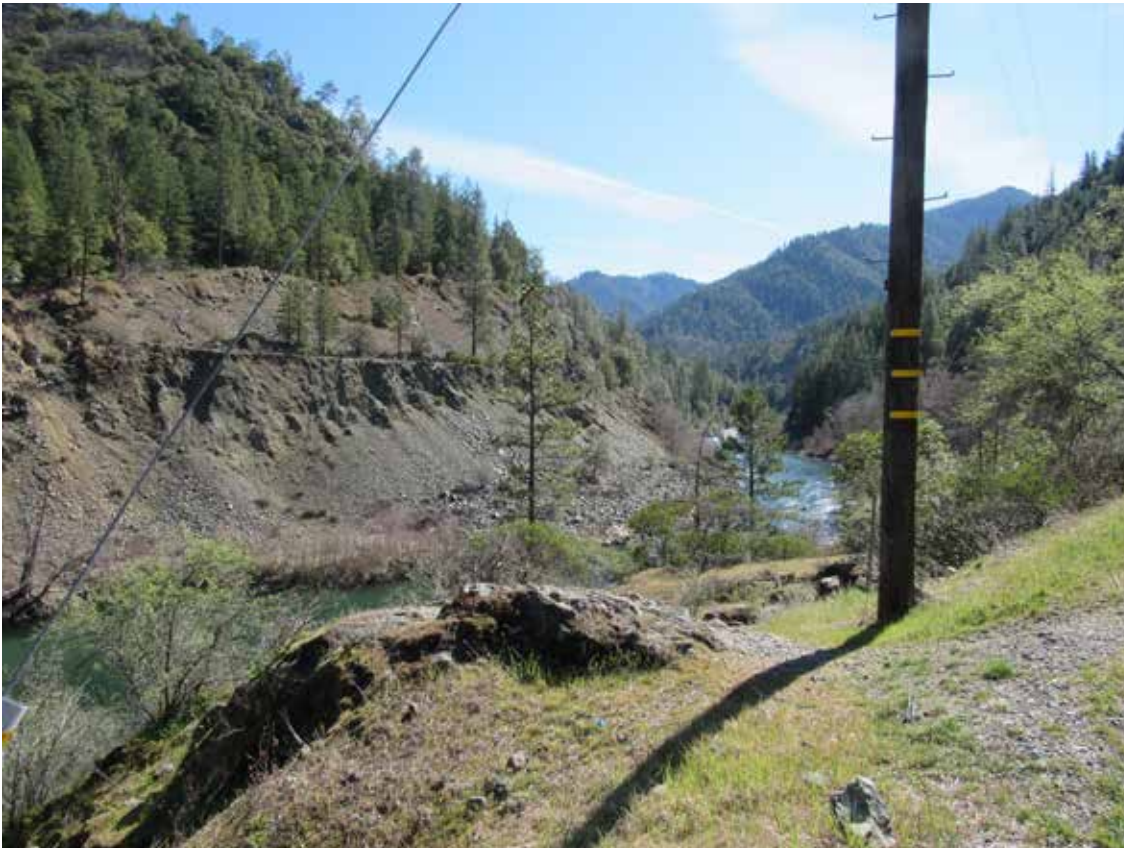
Photo 4.

4 of 11 View southeast, remainder of dam on both sides of Trinity River. (Photo #18)

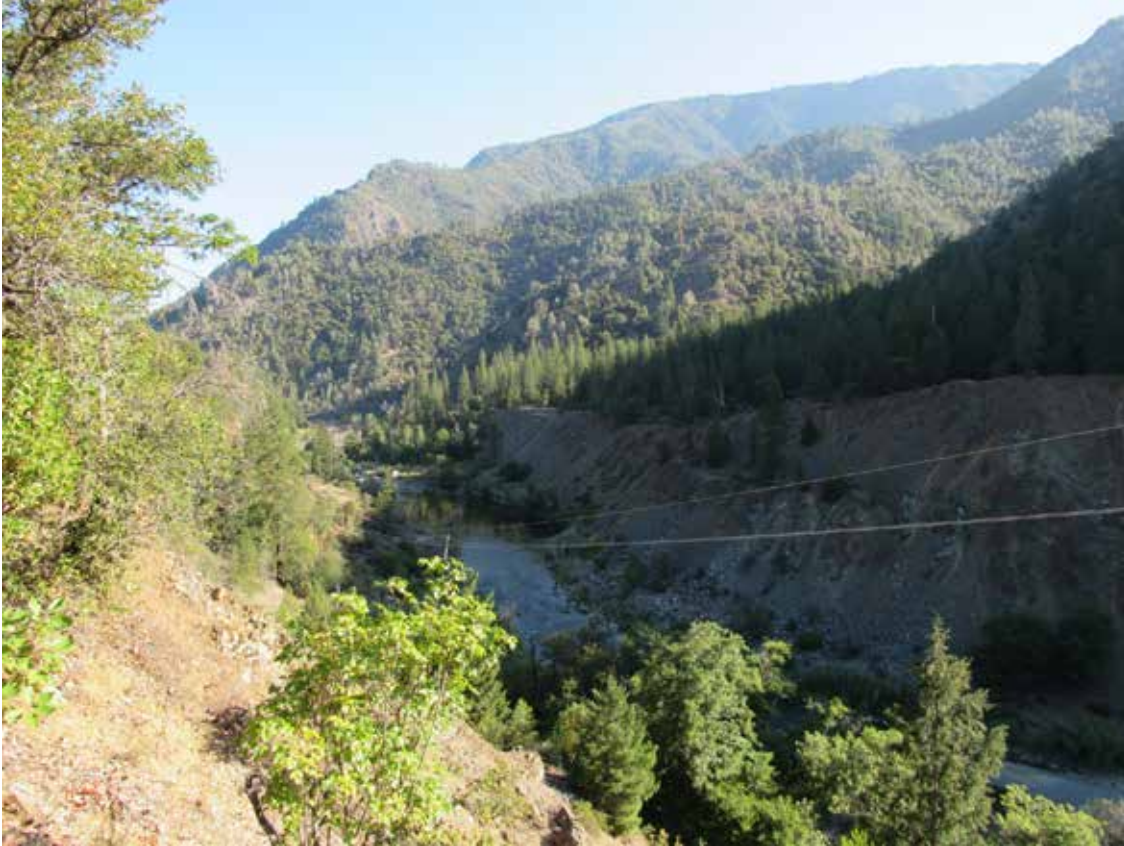
Photo 5.

5 of 11 View north, remainder of dam, showing power lines (Feature 3). (Photo #34) This looks down and to the northern portion of where the river banks were disturbed by the presence and release of the dam. The mouth of Dixon Bar Creek is shown in far background.

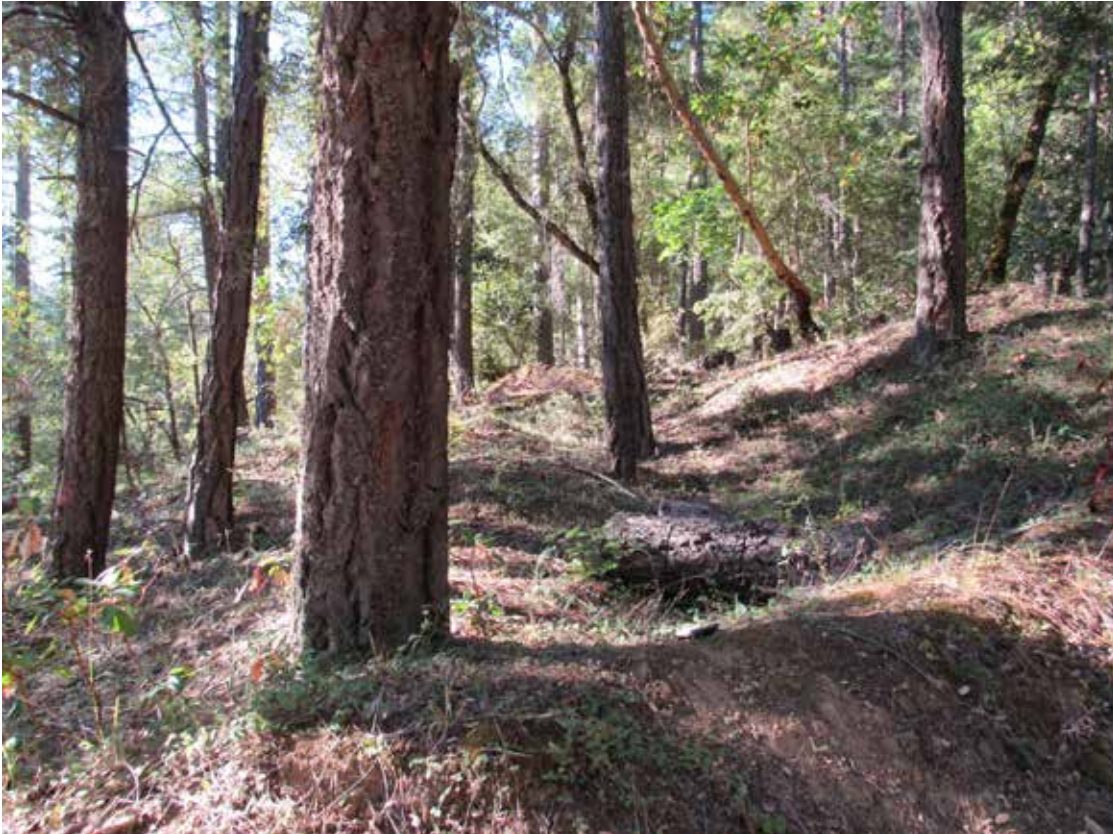
Photo 6.

6 of 11 View south, original ground surface of slide between highway and river. (Photo #32)

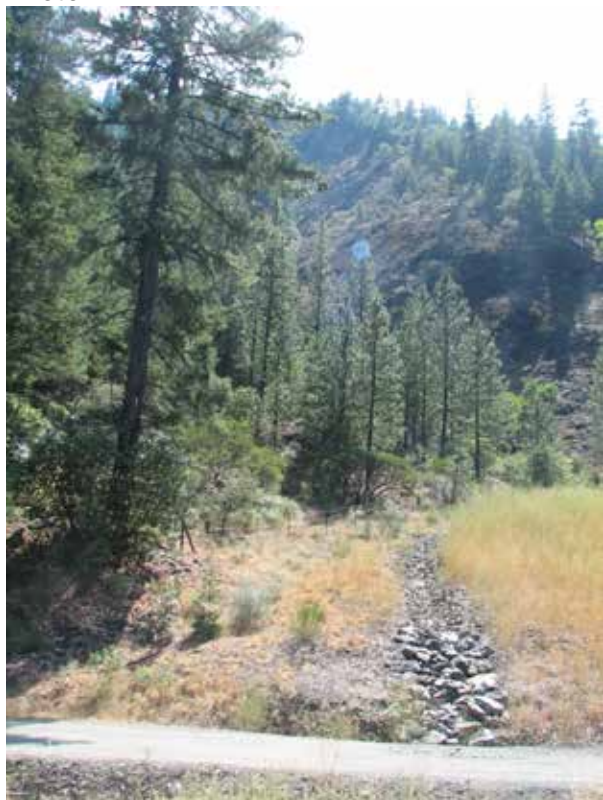
Photo 7.

7 of 11 View southwest, slide face within scar area above highway. (Photo #60) Within several years of the slide event, the historic trail (Feature 5) was reconstructed across the steep rocky area shown in the upper part of this photo.

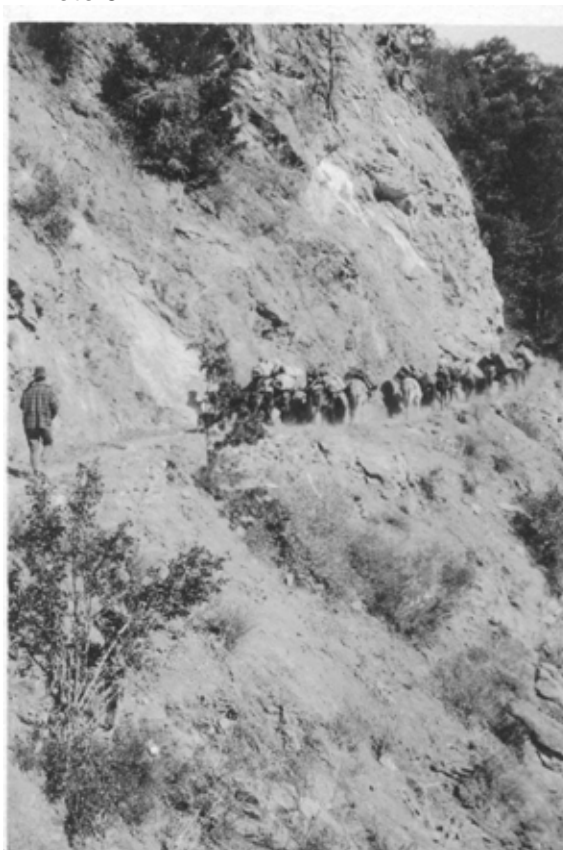
Photo 8.

8 of 11 View north, historic photo (date unknown) of pack train following “new” trail (Feature 5) across slide. The pack train was owned and operated by the Waldorff family who lived near Big Bar.

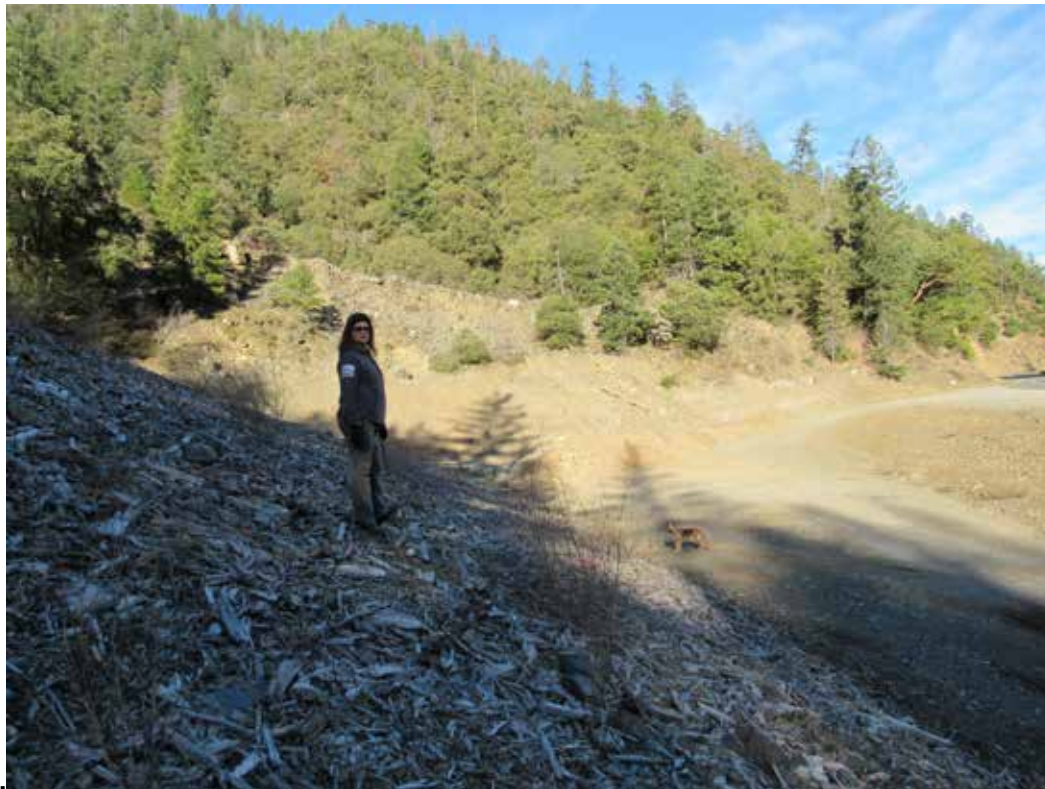
Photo 9.

9 of 11 View north, slide/scar area at left, Caltrans fill material in center, highway at right. (Photo #12) In the foreground are wood shavings, part of Caltrans’ restoration work.

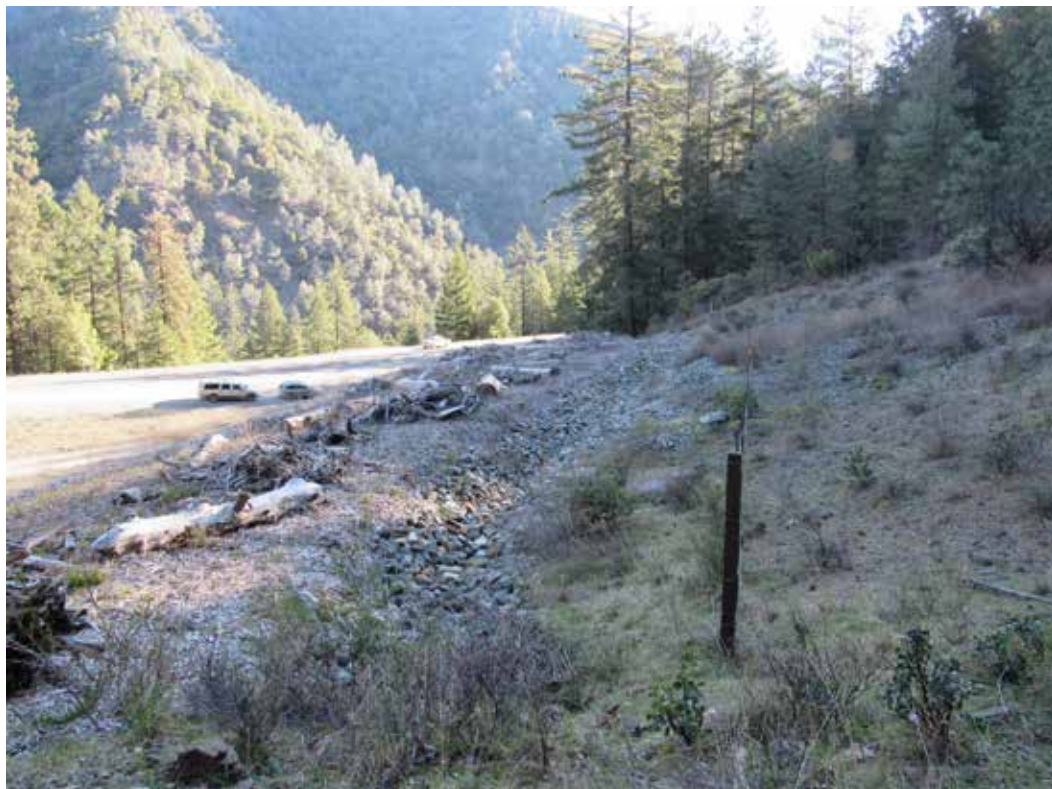
Photo 10.

10 of 11 View east-southeast, Caltrans fill and restoration work within path of slide. (Photo #13) Highway is shown crossing photo in background.

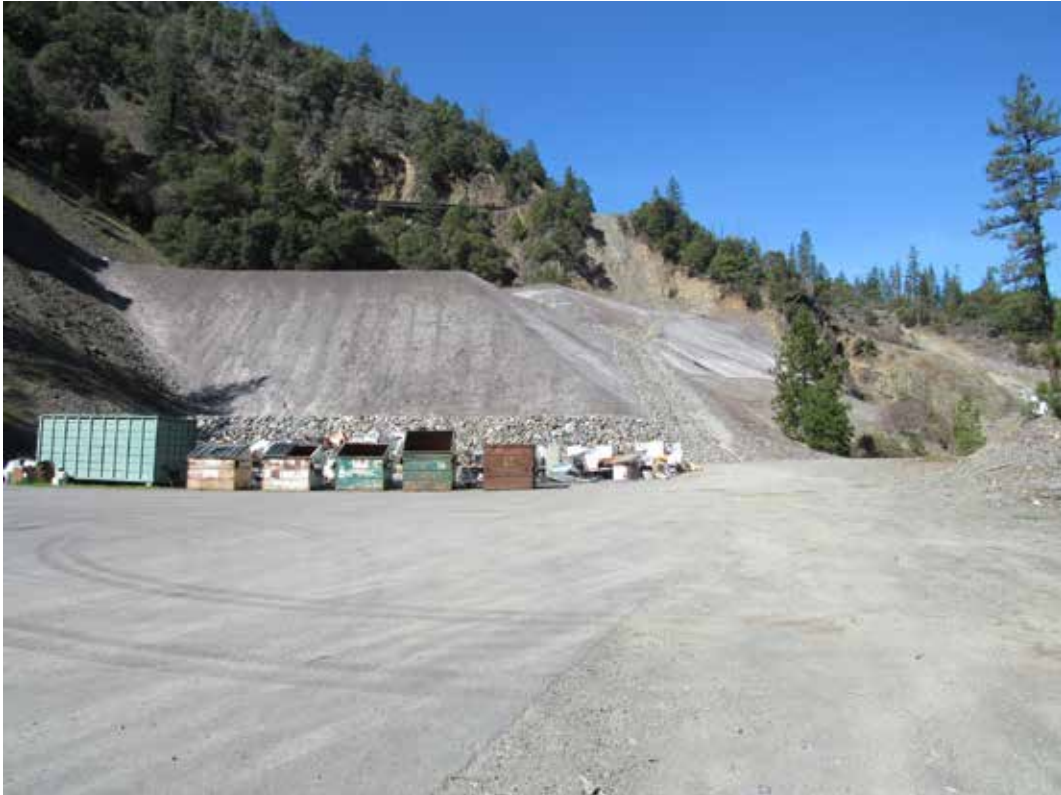
Photo 11.

11 of 11. View north, Burnt Ranch Dump/Transfer Station (Feature 1). (Photo #17) The Burnt Ranch Dump was installed by Trinity County in 1966. This view shows the main transfer facility with receptacles and small “office” along with part of the fill material deposited by Caltrans.
