PRIMARY RECORD

*Resource Name or #: Cambria Chinese Temple

***P10. Survey Type:** California Point of Historical Interest Nomination

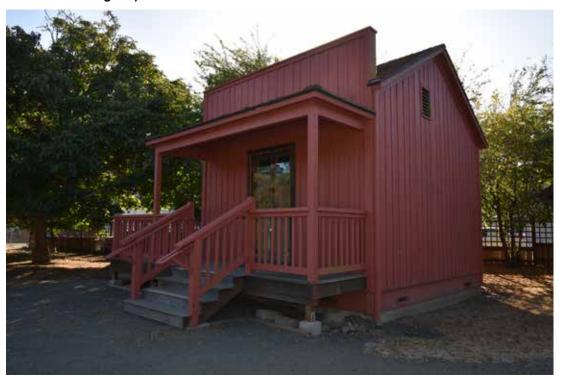
Oblique Shot of Secondary Cambria Chinese Temple-Primary (East) and Secondary (North) Elevations Visible South-Facing View; Photo Taken 10/28/2019

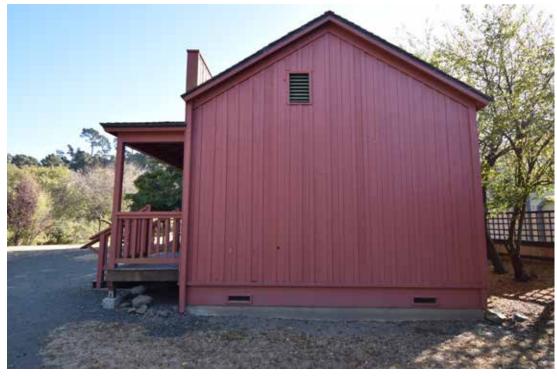
Secondary (North) Elevation of Cambria Chinese Temple South-Facing View; Photo Taken 10/28/2019

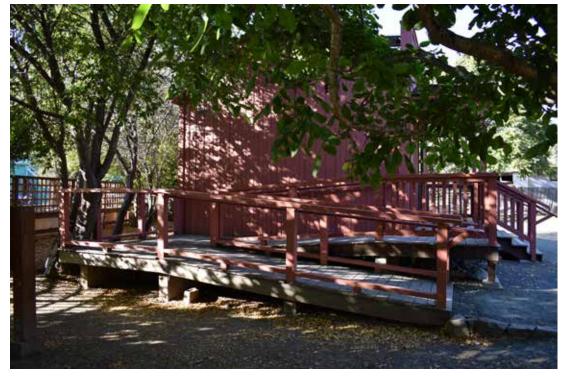
Secondary (South) Elevation of Cambria Chinese Temple North-Facing View; Photo Taken 10/28/2019

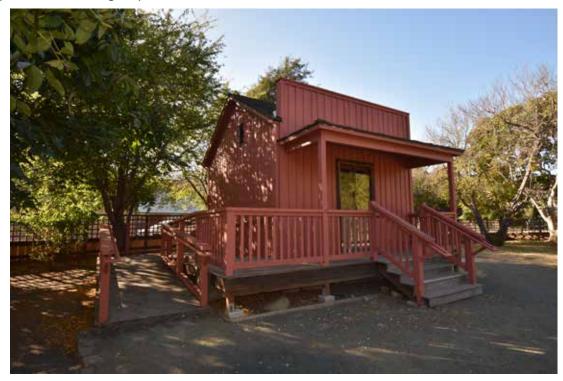
Oblique Shot of Cambria Chinese Temple; Primary (East) and Secondary (South) Elevations Visible Northwest-Facing View; Photo Taken 10/18/2019

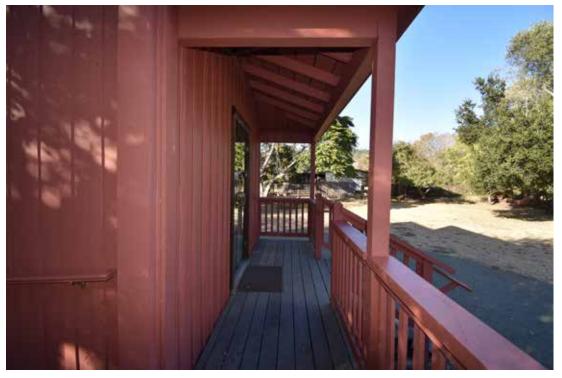
Porch of Cambria Chinese Temple North-Facing View; Photo Taken 10/18/2019

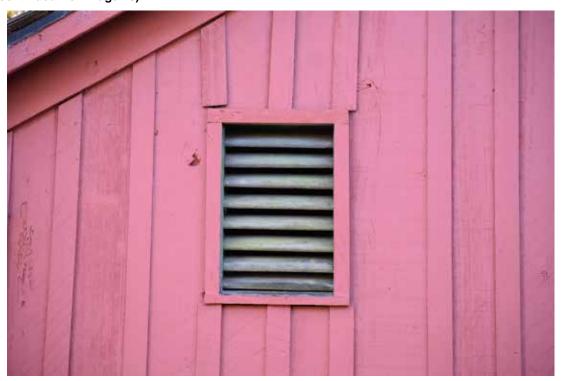
Close-up of Cambria Chinese Temple Gable Vent and Siding; Secondary (North) Elevation South-Facing View; Photo Taken 10/18/2019

Replacement of exterior siding, barge, corner and trim boards deteriorated beyond repair (due primarily to insects and wood rot) with in-kind material; it is estimated that 80% of the exterior siding material is original

Replacement of south wall gable vent horizontal louvers that were previously removed

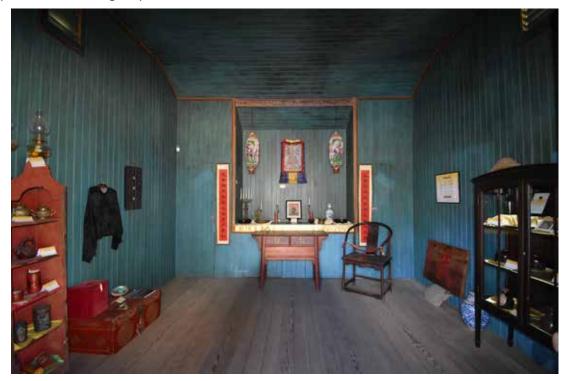
Interior View of Cambria Chinese Temple; Photo taken from Doorway West-Facing View; Photo Taken 10/18/2019

The west interior wall is dominated by a large (roughly 2'2" deep, 6' 10" wide, and 7' at front/6' at back in height) alcove thought to have been historically used as an altar (Greenwood and Associates [Greenwood] 2001). The alcove features a sloped ceiling and extends from approximately 36" above the floor to the wall-ceiling junction. All alcove surfaces are clad and finished in a manner consistent with walls. The recess is framed with the same simple trim found at wall-ceiling junctions. It is surrounded with cabinets; a floor to ceiling cabinet flanks the alcove to either side and two additional cabinets occupy the space below it. Cabinet doors are constructed of beaded tongue and groove boards. The interiors of two of the cabinet doors are whitewashed; otherwise, cabinet interiors are unfinished.

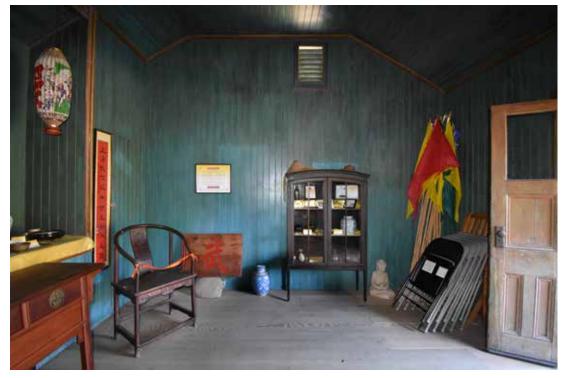
Interior View of Cambria Chinese Temple North-Facing View; Photo Taken 10/18/2019

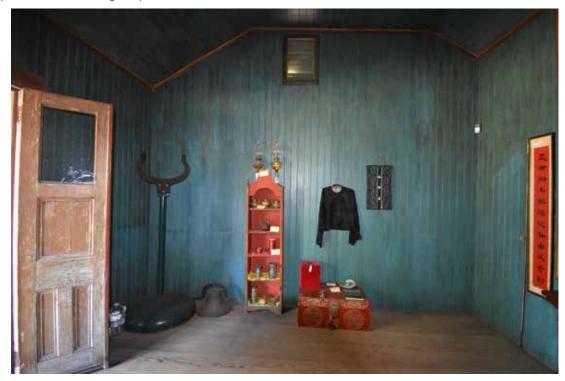
Interior View of Cambria Chinese Temple South-Facing View; Photo Taken 10/18/2019

Removal of small-scale interior features remaining from Warren family (including wooden shelf with metal brackets, wooden hood and a board which were all mounted on south wall and light fixtures and corresponding wiring throughout); minor wall cladding repair was performed due to removal of these items

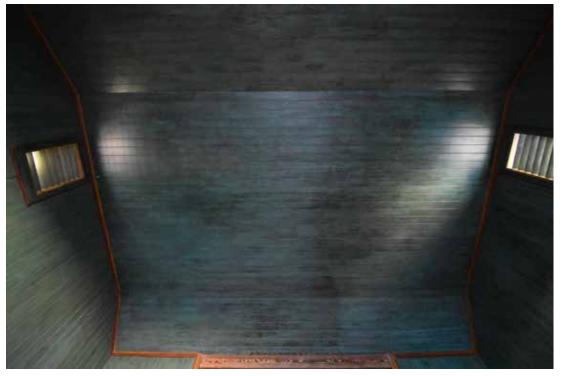
Interior View of the Ceiling of Cambria Chinese Temple Camera Faced up towards Ceiling; Photo Taken 10/`8/2019

Replacement of deficient roof framing with in-kind materials (remaining original roof framing is estimated at 85 %)

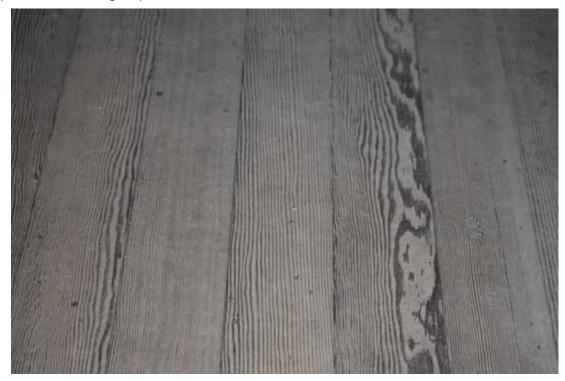
Close-up of Floorboards on Interior of Cambria Chinese Temple Photo Taken 10/18/2019

Removal of linoleum flooring to expose original wood flooring; replacement of flooring deteriorated beyond repair with in-kind material (flooring replacement was isolated in the area just inside double doors; flooring is estimated to be 85 % original material)

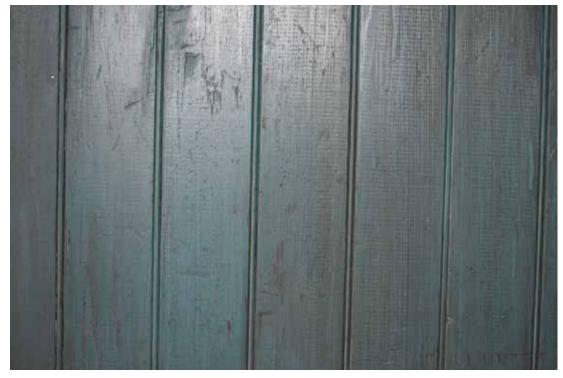
Close-up of Wall Boards on Interior of Cambria Chinese Temple Photo Taken 10/18/2019

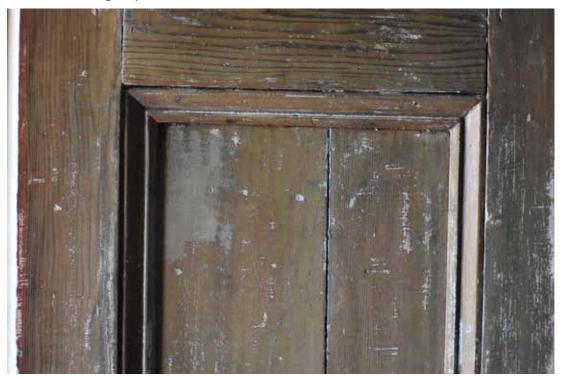
Close-up of Exterior of Cambria Chinese Temple Front Door Photo Taken 10/18/2019

Replacement of head trim over front doors (which was missing) with in kind material; although extant trim was believed to be installed by the Warrens, the style of original trim is unknown, therefor trim was left in place and a missing piece milled in kind

Rehabilitation of door (including cabinet) hardware; exceptions: replacement of front door foot bolt and one cabinet strike plate

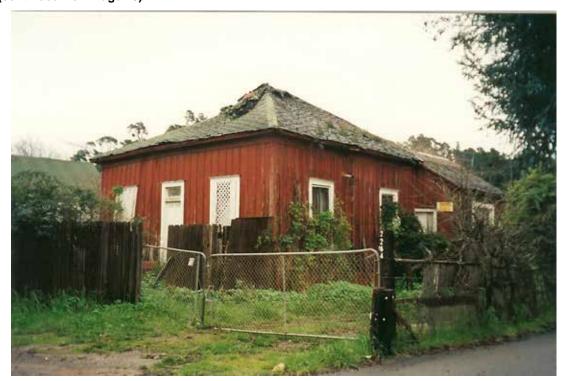
The Red House with Cambria Chinese Temple Attached at Rear Photo Taken ca 1999, Prior to Demolition of Warren Residence

To facilitate the subject building's attachment to the Warren Residence and to accommodate its new use, several modifications were undertaken following its 1925 relocation. Implemented outside the building's associated period of significance (post-1925), a detailed list of these alterations is included on pages 5 and 6. The subject building remained attached to the Warren Residence until 2001, when due to deterioration, all portions of the Warren Residence excluding the former temple building were demolished. Again freestanding, the subject building was then placed on a temporary foundation and secured against the elements.

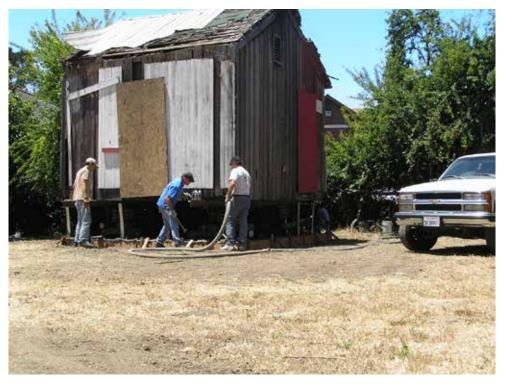
Cambria Chinese Temple Following its Relocation, Prior to its Placement on New Foundation Photo Taken July 6, 2007

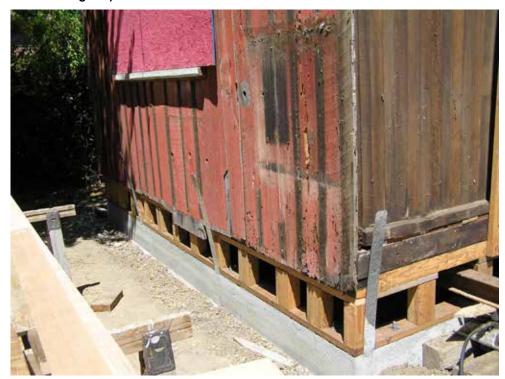
Cambria Chinese Temple Following its placement on New Foundation Photo Taken Ca 2007

Placement of building on foundation meeting current building code- 4 x 4 posts resting on concrete perimeter foundation

Installation of earthquake hold-downs (metal) to secure building to new concrete foundation

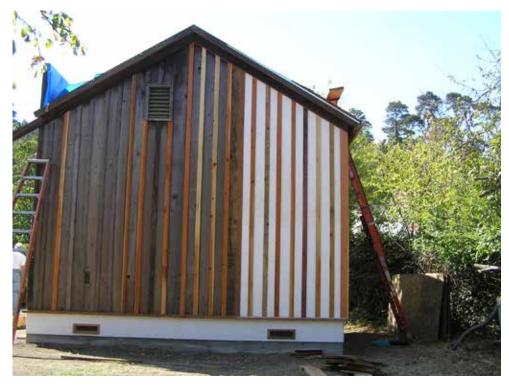
North Elevation of Cambria Chinese Temple Following Siding Repair Photo Taken Ca 2007

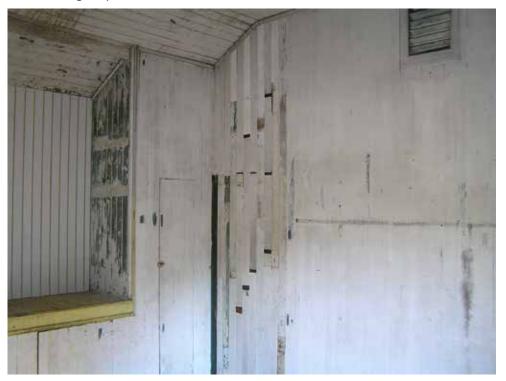
Interior View of Cambria Chinese Temple (North and West Walls) Following Wall Cladding Repairs and Prior to Paint Restoration Photo Taken Ca 2007

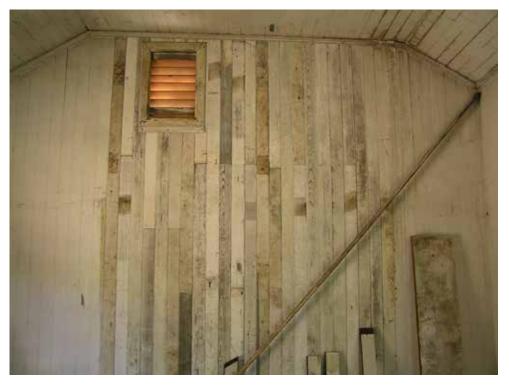
Interior View of Cambria Chinese Temple (South Wall) Following Wall Cladding Repairs and Prior to Paint Restoration
Photo Taken Ca 2007
