National Register of Historic Places Registration Form

Historic name: Wilshire Vista West Historic District DRAFT

Street & number: Roughly bounded by S. Fairfax Avenue, W. San Vicente Boulevard, S. Spaulding Avenue, and Packard Street

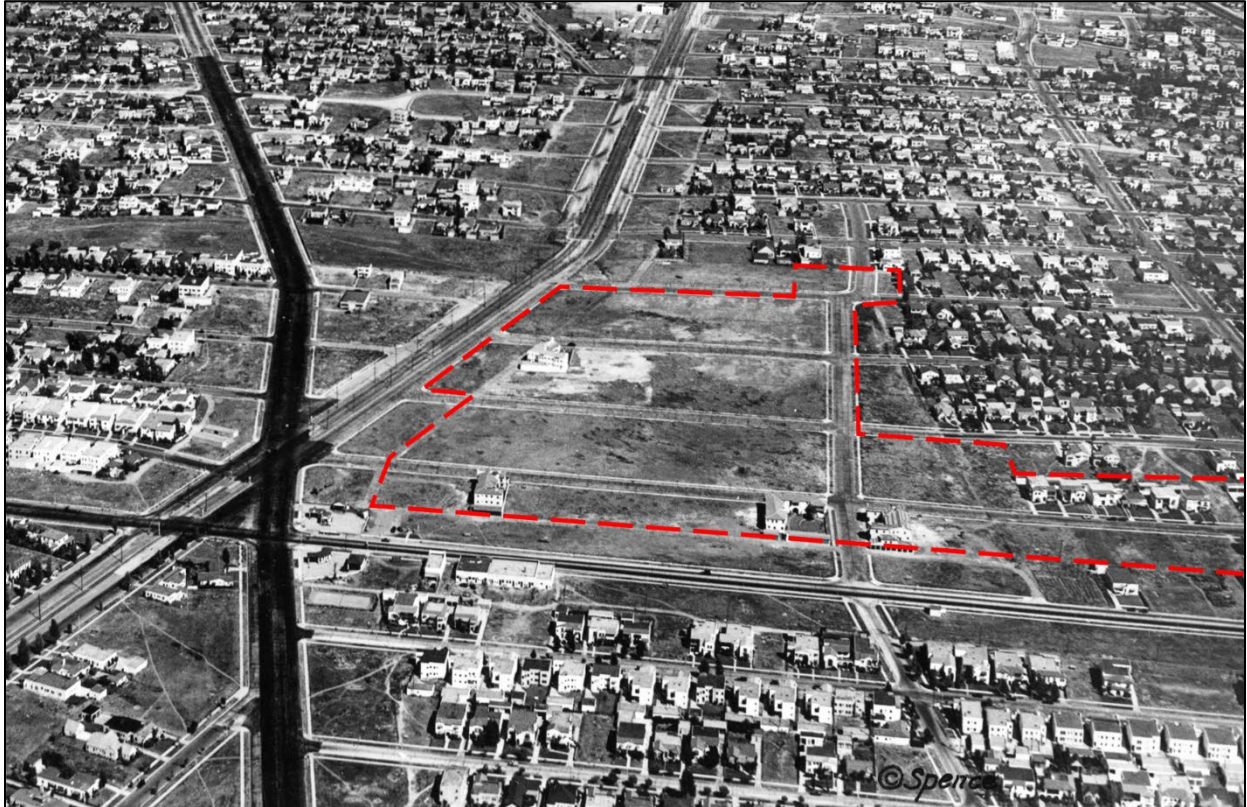
Figure 1. Wilshire Vista West area (outlined in dashed red) in 1931, prior to most construction north of Whitworth Drive, view east. The Benjamin and Gladys Thomas Air Photo Archives (Spence Collection), UCLA.

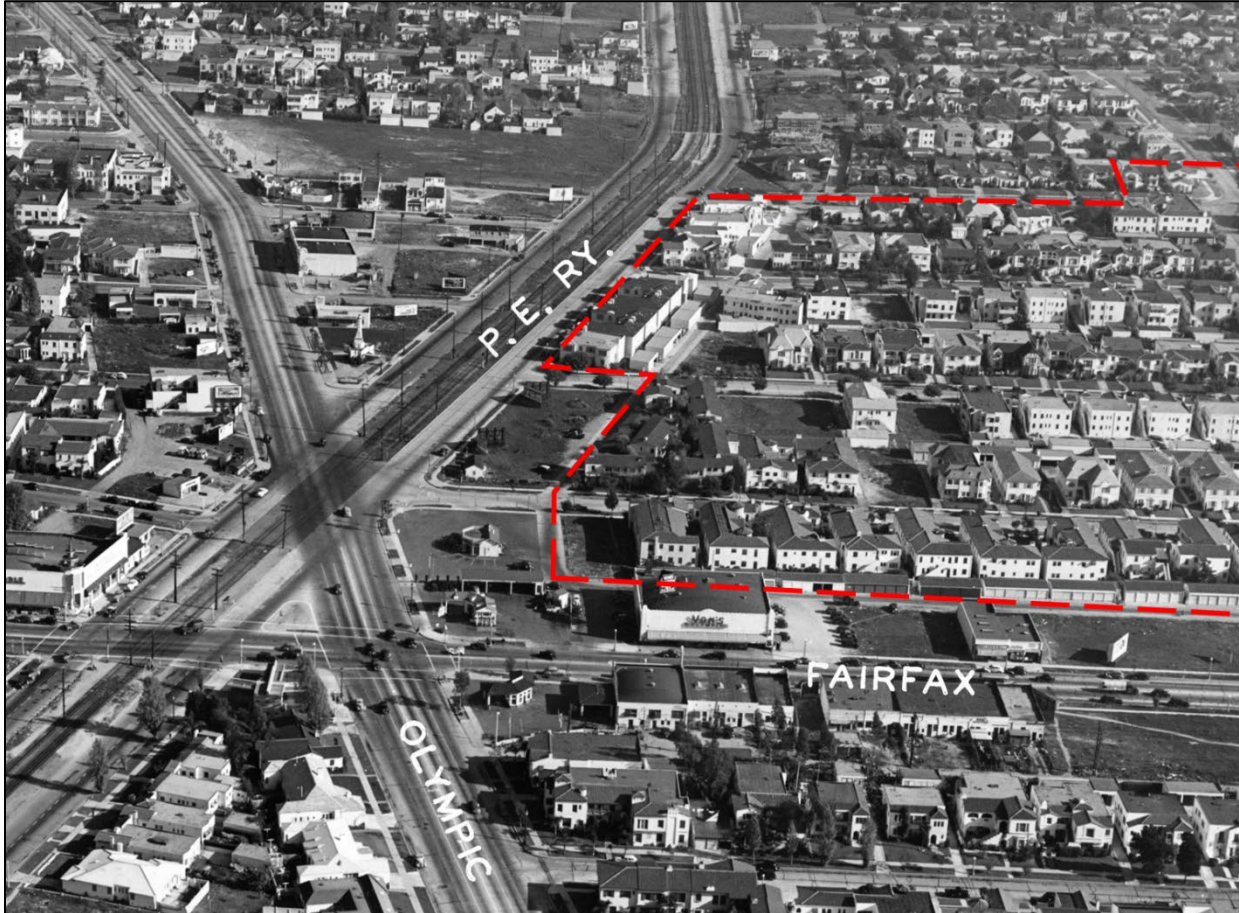
Figure 2. Wilshire Vista West area (northern portion, outlined in dashed red) in 1939, showing 1930s construction, view east. The Benjamin and Gladys Thomas Air Photo Archives (Spence Collection), UCLA.

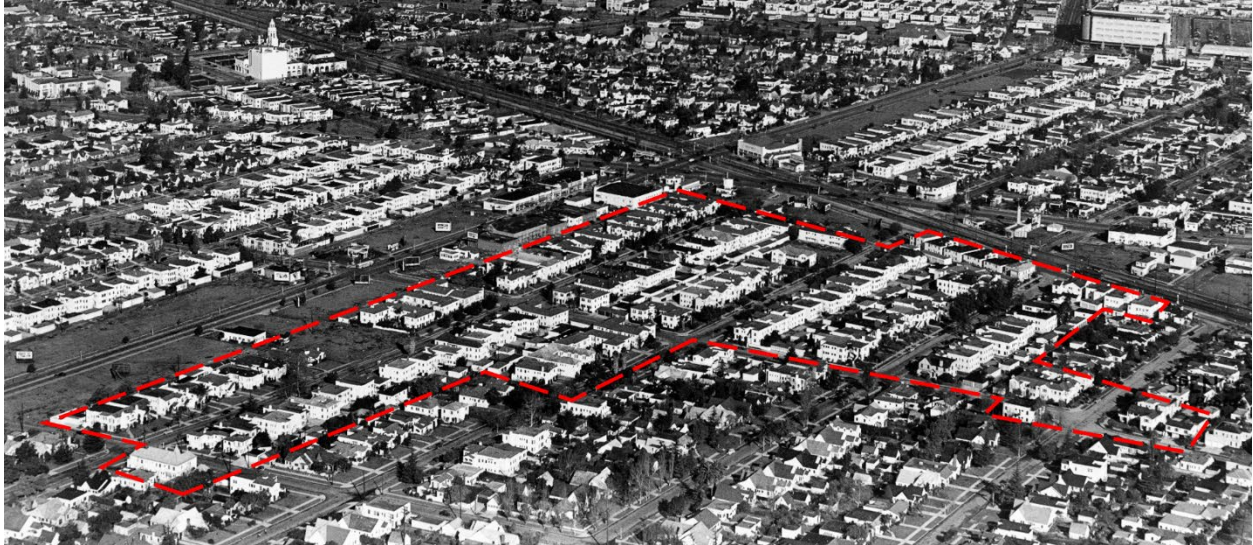
Figure 3. Wilshire Vista West area (outlined in dashed red) in 1946 showing near-total buildout, view northwest. The Benjamin and Gladys Thomas Air Photo Archives (Spence Collection), UCLA.

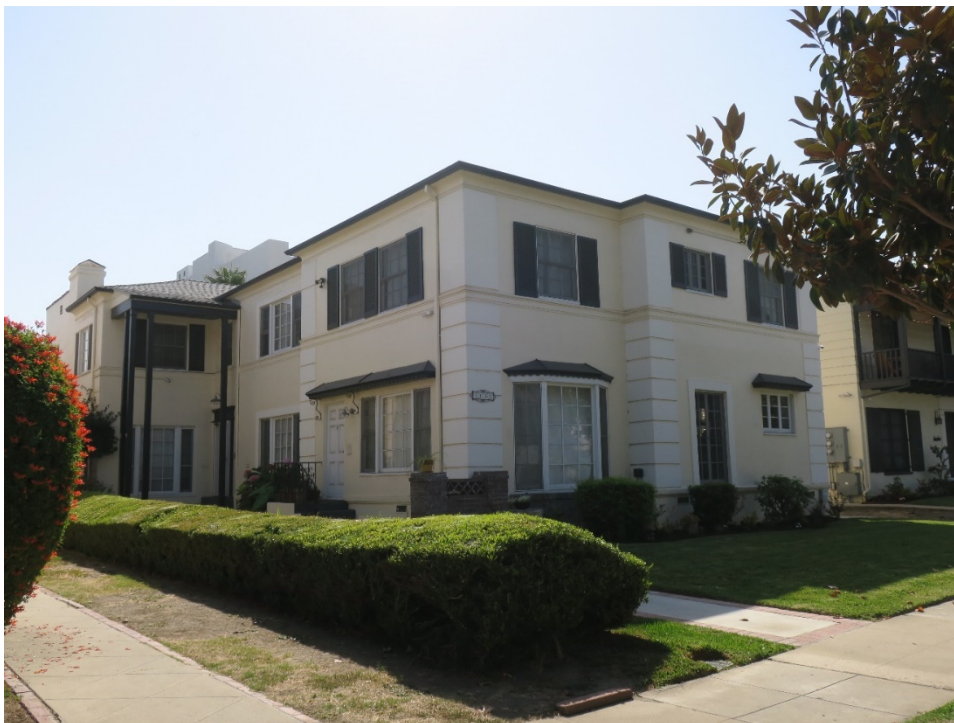
8. 1056-1060 S. Genesee Avenue APN: 5086026007 Contributor 1937
Builder: J.J. Rees; Original Owner: Nick Kalas Photo 6

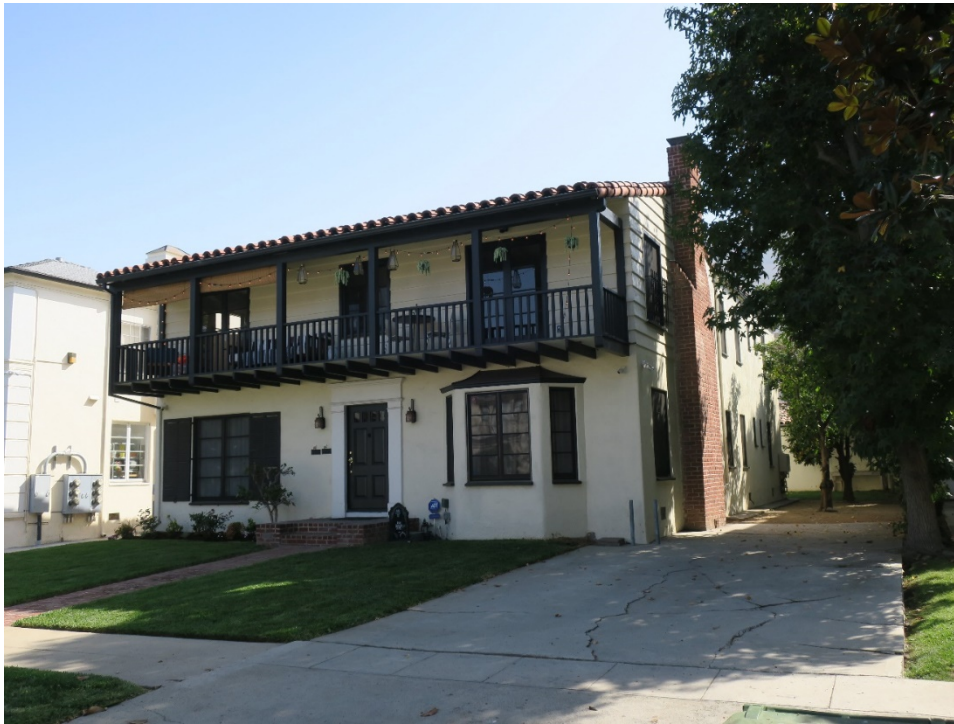
10. 1064-1066 S. Genesee Avenue APN: 5086026006 Contributor 1933
Architect: Arlos R. Sedgley; Original Owner: Dora L. Marte Photo 7

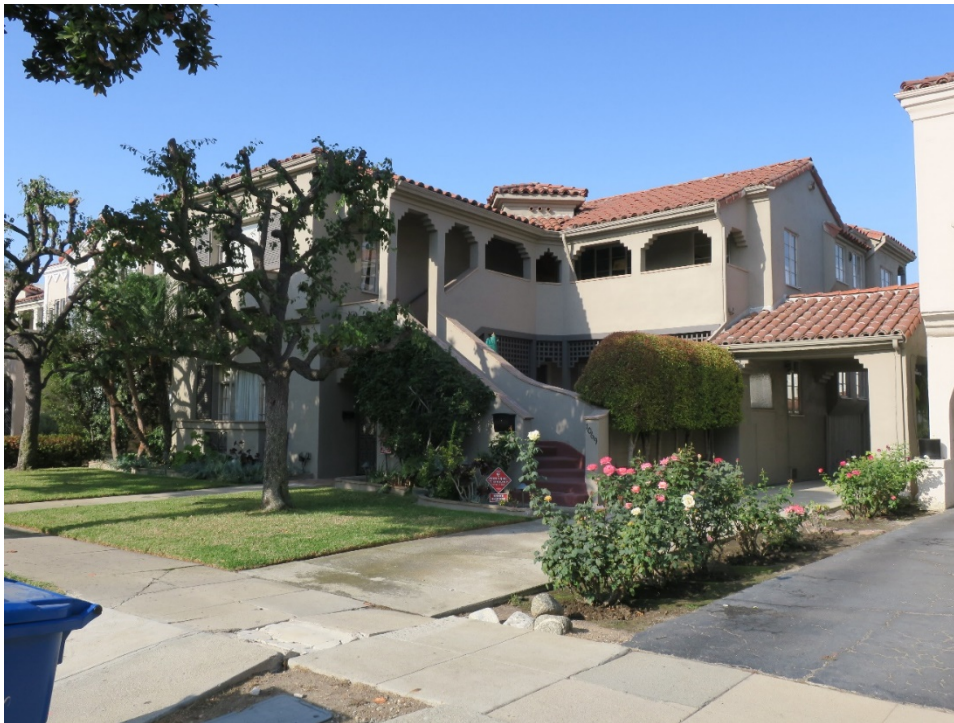
11. 1069-1071 S. Genesee Avenue APN: 5086018024 Contributor 1933
Original Owner: B.I. Coleman Photo 8

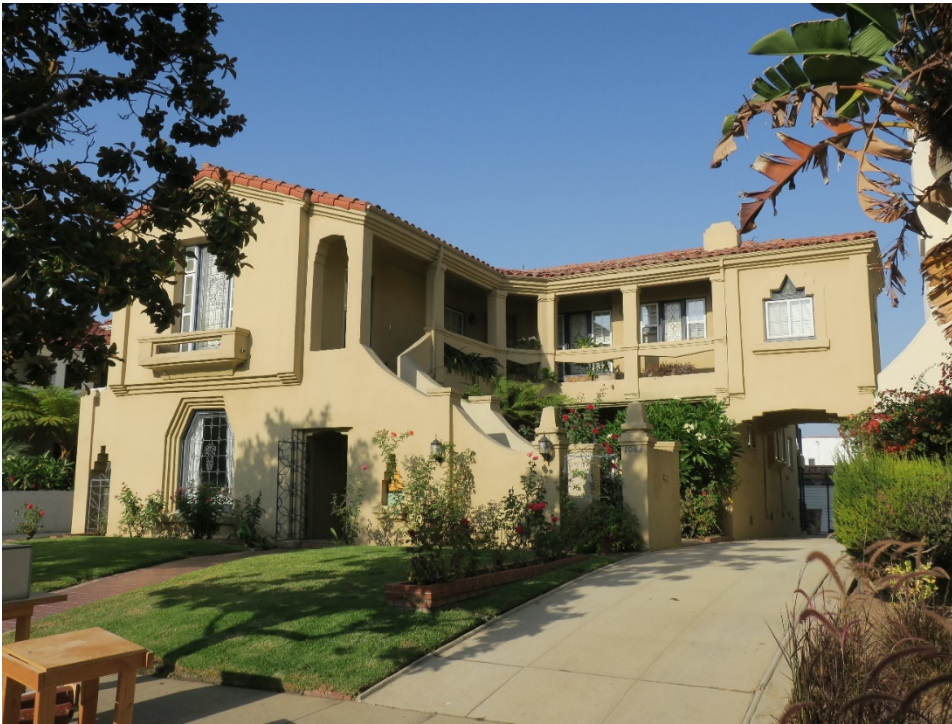
17. 1083-1085 S. Genesee Avenue APN: 5086018027 Contributor 1933
Builder: Mutual Construction Co.; Original Owner: Oscar Kalish Photo 9

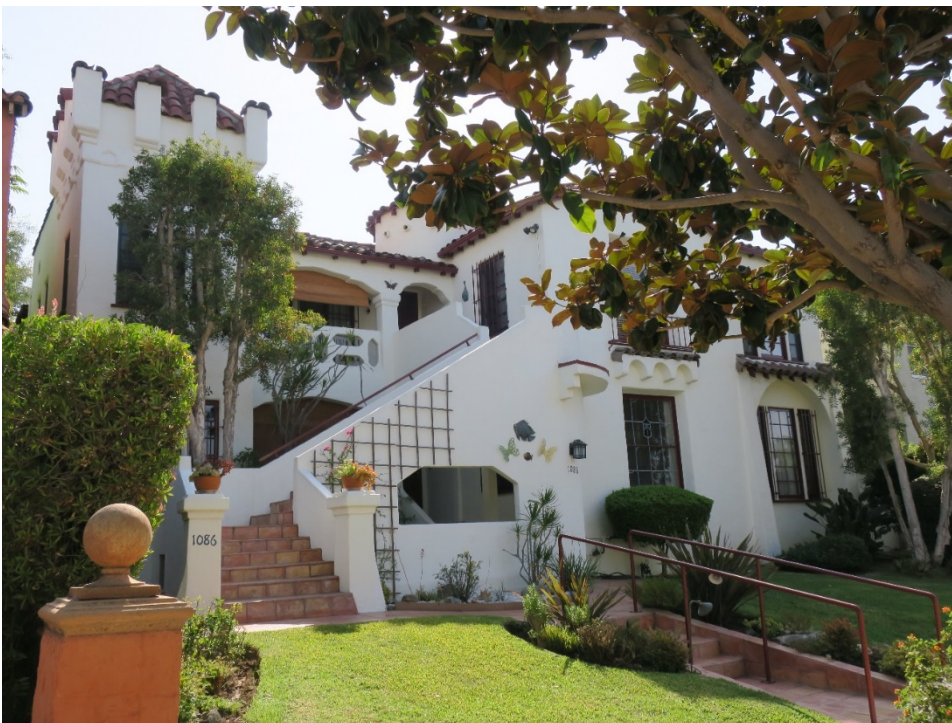
18. 1086-1088 S. Genesee Avenue APN: 5086026002 Contributor 1933
Original Owner: Thomas K. McClelland Photo 10

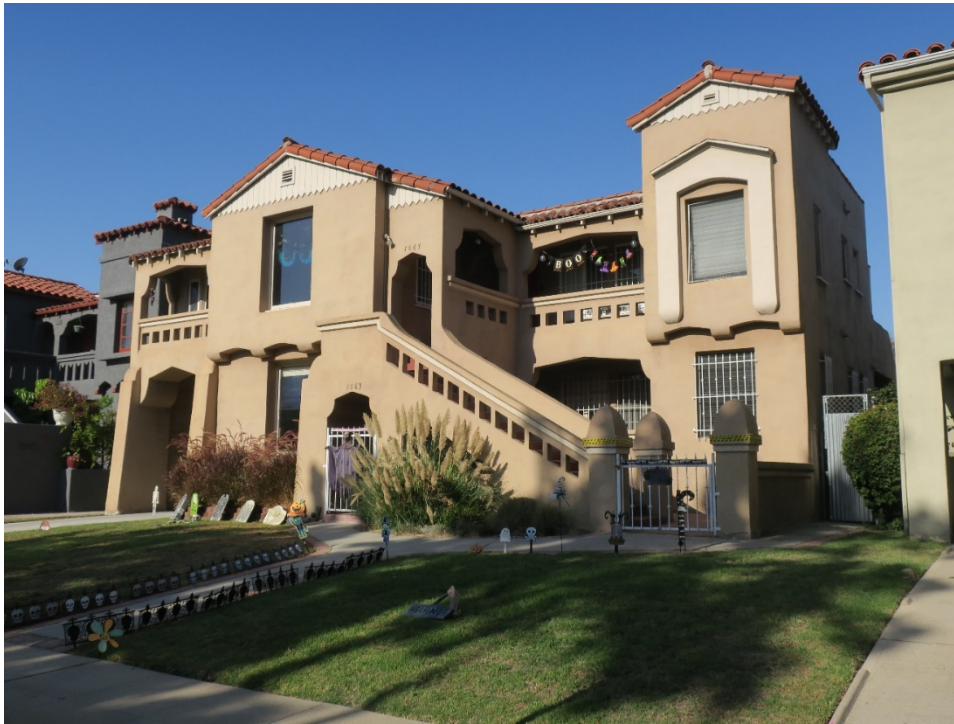
36. 1067-1069 S. Ogden Drive APN: 5086013024 Contributor 1934
Original Owner: A. McClelland Photo 11

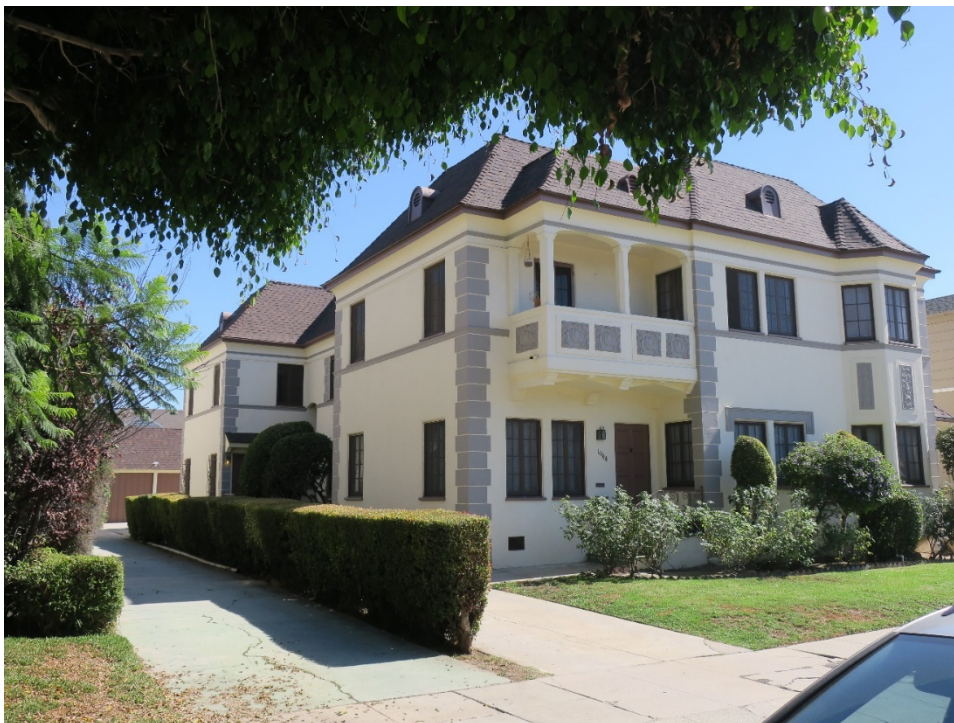
60. 1044-1046 ½ S. Orange Grove Avenue APN: 5086013008 Contributor 1937
Architect: Edith Northman; Original Owner: M. Burgbacher Photo 12

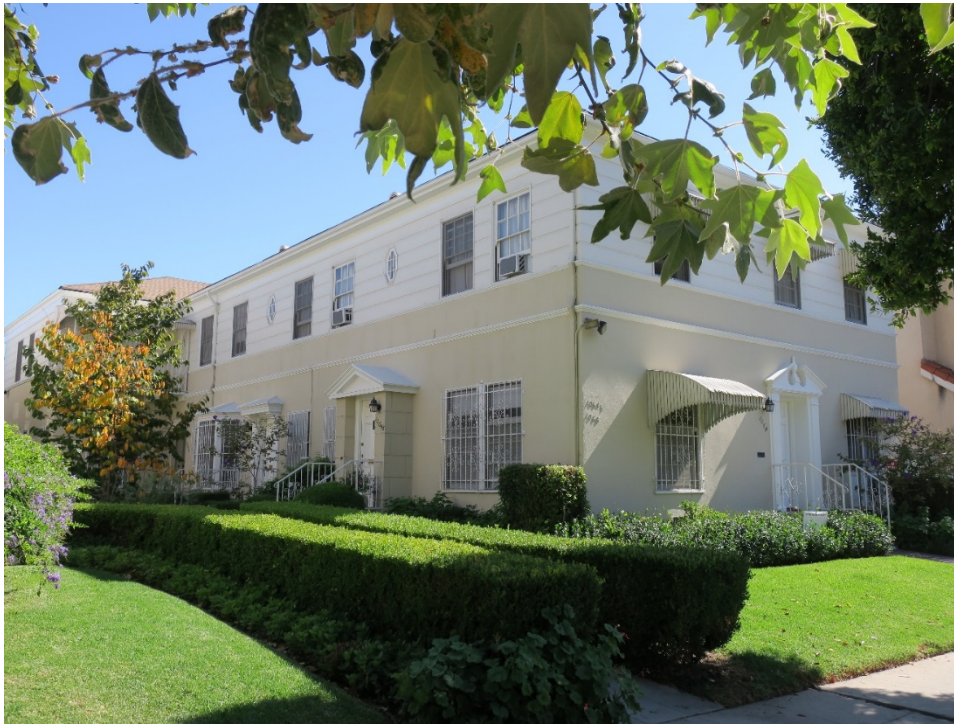
67. 1064-1068 S. Orange Grove Avenue APN: 5086013004 Contributor 1936
Architect: Edith Northman; Original Owner: M. Burgbacher Photo 13

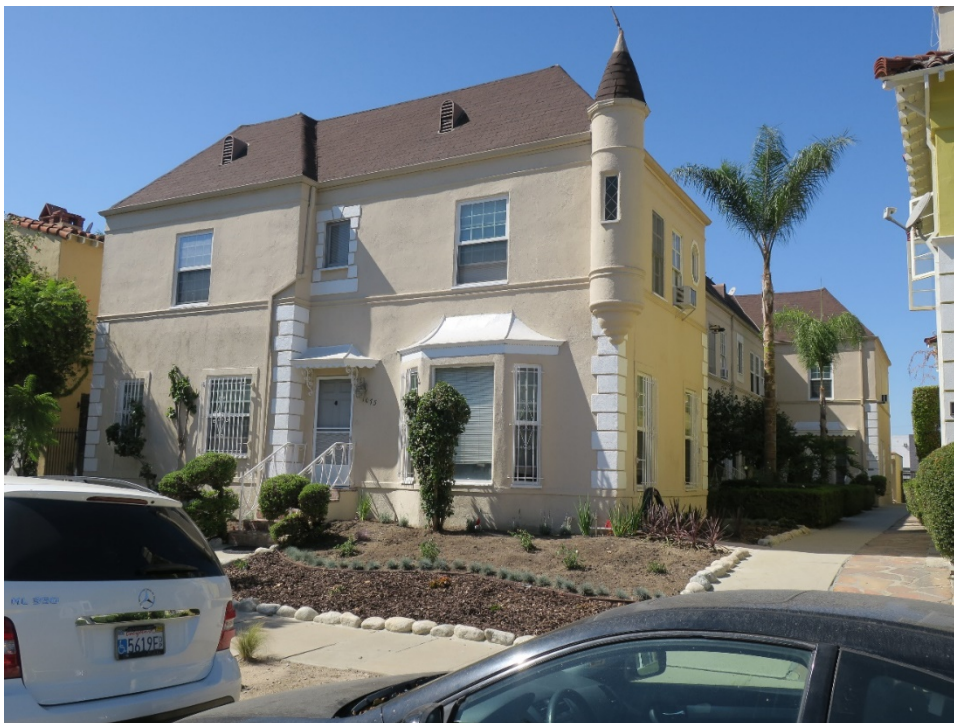
70. 1075-1079 ½ S. Orange Grove Avenue APN: 5086001064 Contributor 1937
Original Owner: Ruth J. Kaplan Photo 14

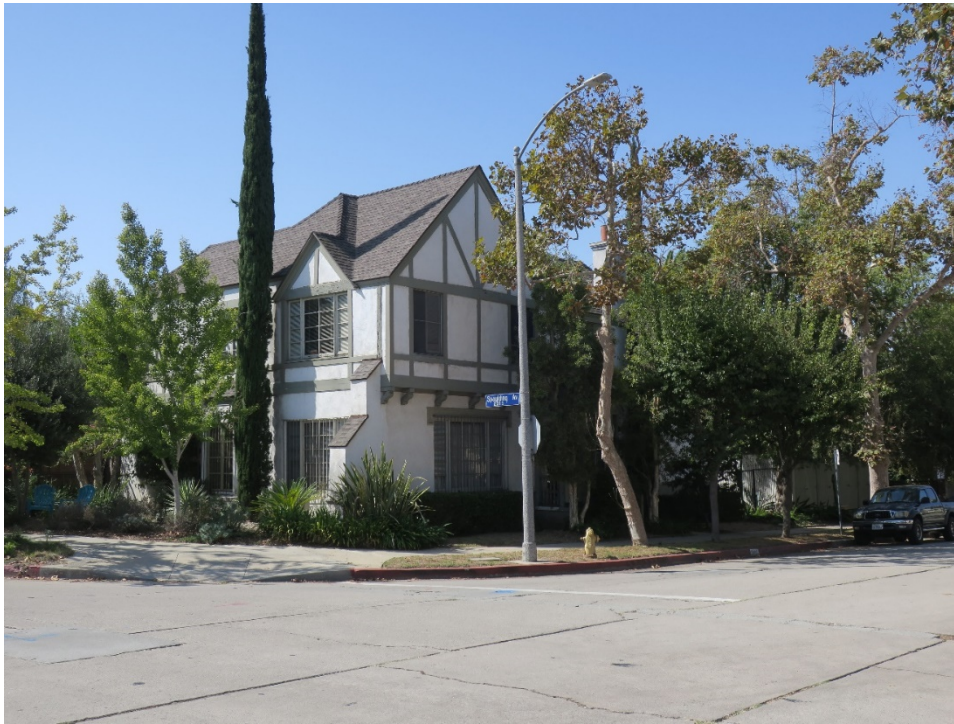
116. 5900 W. Whitworth Drive APN: 5086027029 Contributor 1933
Original Owner: Glenn A. Doughty Photo 15

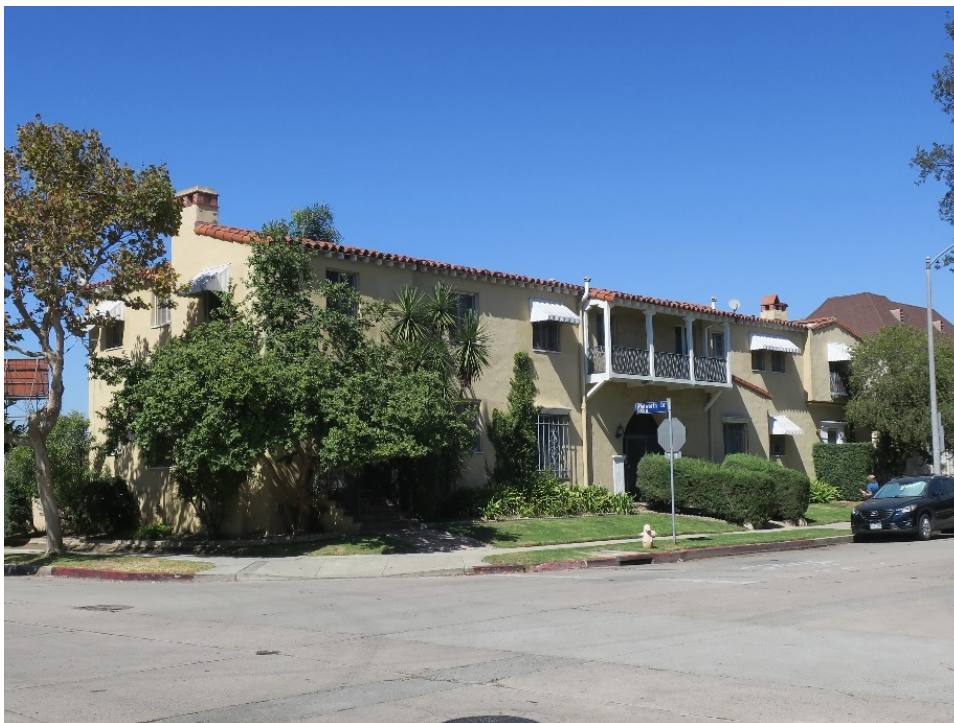
72. 1081-1099 S. Orange Grove Avenue APN: 5086001065 Contributor 1931
Builder: Cartwright and Huffman Ltd.; Original Owner: E.W. Shaw Photo 16

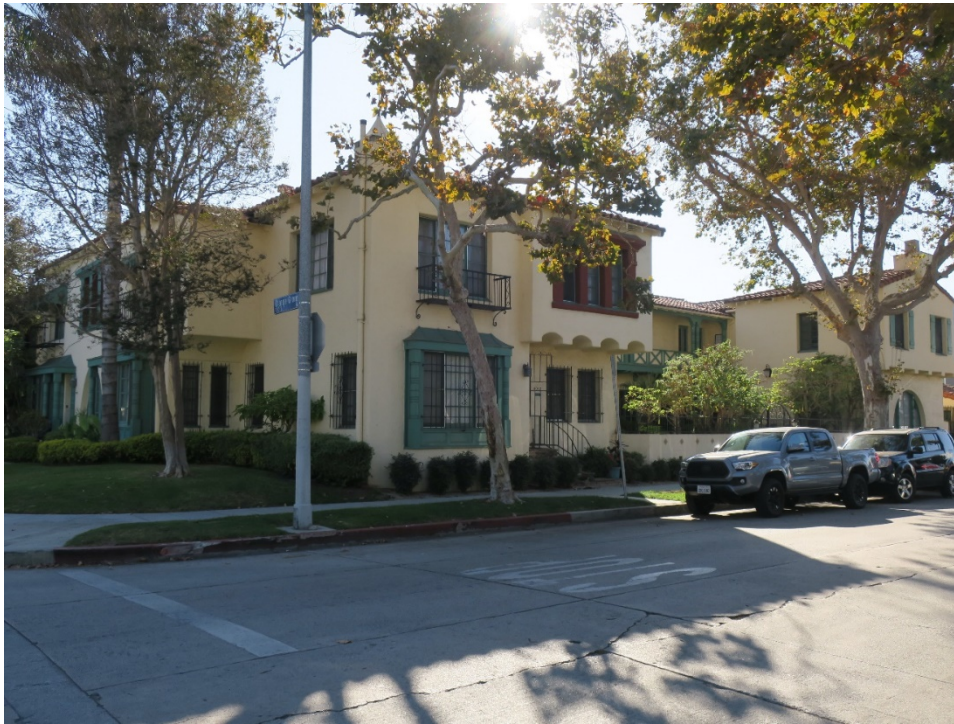
73. 1101-1103 S. Orange Grove Avenue APN: 5086005026 Contributor 1931
Architect: Homer Rice; Builder: Stanley Shave Construction Co.; Original Owner: Dorothy Ralston Buck Photo 17

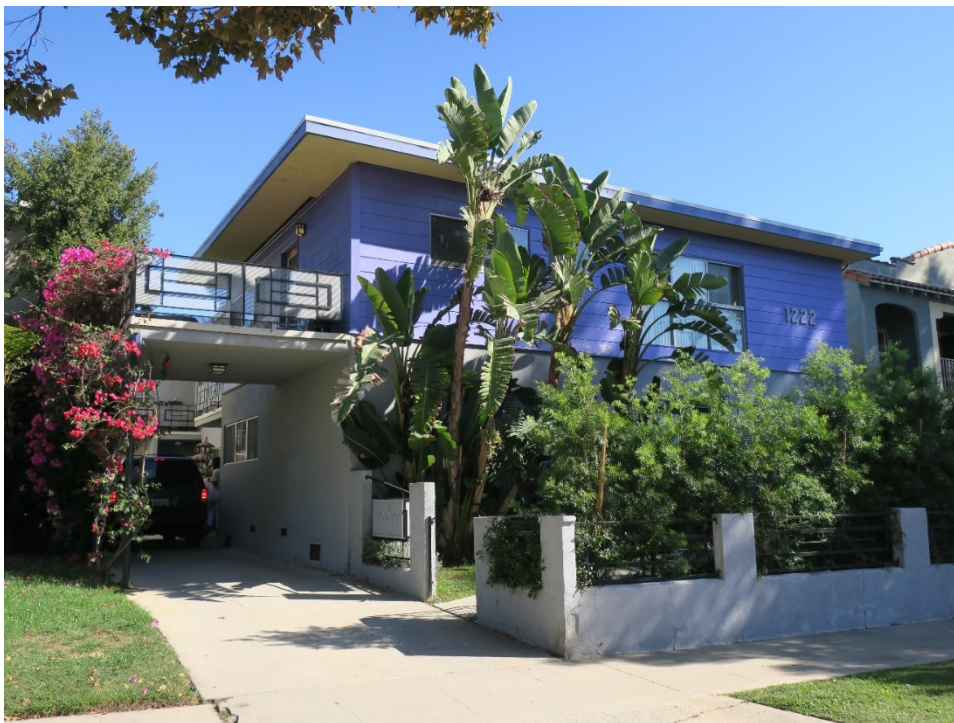
88. 1222 S. Orange Grove Avenue APN: 5086014019 Noncontributor 1955
Original Owner: Ralph Monkarsh Photo 18

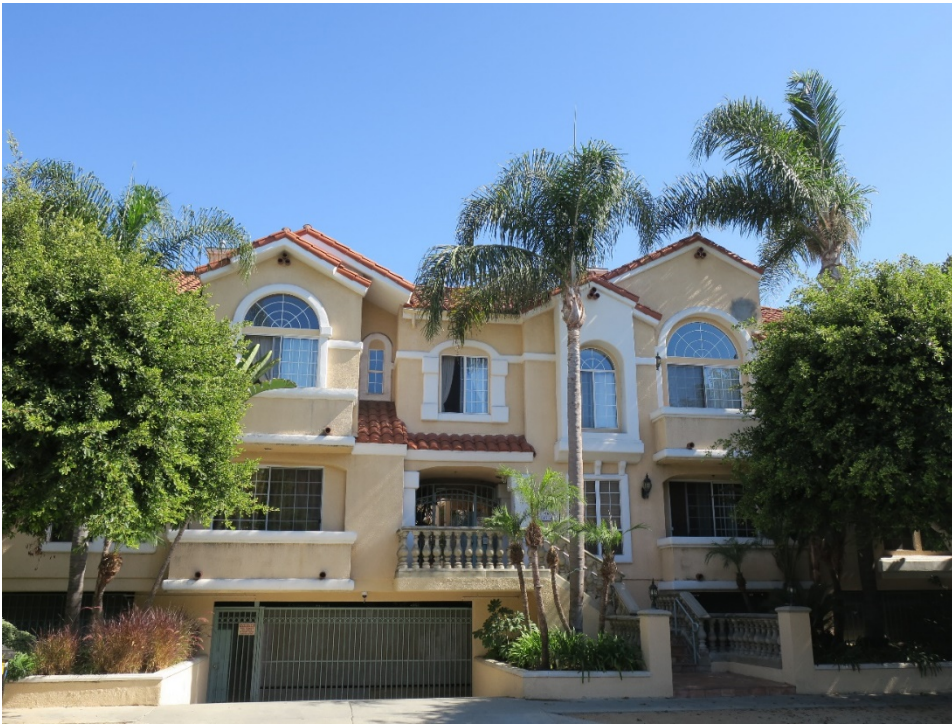
71. 1076 S. Orange Grove Avenue APN: 5086013031 Noncontributor 1991
Architect: Ramon Covarubrias; Original Owner: Darrly Lorian Photo 19
